# New Acland Coal Mine Revised Stage 3 Project

Additional Landholder Bore Survey

QE06644.035 | Final

05 May 2014

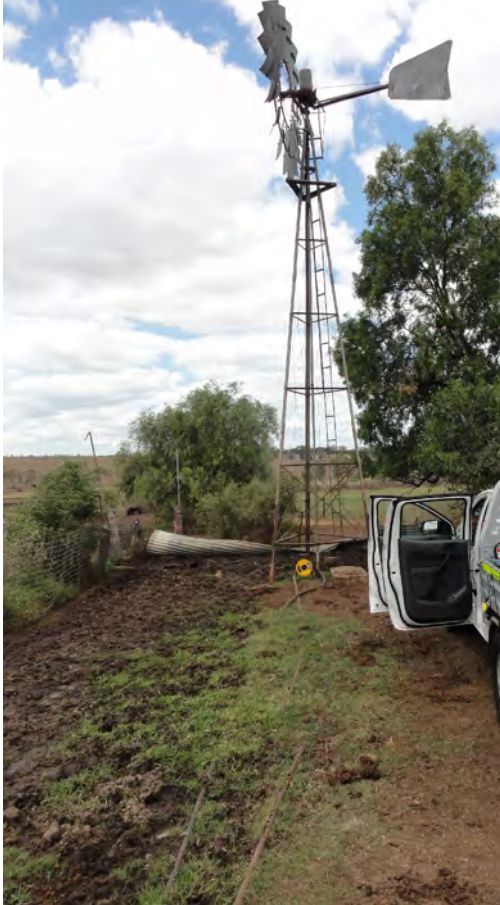
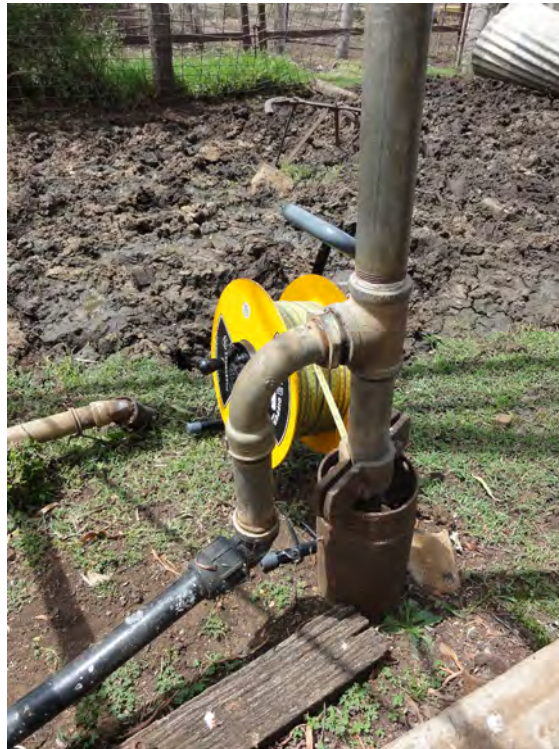
**Assessment Details - 3322 A341637\_01**

<i>Equipment condition:</i>	Windmill is in good condition. The landholder mentions that the bore needed little maintenance early on when installed. But now has seen corrosion on riser. The pipes need replacing every 2 years.
<i>Comments:</i>	
<b>Water Details</b>	
<i>Standing water level (m bgl): (measured or anecdotal)</i>	Brake on the windmill was on when assessment began. Windmill was still pumping intermittently at this time but a standing water level was measured before the brake was taken off. 47.95mbgl (Time: 12:45)
<i>Stable pumping water level (m bgl): (measured, including mins after pump on)</i>	Water level when brake taken off = 47.87mbgl (Time: 13:30). Bore was still pumping intermittently when taking the pumping water level, which may account for an increase in water level.
<i>Water level measuring point</i>	Top of bore casing
<i>Interviewee / owner understanding of typical SWL / PWL (m bgl):</i>	Anecdotal from LH: 24/8/1994 –163ft (49.68m) to water level. 1982 – 163ft (49.68m) to water level.

Landholder comments: "water at the house bore is harder than it used to be 20 years ago"

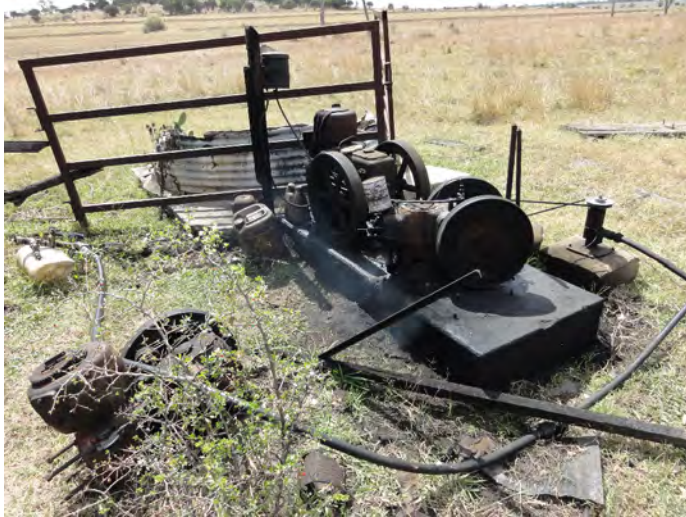
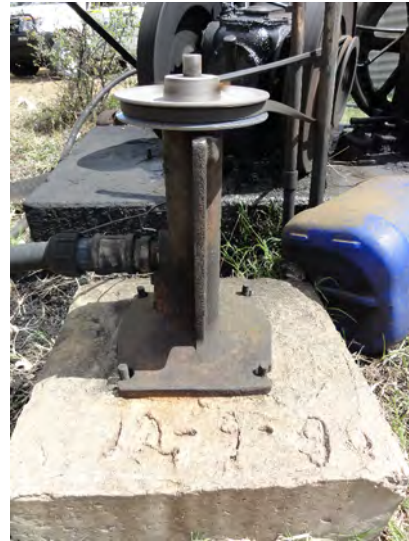
**Assessment Details – 3322\_A341637\_02**

<i>Bore Condition Comments:</i>	Bore in good condition. Landholder mentions that it rarely needs maintenance. Unable to see casing as bore is sealed. Monument is in good condition.
<b>Bore Equipment Details</b>	
<i>Pump Installed?</i>	Y
<i>Pump type, make and model, power source:</i>	Mono pump, A model (1.5 inch)(anecdotal), Diesel engine (crank start).
<i>Date installed:</i>	17/09/1996 installed. The previous pump was a jet pump installed in 1965.
<i>Date of most recent use</i>	03/02/2014 (morning of assessment). Pump on 5:15am and off at 8:45am.
<i>Any repairs?</i>	Checked in 2013 but no repairs required. Rod replacements required in the past were only minor.
<i>Pump intake depth (m bgl):</i>	138ft approx (42.06m) (anecdotal). LH states the pump intake depth is believed to be very close to TD.
<i>Interviewee's est. annual take (ML):</i>	1.55ML
<i>Basis for estimate:</i>	During drier months pumps every day. When wetter every 2 days. Pumps for 3-5 hours. Flow rate used: 0.4L/s

<i>Equipment condition:</i>	When equipment checked by the landholder in 2013, didn't need replacing. Diesel motor is old and has signs of leakage but in good working order.
<i>Comments:</i>	
<b>Water Details</b>	
<i>Standing water level (m bgl): (measured or anecdotal)</i>	Na
<i>Stable pumping water level (m bgl): (measured, including mins after pump on)</i>	Na
<i>Water level measuring point</i>	Na
<i>Interviewee / owner understanding of typical SWL / PWL (m bgl):</i>	None.
<i>Comments:</i>	The bore is completely sealed and there is no airline.
<b>Water Sampling Details</b>	
<i>Any historic water quality data available from owner?</i>	None available
<i>Any account of gas in the bore from interviewee?</i>	None
<i>Any potential for contamination at bore? (fuel storage, open bore casing, no stickup, aquifer intermixing from casing degradation)</i>	The diesel motor has leaked in the past. Old engine parts and vehicle is laid as scrap nearby. Plastic containers, with unknown contents are stored next to bore. The bore is well sealed and there is no diesel around monument.

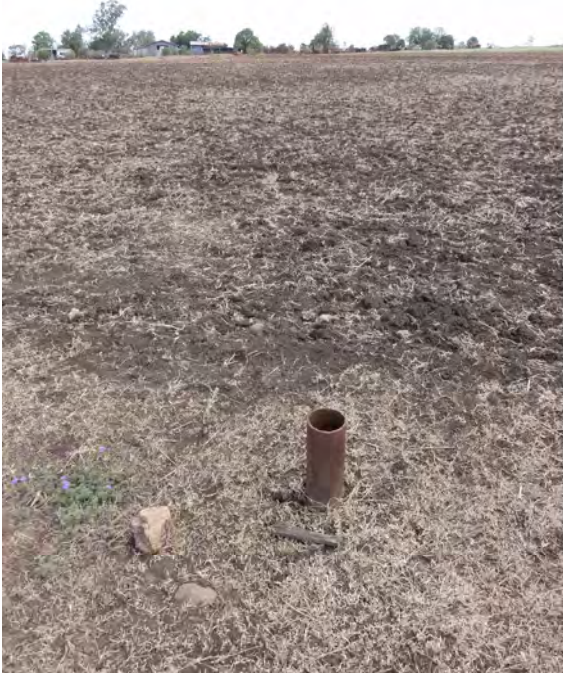
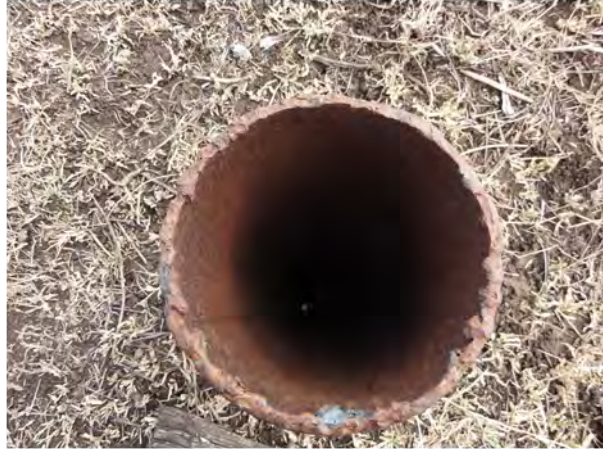
**Assessment Details – 3322\_A341637\_03**

<b>Assessment Details – 3322_A341637_03</b>	
<i>Typical duration and frequency of pumping: (any seasonal variations?)</i>	Na
<i>Measured Maximum Flow Rate of Bore and Headworks at Site Visit (L/s)</i>	Na
<i>Describe riser, headwork and water distribution details:</i>	Open casing
<i>Equipment condition:</i>	Na
<i>Comments:</i>	
<b>Water Details</b>	
<i>Standing water level (m bgl): (measured or anecdotal)</i>	4.8mbgl
<i>Stable pumping water level (m bgl): (measured, including mins after pump on)</i>	Na
<i>Water level measuring point</i>	Top of casing
<i>Interviewee / owner understanding of typical SWL / PWL (m bgl):</i>	Na. The owner once put a fireman's pump in the bore and it stopped and started when the intake was set at 27ft (8.2m) (potentially indicating that the water level was drawn below this point)
<i>Comments:</i>	
<b>Water Sampling Details</b>	
<i>Any historic water quality data available from owner?</i>	No

<i>Any account of gas in the bore from interviewee?</i>	None
<i>Any potential for contamination at bore? (fuel storage, open bore casing, no stickup, aquifer intermixing from casing degradation)</i>	Bore is open and is to the edge of a field and could potentially be contaminated by ploughing activities. There is potential for contamination from a number of organic sources (e.g. cattle).
<i>Water quality sample collected during this assessment?</i>	No
<i>Sample type: (primary, duplicate, field blank)</i>	Na
<b>General Comments</b>	
<b>Pictures</b>

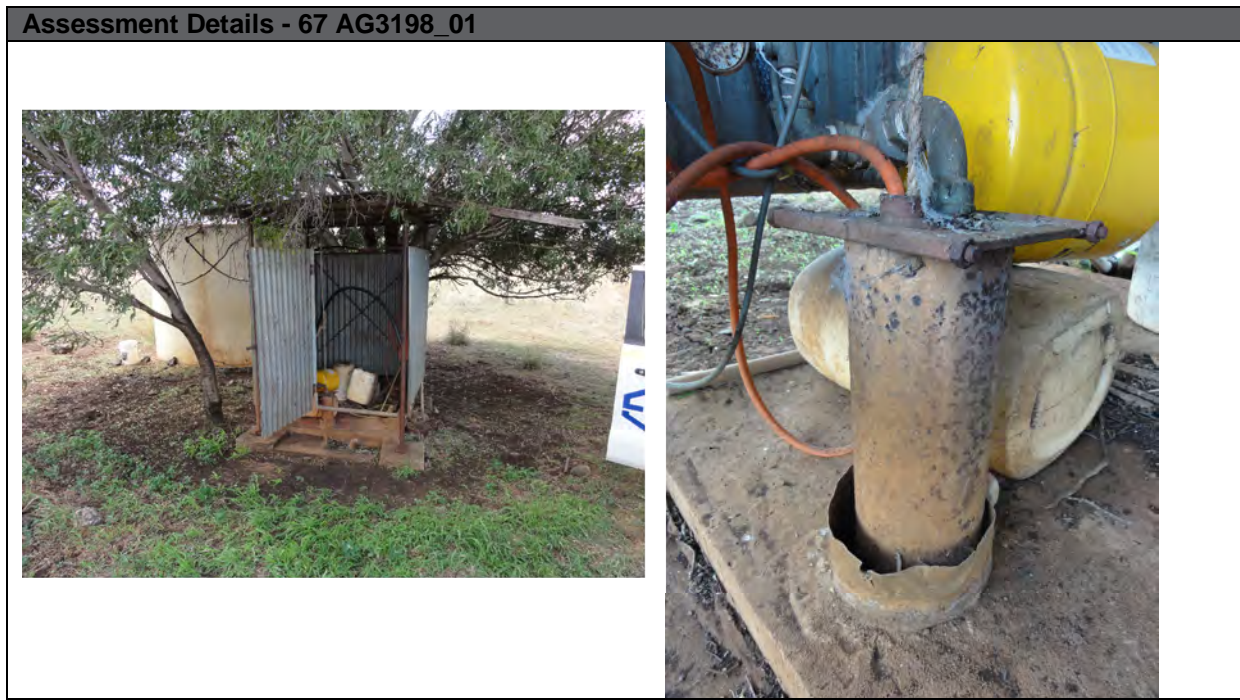
Surface casing dia. (mm), and material:	165mm, Believed to be Tin (Thought to be protecting the bore when the concrete step was set)
Bore casing dia. (mm), and material:	Approx. 130mm, Steel
Bore casing stickup above ground (m):	0.34m
Aquifer: (& source of information: log, anecdotal)	Unknown
Top of screen (m bgl):	Unknown
Bottom of screen (m bgl):	Unknown
Top of open hole (m bgl):	Unknown
Total depth (m):	Unknown
Bore Condition Comments:	Bore casing shows surface corrosion but structure appears sound. The concrete step around the bore reduces potential damage and contamination. The bore has a cap on top, which creates a fairly tight seal.
<b>Bore Equipment Details</b>	
Pump Installed?	Yes
Pump type, make and model, power source:	Submersible, Unknown make and model, electrical supply.
Date installed:	Unknown
Date of most recent use	Used 03/02/2014 (anecdotal from landholder)
Any repairs?	Unknown
Pump intake depth (m bgl):	Unknown

<i>Sample type: (primary, duplicate, field blank)</i>	Primary
<b>General Comments</b>	
Landholder does not want water running on to land for duration of test. Have to start and stop pump to purge and sample, disconnecting the outflow to the storage tank. This is then repeated until water chemistry parameters stabilise and a sample was taken for laboratory analysis.	
The landholder was unavailable to assist or to be interviewed during the survey.	
<b>Pictures</b>

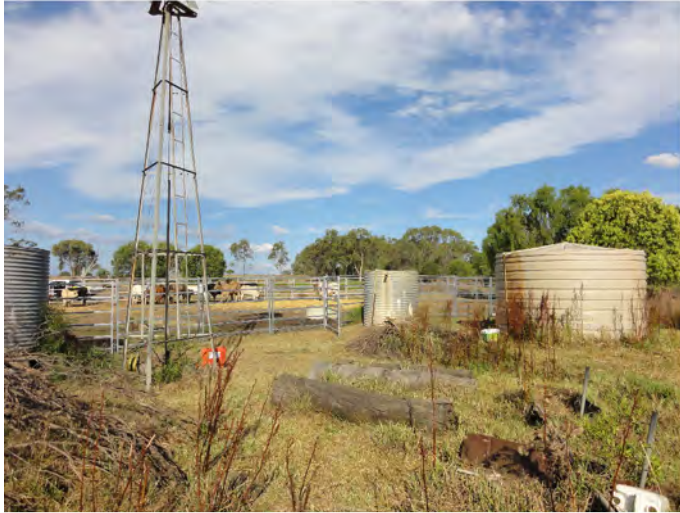
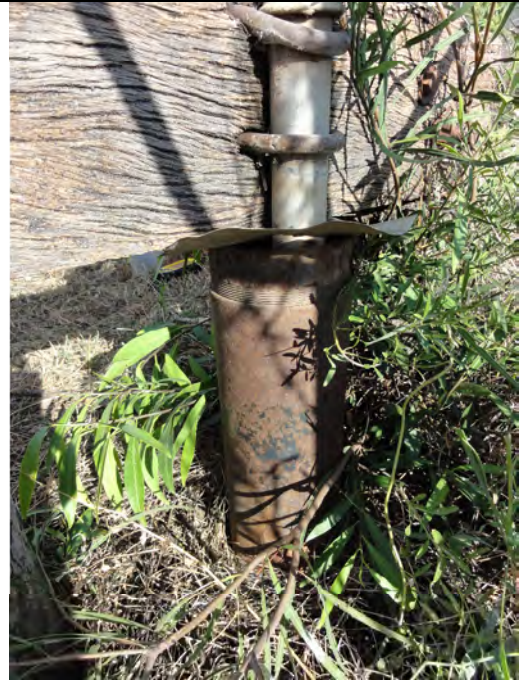
**Assessment Details – 10\_RP36467\_01**

Date Installed:	Unknown
Surface casing dia. (mm), and material:	Approx. 127mm, steel
Bore casing dia. (mm), and material:	As above
Bore casing stickup above ground (m):	0.38m
Aquifer: (& source of information: log, anecdotal)	Unknown
Top of screen (m bgl):	Unknown
Bottom of screen (m bgl):	Unknown
Top of open hole (m bgl):	Unknown
Total depth (m):	Measured at 41.91mbgl (total depth or obstruction)
Bore Condition Comments:	Bore is in good condition. Bore casing shows surface corrosion but structure appears sound. A basic tin cap on top of bore limits contamination.
<b>Bore Equipment Details</b>	
Pump Installed?	Y
Pump type, make and model, power source:	Windmill pump, southern cross windmill (30ft estimated)
Date installed:	Unknown
Date of most recent use	Constant
Any repairs?	Unknown
Pump intake depth (m bgl):	Unknown
Interviewee's est. annual take (ML):	Unknown
Basis for estimate:	Unknown
Is bore use metered? Give details:	No

<b>General Comments</b>	
Wind is intermittent but has been blowing on and off since first visited the site earlier this afternoon. Wind became stronger and more consistent towards the end of test as the afternoon continued.	
The landholder was unavailable to assist or to be interviewed during the survey.	
<b>Pictures</b>

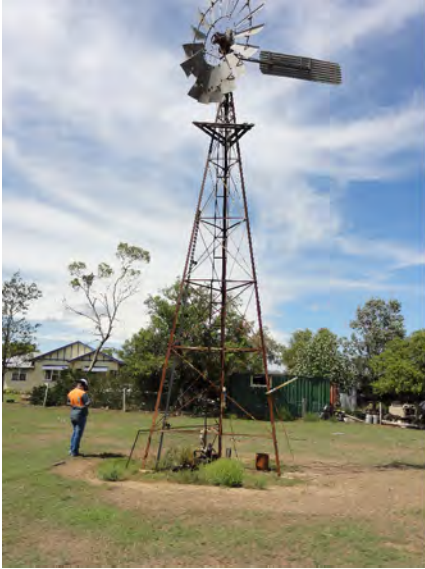
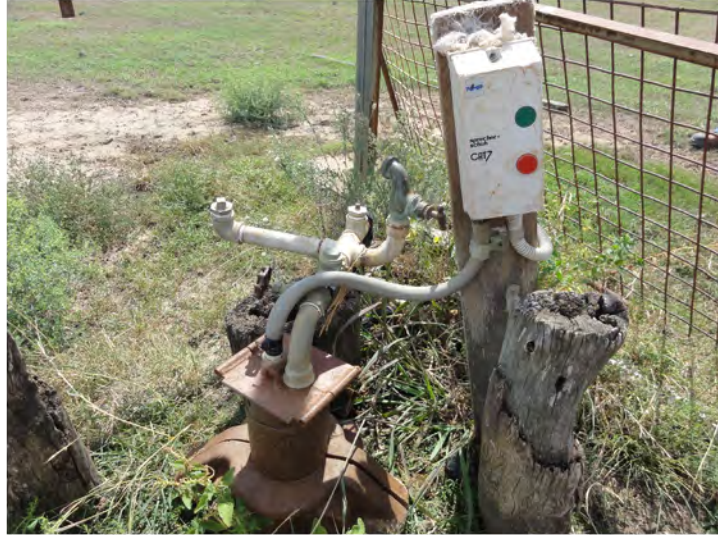
**Assessment Details – 2\_RP40478\_01**

<i>Pump Installed?</i>	Unknown
<i>Pump type, make and model, power source:</i>	The pump control box appears to be connected to an electric cable, which becomes buried. It is unknown if the bore is equipped with a pump or if in working condition.
<i>Date installed:</i>	Unknown
<i>Date of most recent use</i>	Unknown
<i>Any repairs?</i>	Unknown
<i>Pump intake depth (m bgl):</i>	Unknown
<i>Interviewee's est. annual take (ML):</i>	Unknown
<i>Basis for estimate:</i>	Unknown
<i>Is bore use metered? Give details:</i>	Unknown
<i>Detail specific uses of the bore water:</i>	Unknown
<i>Detail all other water sources for property:</i>	Aware of 9 other bores on the property, that were visited as part of the assessments. On the day of assessment only 4 of these bores were known to

<i>Comments:</i>	Unsure about the bore set up and whether it is in working condition. LH not present, so unable to turn bore on.
<b>Water Details</b>	
<i>Standing water level (m bgl): (measured or anecdotal)</i>	Unknown
<i>Stable pumping water level (m bgl): (measured, including mins after pump on)</i>	Unknown
<i>Water level measuring point</i>	Na
<i>Interviewee / owner understanding of typical SWL / PWL (m bgl):</i>	Unknown
<i>Comments:</i>	Bore is sealed and does not have an airline.
<b>Water Sampling Details</b>	
<i>Any historic water quality data available from owner?</i>	Unknown
<i>Any account of gas in the bore from interviewee?</i>	Unknown
<i>Any potential for contamination at bore? (fuel storage, open bore casing, no stickup, aquifer intermixing from casing degradation)</i>	Bore is very well sealed. There are storage sheds and barns nearby, which appear to contain vehicles and farm equipment.

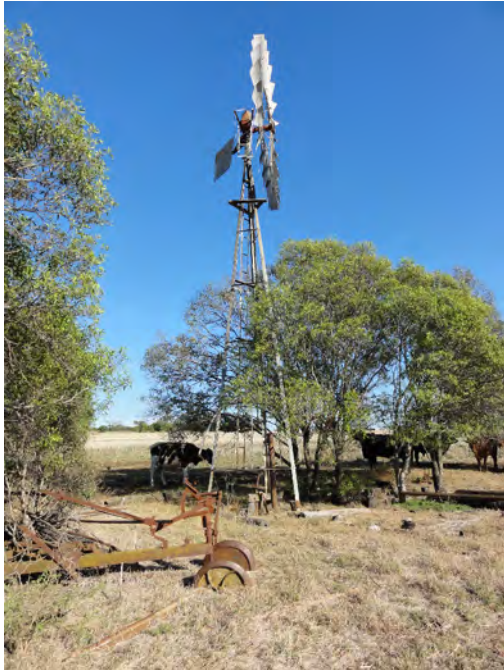
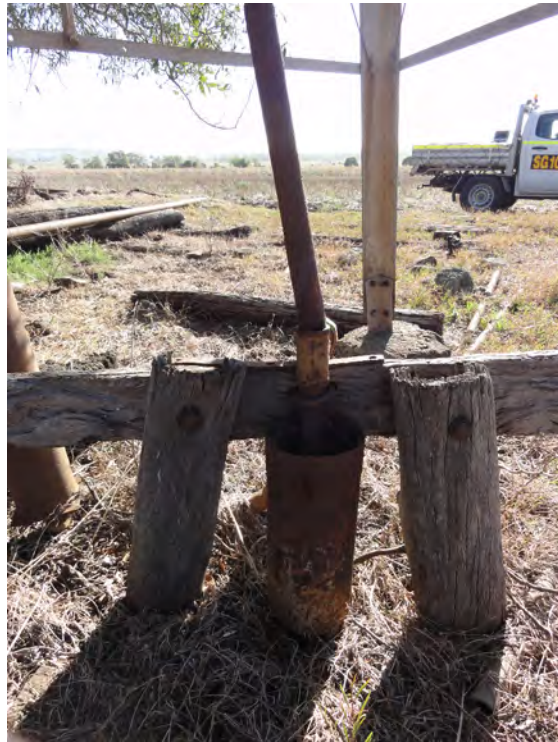
**Assessment Details – 2\_RP36455\_01**

<i>GDA Longitude (decimal deg.):</i>	151°41'29.27"E
<i>Water licence number and details: (if available to view)</i>	Unknown
<b>Bore Construction Details</b>	
<i>Construction details / log available?</i>	Unknown
<i>Date Installed:</i>	Unknown
<i>Surface casing dia. (mm), and material:</i>	160mm, Steel
<i>Bore casing dia. (mm), and material:</i>	At 0.05m above ground level the casing reduces in diameter to approx. 140mm
<i>Bore casing stickup above ground (m):</i>	0.405m
<i>Aquifer: (&amp; source of information: log, anecdotal)</i>	Unknown
<i>Top of screen (m bgl):</i>	Unknown
<i>Bottom of screen (m bgl):</i>	Unknown
<i>Top of open hole (m bgl):</i>	Unknown
<i>Total depth (m):</i>	Measured at 79.955 mbgl (total depth or obstruction). Some difficulty was experienced retrieving equipment after tagging what is believed to be total depth.
<i>Bore Condition Comments:</i>	The bore casing above ground is heavily corroded and has some minor holes, which allows the potential of contamination.

<b>Bore Equipment Details</b>	
<i>Pump Installed?</i>	Unknown. Rising main is still secured in the bore but disconnected from windmill above ground.
<i>Pump type, make and model, power source:</i>	Na
<i>Date installed:</i>	Unknown
<i>Date of most recent use</i>	Unknown
<i>Any repairs?</i>	Unknown
<i>Pump intake depth (m bgl):</i>	Unknown
<i>Interviewee's est. annual take (ML):</i>	Unknown
<i>Basis for estimate:</i>	Unknown
<i>Is bore use metered? Give details:</i>	No
<i>Detail specific uses of the bore water:</i>	Believed it would have historically been used for stock.
<i>Detail all other water sources for</i>	Aware of 9 other bores on the property, that were visited as part of the

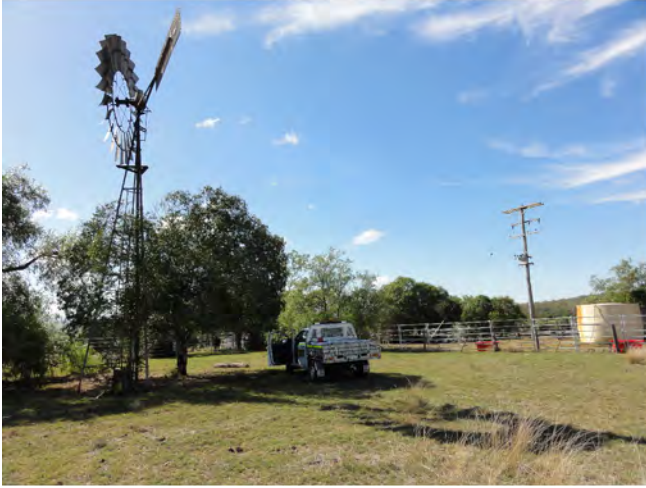
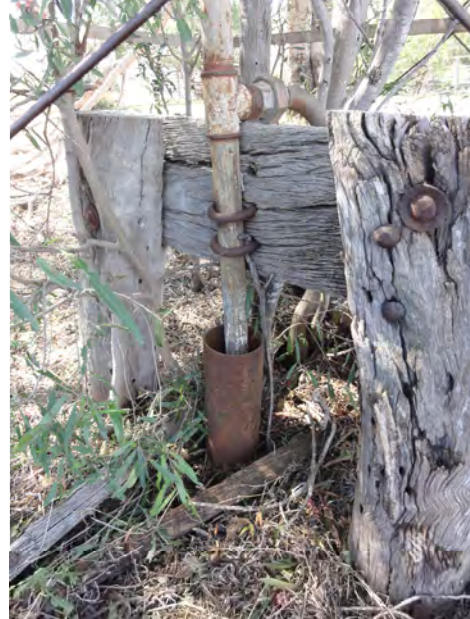
**Assessment Details – 2\_RP36455\_02**

<i>GDA Latitude (decimal deg.):</i>	27°21'25.69"S
<i>GDA Longitude (decimal deg.):</i>	151°41'17.75"E
<i>Water licence number and details: (if available to view)</i>	Unknown
<b>Bore Construction Details</b>	
<i>Construction details / log available?</i>	Unknown
<i>Date Installed:</i>	Unknown
<i>Surface casing dia. (mm), and material:</i>	127mm, steel
<i>Bore casing dia. (mm), and material:</i>	At 0.1m above ground level the casing diameter reduces to approx. 107mm.
<i>Bore casing stickup above ground (m):</i>	0.34m
<i>Aquifer: (&amp; source of information: log, anecdotal)</i>	Unknown
<i>Top of screen (m bgl):</i>	Unknown
<i>Bottom of screen (m bgl):</i>	Unknown
<i>Top of open hole (m bgl):</i>	Unknown
<i>Total depth (m):</i>	Unknown. Did not dip total depth, due to potential obstruction when measuring water level, which may have snagged equipment.
<i>Bore Condition Comments:</i>	Bore is in good condition. Bore casing shows surface corrosion but structure appears sound. On the outside of the casing there is heavy corrosion for the first 0.1m above ground.

<b>Bore Equipment Details</b>	
<i>Pump Installed?</i>	Unknown. Rising main is still in the bore but disconnected from the windmill above ground.
<i>Pump type, make and model, power source:</i>	Unknown
<i>Date installed:</i>	Unknown
<i>Date of most recent use</i>	Unknown
<i>Any repairs?</i>	Unknown
<i>Pump intake depth (m bgl):</i>	Unknown
<i>Interviewee's est. annual take (ML):</i>	Unknown
<i>Basis for estimate:</i>	Unknown
<i>Is bore use metered? Give details:</i>	No
<i>Detail specific uses of the bore water:</i>	Believed it would have once been used for stock water.
<i>Detail all other water sources for</i>	Aware of 9 other bores on the property, that were visited as part of the

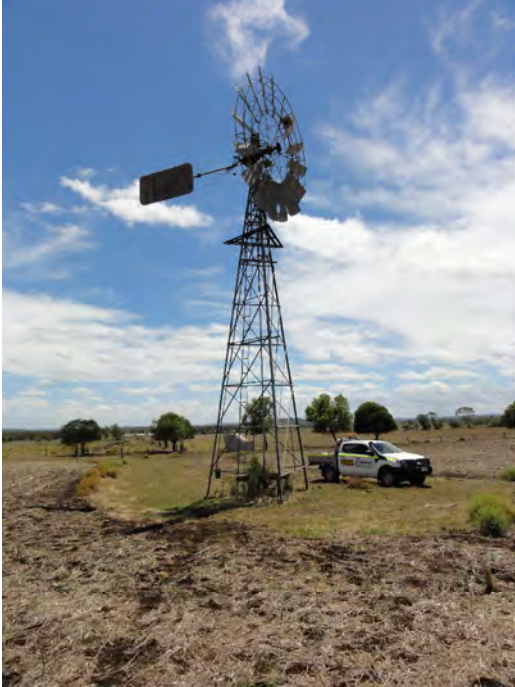
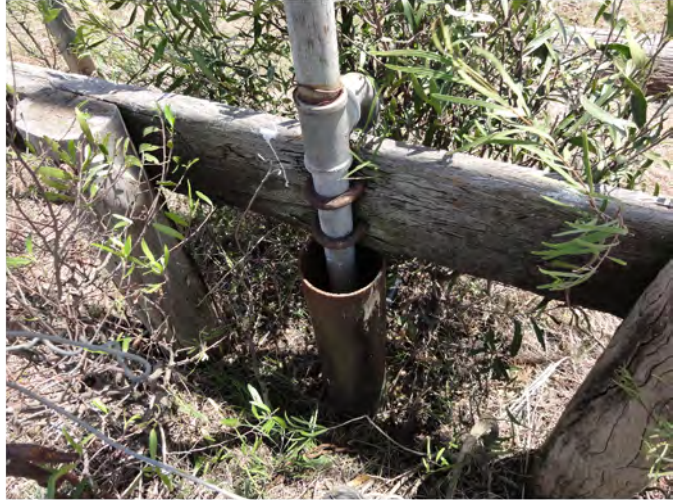
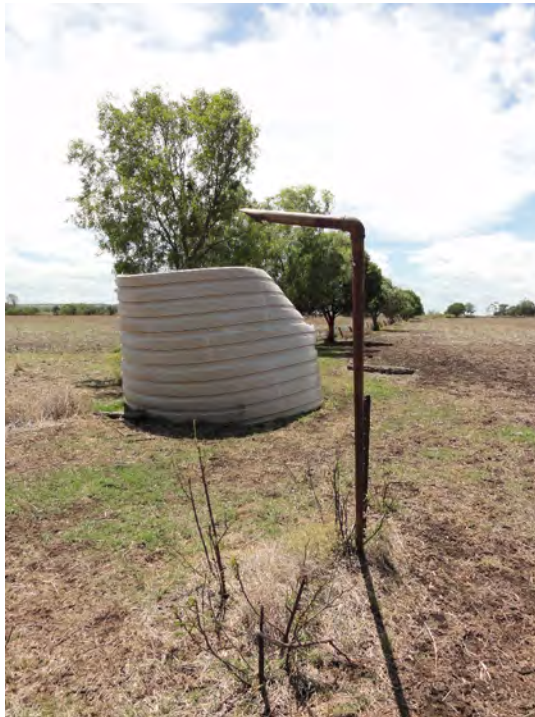
**Assessment Details - 2\_RP40478\_02**

<b>Assessment Details - 2_RP40478_02</b>	
<i>Property name:</i>	Unknown
<i>Local bore name:</i>	Unknown Description: the chained off windmill that can be seen from the property on Acland Sabine Road. It is in the paddock next to the broken white water storage tank.
<i>Registered Number:</i>	Unknown but believed to be RN 87948
<i>Registered number source: (anecdotal, DNRM records, bore log etc)</i>	DNRM database search
<i>Assessment date and time:</i>	05/02/2014 10:30
<i>Field staff name:</i>	C Dilley
<b>Property Details</b>	
<i>Lot and Plan number:</i>	2 RP40478
<b>Interviewee Details</b>	
<i>Interviewee relationship to property: (owner, tenant, manager etc)</i>	Not available on day of assessment (see <i>general comments</i> below)
<b>Bore Details</b>	
<i>Status of bore: (existing, abandoned, destroyed)</i>	Existing
<i>Uses of bore: (Stock, feedlot, domestic, irrigation etc)</i>	Believed it would have been used for stock. Windmill appears to be chained to the frame to stop movement. Water storage tank near bore is damaged and not in use.

<i>GDA Latitude (decimal deg.):</i>	27°21'5.73"S
<i>GDA Longitude (decimal deg.):</i>	151°40'59.93"E
<i>Water licence number and details: (if available to view)</i>	Unknown
<b>Bore Construction Details</b>	
<i>Construction details / log available?</i>	Unknown
<i>Date Installed:</i>	Unknown
<i>Surface casing dia. (mm), and material:</i>	140mm, Steel
<i>Bore casing dia. (mm), and material:</i>	As above
<i>Bore casing stickup above ground (m):</i>	0.55m
<i>Aquifer: (&amp; source of information: log, anecdotal)</i>	Unknown
<i>Top of screen (m bgl):</i>	Unknown
<i>Bottom of screen (m bgl):</i>	Unknown
<i>Top of open hole (m bgl):</i>	Unknown
<i>Total depth (m):</i>	90.28mbgl (total depth or obstruction)
<i>Bore Condition Comments:</i>	Bore casing shows small areas of surface corrosion but structure appears sound.
<b>Bore Equipment Details</b>	
<i>Pump Installed?</i>	Unknown. Believed to be a fully functional windmill set up that has been chained off, which may be because of damaged water tank. There appears to be no infrastructure in place for the bore to pump to.

<i>Equipment condition:</i>	Appears to be in good condition above ground. Unknown condition of pump.
<i>Comments:</i>	
<b>Water Details</b>	
<i>Standing water level (m bgl): (measured or anecdotal)</i>	49.99mbgl
<i>Stable pumping water level (m bgl): (measured, including mins after pump on)</i>	Na
<i>Water level measuring point</i>	Top of casing
<i>Interviewee / owner understanding of typical SWL / PWL (m bgl):</i>	Unknown
<i>Comments:</i>	
<b>Water Sampling Details</b>	
<i>Any historic water quality data available from owner?</i>	Unknown
<i>Any account of gas in the bore from interviewee?</i>	Unknown
<i>Any potential for contamination at bore? (fuel storage, open bore casing, no stickup, aquifer intermixing from casing degradation)</i>	The bore is not sealed and has some vegetation growing around the opening. The bore is protected from cattle by the windmill structure.
<i>Water quality sample collected during this assessment?</i>	N

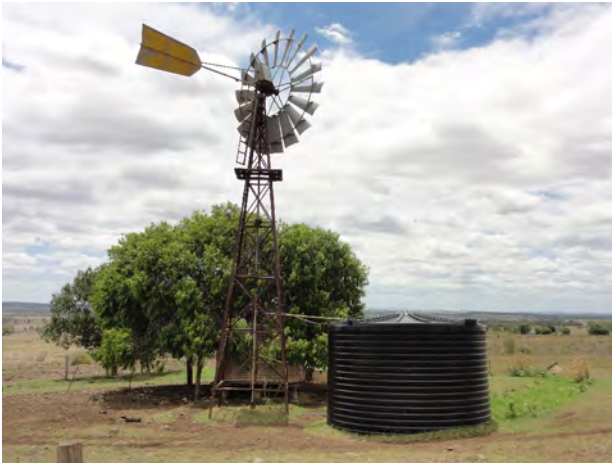
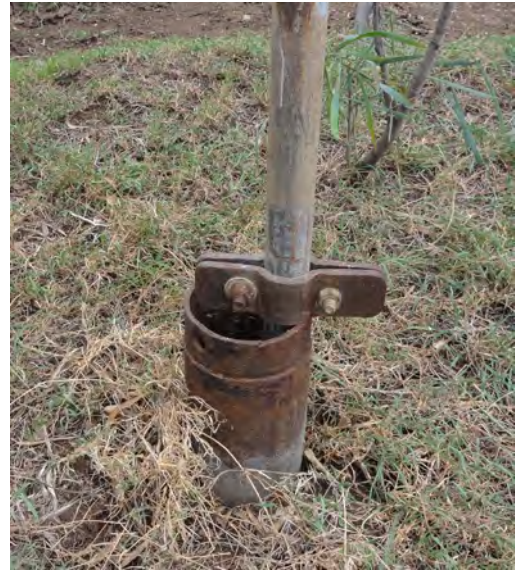
**Assessment Details - 2517 \_ A341144\_ 01**

Date Installed:	Unknown
Surface casing dia. (mm), and material:	127mm, Steel
Bore casing dia. (mm), and material:	As above
Bore casing stickup above ground (m):	0.23m
Aquifer: (& source of information: log, anecdotal)	Unknown
Top of screen (m bgl):	Unknown
Bottom of screen (m bgl):	Unknown
Top of open hole (m bgl):	Unknown
Total depth (m):	Unknown. Did not measure on day of assessment because when nearing the water level the dipper encountered some resistance and nearly got caught.
Bore Condition Comments:	Bore casing shows surface corrosion but structure appears sound. Concern about internal structure due to potential internal obstruction encountered
<b>Bore Equipment Details</b>	
Pump Installed?	Yes
Pump type, make and model, power source:	Windmill, Unknown.
Date installed:	Unknown
Date of most recent use	Constant use
Any repairs?	Unknown
Pump intake depth (m bgl):	Unknown
Interviewee's est. annual take (ML):	Unknown

<i>Water quality sample collected during this assessment?</i>	Y
<i>Sample type: (primary, duplicate, field blank)</i>	Primary
<b>General Comments</b>	
The landholder was unavailable to assist or to be interviewed during the survey.	
Wind has been fairly strong all day. Flow rate is approx. 1 L per min at time of sampling.	
<b>Pictures</b>

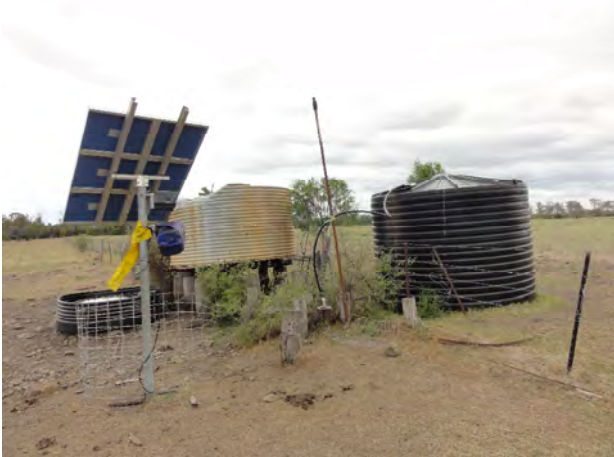
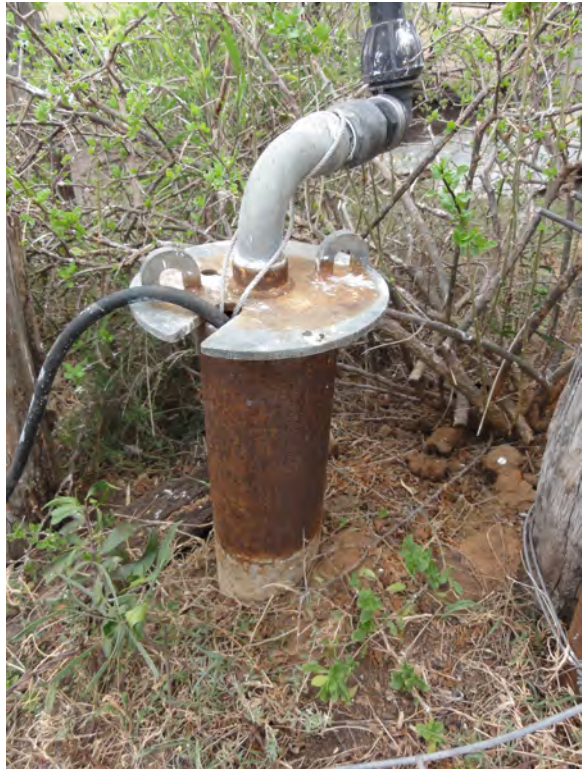
**Assessment Details - 3315\_A341636\_01**

<i>Stable pumping water level (m bgl): (measured, including mins after pump on)</i>	Unknown
<i>Water level measuring point</i>	Na
<i>Interviewee / owner understanding of typical SWL / PWL (m bgl):</i>	Unknown
<i>Comments:</i>	
<b>Water Sampling Details</b>	
<i>Any historic water quality data available from owner?</i>	Unknown
<i>Any account of gas in the bore from interviewee?</i>	Unknown
<i>Any potential for contamination at bore? (fuel storage, open bore casing, no stickup, aquifer intermixing from casing degradation)</i>	The bore is in the middle of a paddock and livestock use the water trough next to the bore. There are some remains of the old windmill that used to previously be on the site and an old water tank that is no longer used. As the bore is fairly well sealed the potential for contamination is low.
<i>Water quality sample collected during this assessment?</i>	No, Unable to sample on day of assessment due to mechanical problem with the pump.

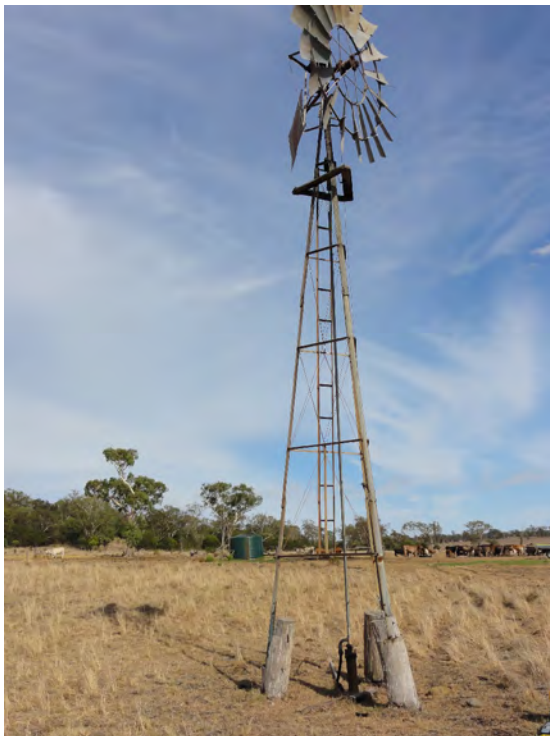
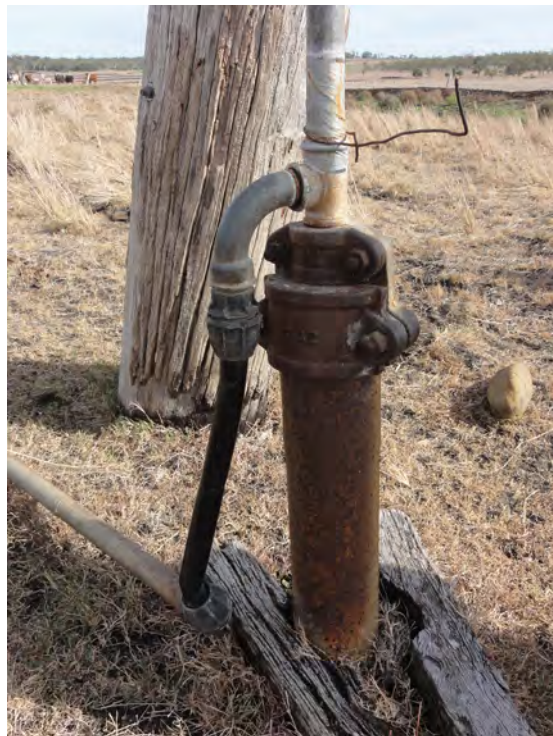
**Assessment Details - 19\_RP36468\_01**

<i>Date Installed:</i>	Unknown
<i>Surface casing dia. (mm), and material:</i>	140mm (estimated as unable to measure because of steel clamp), Steel
<i>Bore casing dia. (mm), and material:</i>	Believed to be as above
<i>Bore casing stickup above ground (m):</i>	0.63 m
<i>Aquifer: (&amp; source of information: log, anecdotal)</i>	Unknown
<i>Top of screen (m bgl):</i>	Unknown
<i>Bottom of screen (m bgl):</i>	Unknown
<i>Top of open hole (m bgl):</i>	Unknown
<i>Total depth (m):</i>	Unknown - Unable to measure on day of assessment because the bore is fully sealed.
<i>Bore Condition Comments:</i>	Unable to see top of bore as covered by a 6 inch steel clamp to hold the rising main in place.
<b>Bore Equipment Details</b>	
<i>Pump Installed?</i>	Yes
<i>Pump type, make and model, power source:</i>	Windmill pump (Southern cross windmill), unknown make and model.
<i>Date installed:</i>	Unknown
<i>Date of most recent use</i>	On constantly. Break regularly applied but still pumps with brake on.

<i>Any repairs?</i>	2012 - leathers in windmill pump replaced
<i>Pump intake depth (m bgl):</i>	Anecdotal from Landholder: 6-7 length of pipe estimated 120-140 feet (36.6-42.7m)
<i>Interviewee's est. annual take (ML):</i>	Minimum of 0.44ML
<i>Basis for estimate:</i>	For 6 months of the year the landholder has approximately 80 head of cattle. The landholder estimates the cattle requires 30 L of water each per day. This is believed to be an underestimate of the true usage because even when the brake is on the windmill can still pump and the water is allowed to overflow.
<i>Is bore use metered? Give details:</i>	No
<i>Detail specific uses of the bore water:</i>	Water for stock, 60-80 head for 6 months of the year.
<i>Detail all other water sources for</i>	9-10 working bores, 3-4 dams and use creek for some stock.

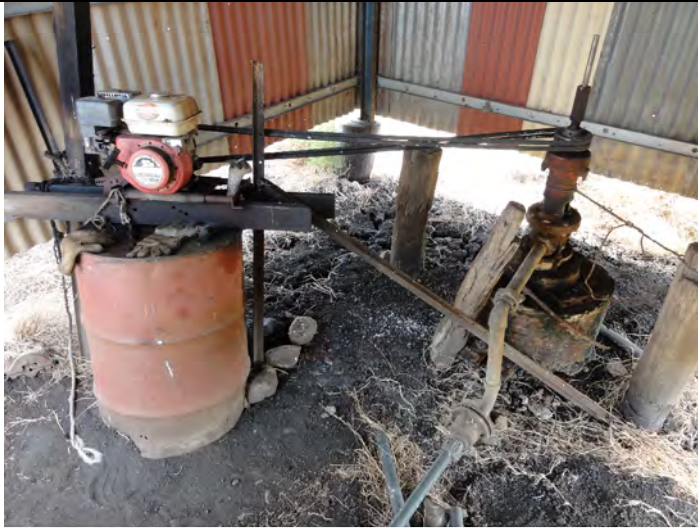
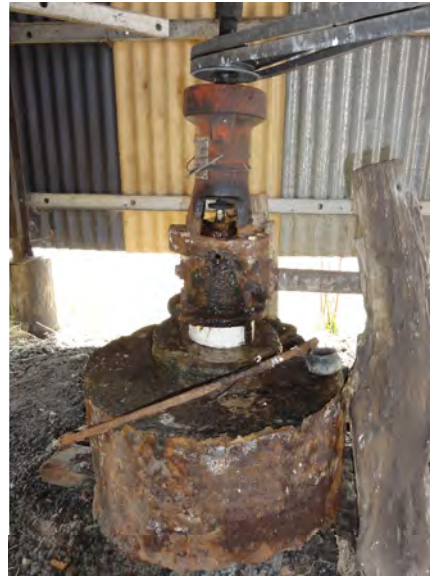
**Assessment Details - 20\_RP36468\_01**

<i>Date Installed:</i>	Pre 1970 (anecdotal from interviewee)
<i>Surface casing dia. (mm), and material:</i>	White PVC casing appears to be the surface and bore casing. The mono pump head works, which are steel and heavily corroded, cover the bore casing making measurement difficult. Estimated 125mm.
<i>Bore casing dia. (mm), and material:</i>	As above
<i>Bore casing stickup above ground (m):</i>	0.52m
<i>Aquifer: (&amp; source of information: log, anecdotal)</i>	Anecdotal from interviewee : Basalt
<i>Top of screen (m bgl):</i>	Unknown
<i>Bottom of screen (m bgl):</i>	Unknown
<i>Top of open hole (m bgl):</i>	Unknown
<i>Total depth (m):</i>	Anecdotal from brother of owner - 200ft (60m).
<i>Bore Condition Comments:</i>	The bore has been set in a monument, which appears to be an old oil drum filled with cement supported by wooden stakes. There is a gap below the monument where the pvc casing can be seen. It appears the monument is used to support the mono pump steel head works (see photo)

<i>Equipment condition:</i>	The equipment is old and corroded but appears to be in good working condition. The storage shed which completely covers the bore and the generator has reduced the impacts of the elements on the equipment and also protected it from cattle damage. The generator appears to have leaked oil and fuel over time. The bottom half of the mono pump is heavily corroded but the equipment appears to be in good working condition.
<i>Comments:</i>	
<b>Water Details</b>	
<i>Standing water level (m bgl): (measured or anecdotal)</i>	Na
<i>Stable pumping water level (m bgl): (measured, including mins after pump on)</i>	Na
<i>Water level measuring point</i>	Na
<i>Interviewee / owner understanding of typical SWL / PWL (m bgl):</i>	Na
<i>Comments:</i>	No airline and unable to dip because the bore is fully sealed.
<b>Water Sampling Details</b>	
<i>Any historic water quality data available from owner?</i>	No

<i>Any account of gas in the bore from interviewee?</i>	No
<i>Any potential for contamination at bore? (fuel storage, open bore casing, no stickup, aquifer intermixing from casing degradation)</i>	The generator is sitting on an old rusty fuel drum. The petrol generator has leaked fuel/oil over its lifetime. There are fuel storage drums and oil bottles in the shed, which are used to the running and maintenance of the bore but could be sources of contamination. The bore is well sealed, limiting potential contamination.
<i>Water quality sample collected during this assessment?</i>	Y
<i>Sample type: (primary, duplicate, field blank)</i>	Primary
<b>General Comments</b>

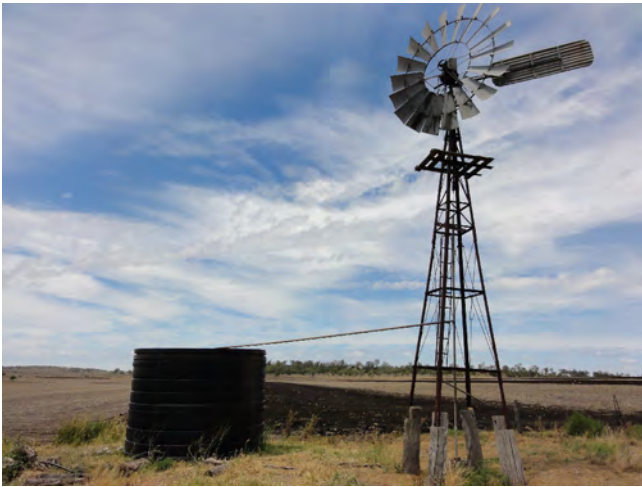
<i>Bore Condition Comments:</i>	Bore is old but in good condition. The landholder has said that one of the bore rods has broken and needs replacing but he hasn't yet done this When dipping the bore debris could be heard falling into the water, which could be corroded casing.
<b>Bore Equipment Details</b>	
<i>Pump Installed?</i>	Yes
<i>Pump type, make and model, power source:</i>	Windmill, Alderdyce.
<i>Date installed:</i>	Pump installed in 1988. Latest pump (installed in 2009) was a replacement for older pump. New southern cross mill installed 24/03/1933.
<i>Date of most recent use</i>	Bore stopped being used 6 months ago. Approximately in August 2013.
<i>Any repairs?</i>	Replacement of pipes is required every couple of years but this is only for the

<b>Assessment Details - 22_RP36468_01</b>	
	odd replacement. The wooden post the windmill is set on was replaced on 4/4/61.
<i>Pump intake depth (m bgl):</i>	120-140ft anecdotal from D cooke based on number of rods in the bore.
<i>Interviewee's est. annual take (ML):</i>	0.216ML (currently not used)
<i>Basis for estimate:</i>	80 head of cattle use this bore for 3 months of the year. Landholder estimates that his cattle require approx. 30L of water per day. When there are no cattle in the field the brake is applied to the bore.
<i>Is bore use metered? Give details:</i>	No
<i>Detail specific uses of the bore water:</i>	Stock water for 80 head of cattle, 3 months of the year.
<i>Detail all other water sources for property:</i>	9-10 working bores, 3-4 dams and use creek for some stock.
<i>Typical pumping rate of bore (L/s):</i>	Na
<i>Does this rate vary annually or can the pump rate be varied?:</i>	Na
