G.4.2 Landholder Bore Survey Results

New Acland Coal Mine Stage 3 Project Environmental Impact Assessment

LANDHOLDER BORE SURVEY

Document title: Landholder Bore Survey – New Acland Revised Stage 3 Project

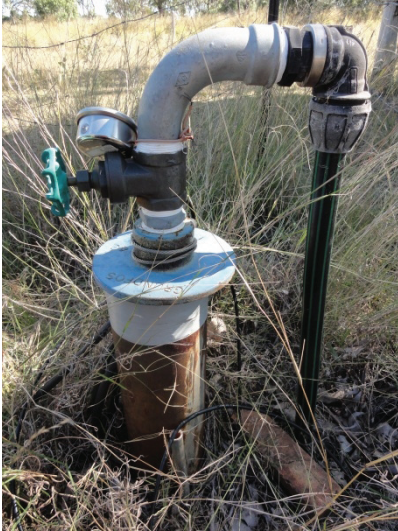
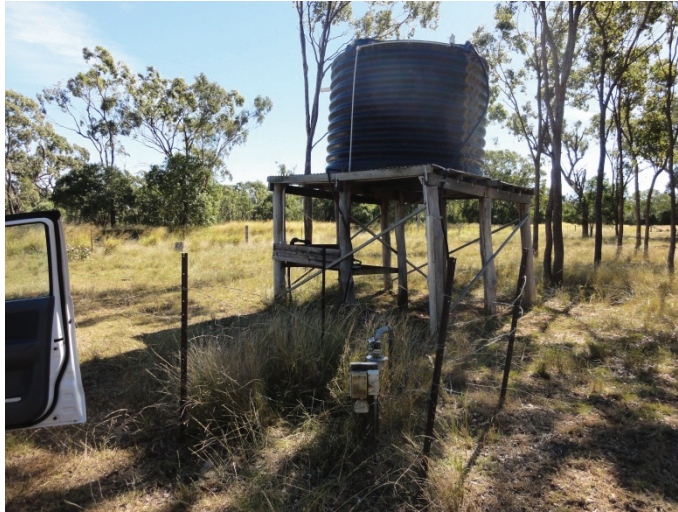
<i>Equipment condition:</i>	Appears in good condition, fairly new and well kept. Protected from cattle by a fence.
<i>Comments:</i>	
Water Details	
<i>Standing water level (m bgl): (measured or anecdotal)</i>	Drillers log indicates a water level of 14.2m bgl after bore installation. At the time of the site survey, the airline read 40 - 41psi (approximately 29m of water above the airline), however the depth the airline is set is unknown.
<i>Stable pumping water level (m bgl): (measured, including mins after pump on)</i>	not known
<i>Water level measuring point</i>	Airline
<i>Interviewee / owner understanding of typical SWL / PWL (m bgl):</i>	Drillers log indicates a water level of 14.2m bgl after bore installation.
<i>Comments:</i>	Interviewee believes the bore was originally drawing water from 5 "streams" but believes 3 "streams" have been "lost" - presumably referring to water level dropping below slotted intervals. (Interviewee blames mining activities). However there is no water level data to support the theory of the change in water level (or the cause).

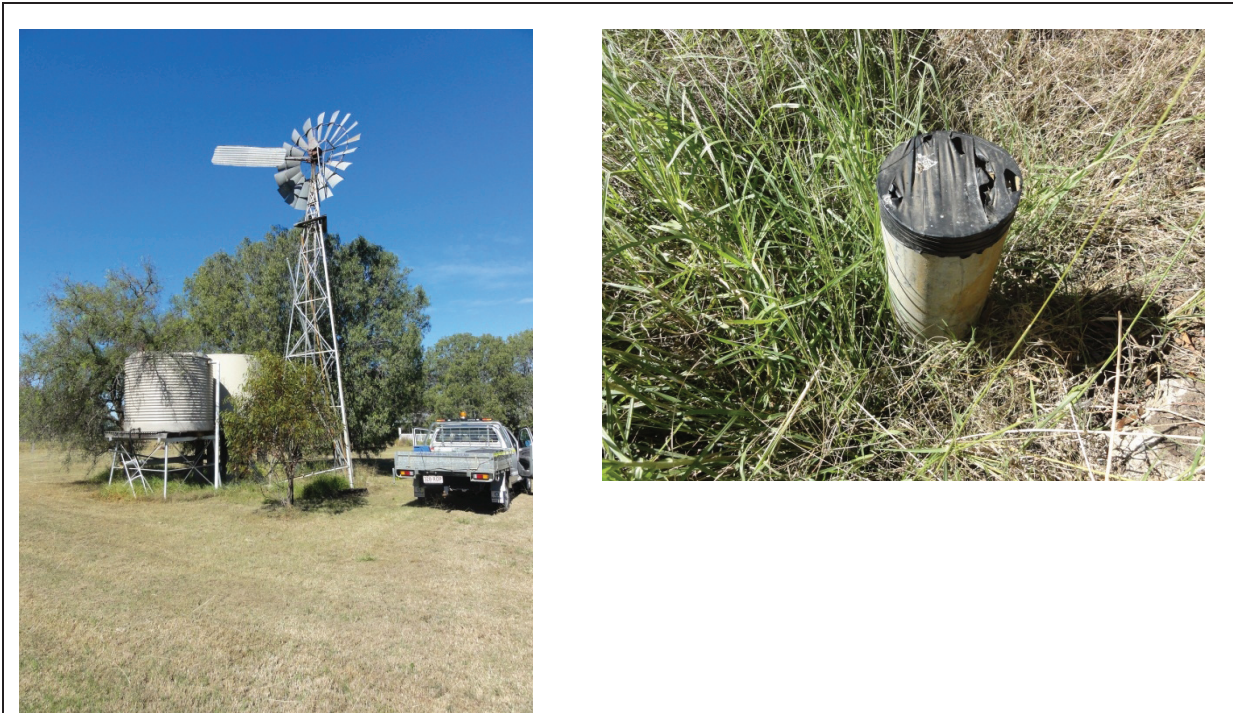
<i>Equipment condition:</i>	The infrastructure is in place but the bore currently does not have a pump installed.
<i>Comments:</i>	After replacing the old tin casing with steel casing, attempts were made to put the rising main pipes back in the hole, but were unable to complete this due to an obstruction in the bore. The bore has been unequipped since 2011.
Water Details	
<i>Standing water level (m bgl): (measured or anecdotal)</i>	Measured 13.46 m bgl (13.89m below TOC)
<i>Stable pumping water level (m bgl): (measured, including mins after pump on)</i>	n.a.
<i>Water level measuring point</i>	TOC (top of casing)
<i>Interviewee / owner understanding of typical SWL / PWL (m bgl):</i>	90ft (27m) is believed to be the SWL with a 2m drop during pumping (anecdotal from interviewee)
<i>Comments:</i>	Believes mine has had an impact on the water level in the bore and therefore on the rate at which the well pumps.

Water Sampling Details	
<i>Any historic water quality data available from owner?</i>	No
<i>Any account of gas in the bore from interviewee?</i>	No
<i>Any potential for contamination at bore? (fuel storage, open bore casing, no stickup, aquifer intermixing from casing degradation)</i>	This bore is approx. 70 m from storage sheds, which contains oil drums and apparently chemicals for spraying. Represents a potential source of contamination. LH has attempted to seal bore casing with tape but the tape now has holes in it. Chemicals stored under water tanks (herbicide and wetting agent - see pictures).
<i>Water quality sample collected during this assessment?</i>	No (no pump in the bore)
<i>Sample type: (primary, duplicate, field blank)</i>	n.a.
General Comments	
Six rods above ground approx. 6m each, and one approx. 3m. Alderdyce pump also above ground.	
Two sample taps below tanks. The second tank does not appear to be currently connected.

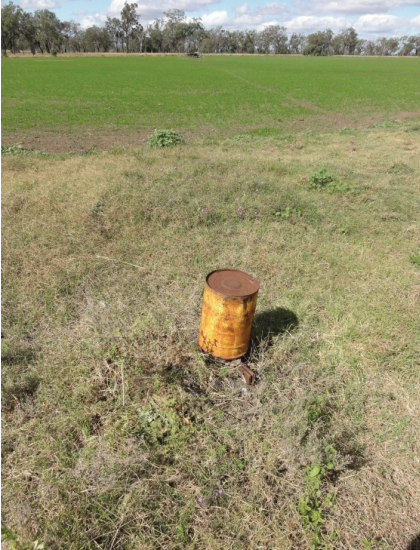
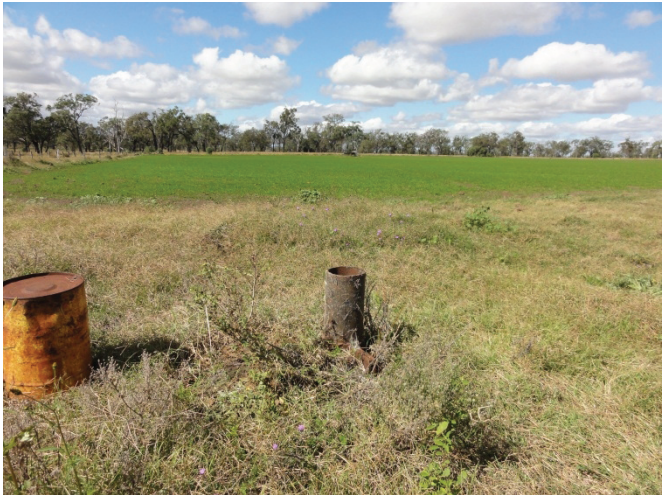
<i>pumping: (any seasonal variations?)</i>	
<i>Measured Maximum Flow Rate of Bore and Headworks at Site Visit (L/s)</i>	NA
<i>Describe riser, headwork and water distribution details:</i>	Open casing. Steel brace is supported on two planks of wood.
<i>Equipment condition:</i>	
<i>Comments:</i>	
Water Details	
<i>Standing water level (m bgl): (measured or anecdotal)</i>	23.35mbgl (measured ToC 23.74 m)
<i>Stable pumping water level (m bgl): (measured, including mins after pump on)</i>	NA
<i>Water level measuring point</i>	Top of casing
<i>Interviewee / owner understanding of typical SWL / PWL (m bgl):</i>	2006 SWL - 20.6mgl (anecdotal from LH)
<i>Comments:</i>	1995 SWL - 19.6 m bgl (according to bore log)
Water Sampling Details	
<i>Any historic water quality data available from owner?</i>	No
<i>Any account of gas in the bore from interviewee?</i>	No
<i>Any potential for contamination at bore? (fuel storage, open bore casing, no stickup, aquifer intermixing from casing degradation)</i>	Open and only covered with old oil drum.

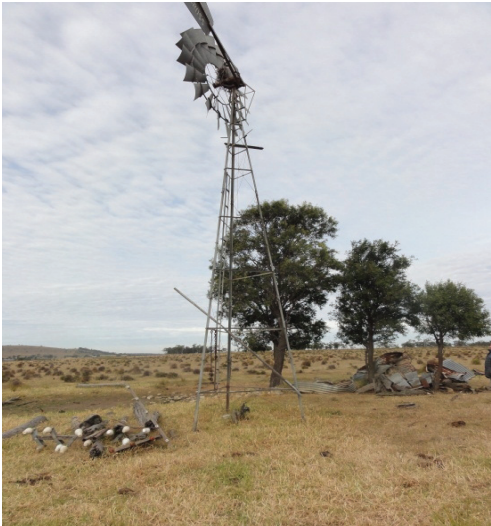
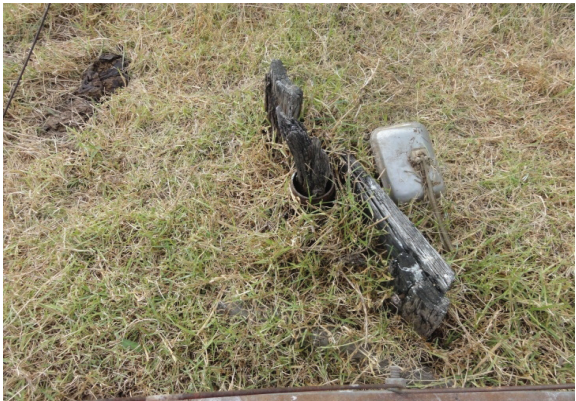
Water quality sample collected during this assessment?	No
Sample type: (primary, duplicate, field blank)	NA
General Comments	
There is an old hand dug well approximately 10m away. LH has covered with old bore tank pieces (see photos). Believed to be 150ft deep.	
Photos

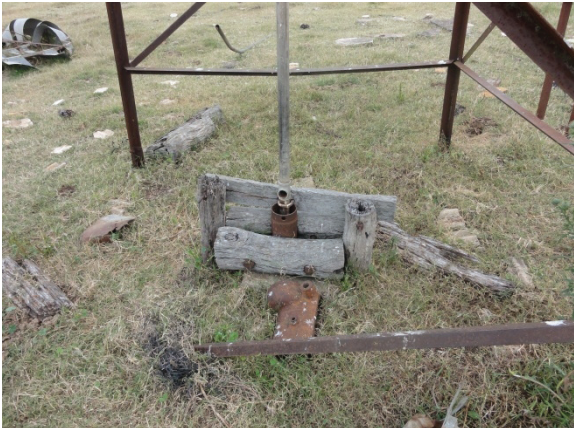
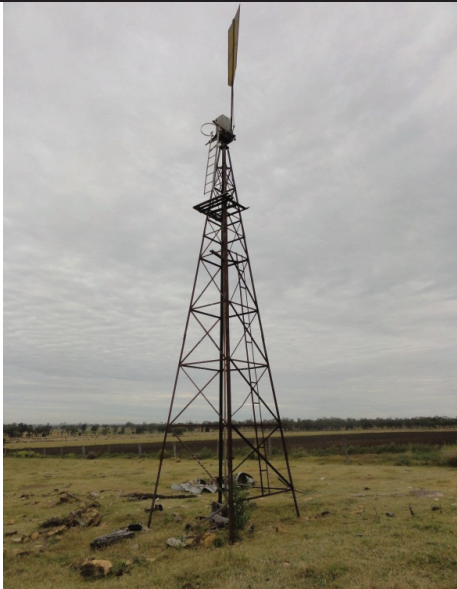
Any potential for contamination at bore? (fuel storage, open bore casing, no stickup, aquifer intermixing from casing degradation)	Bore is open. Some scrap cars nearby and storage sheds. Potential source of contaminant.
Water quality sample collected during this assessment?	No
Sample type: (primary, duplicate, field blank)	NA
General Comments	
Photos
