**J.12 Acland Colliery Conservation
Management Plan**

ACLAND COLLIERY CONSERVATION MANAGEMENT PLAN

*New Acland Coal Mine Stage
3 Project*

JANUARY 2014

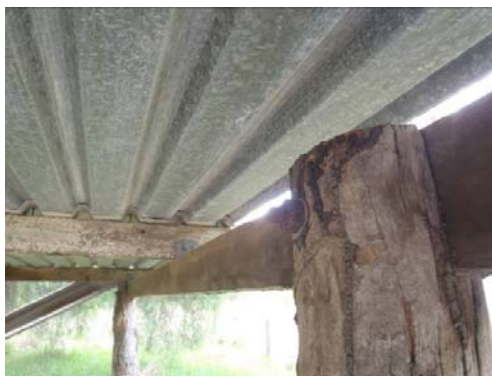
Photo 5 – Typical Fixing Detail

The structural condition of the shelter is fair, termite tracks were noted on most posts and the structural capacity of the rafter has been reduced in several locations by termite attack and will collapse shortly without rectification works.

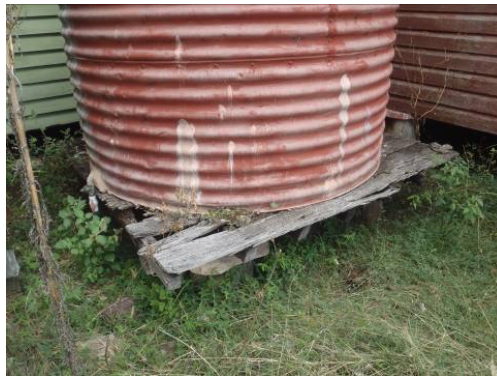
The tank stand, adjacent to the manager’s office, is in a poor condition with decay to the decking and joists, this is considered minor with no immediate repair required.

Photo 11 – Decay to Tank Stand

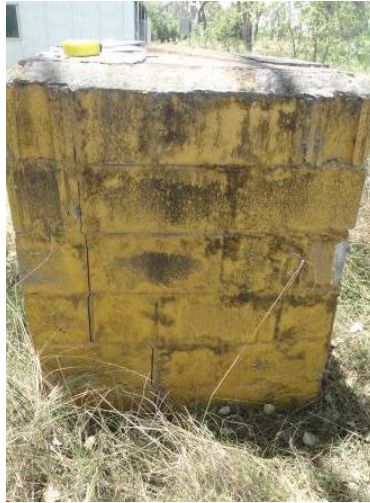
The detonator store is a small structure located adjacent to the manager’s office. The structure consists of core-filled block construction with a concrete lid. The blocks are porous in construction indicating inadequate compaction. The store is 1m x 1m x 1.3m high and is painted yellow. There is a steel frame at the top of the lid which supports the concrete lid. The overall condition of the detonator store is excellent with no signs of distress. There has been cracking to one of the walls.

Photo 13 – Cracking to Wall

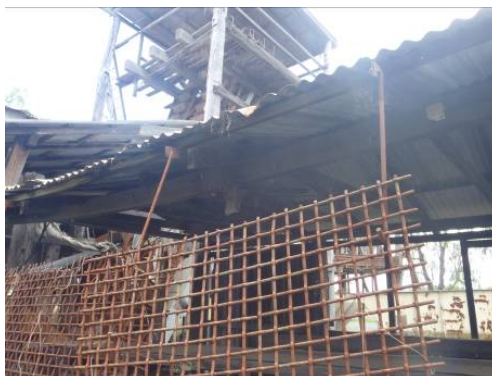
The structural condition of the picking belt shed is fair. There is considerable sag in one roof beam on the eastern side. There are positive bolt fixings of beams to posts but not for purlins or rafters. Roofing iron sheets are loose.

Photo 26 – Sagging Roof Beam

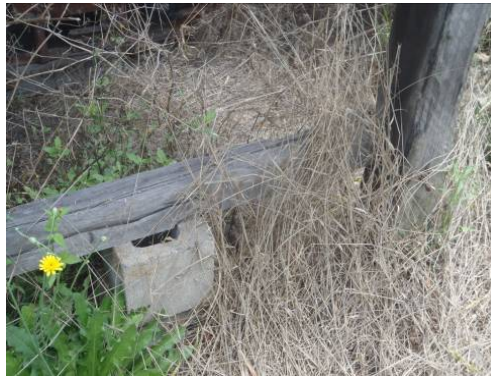
Floor bearers are weathered and fixing corroded. One floor bearer has been propped on a concrete block.

Photo 27 – Floor Bearer Propped on a Concrete Block

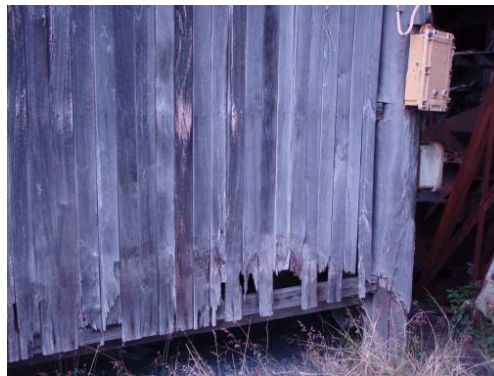
Photo 28 – Decayed Vertical Weatherboards to Picking Belt Shed

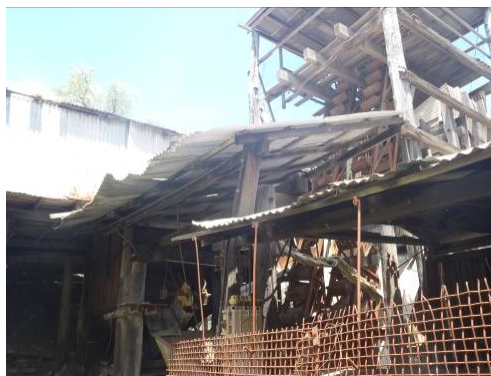
Photo 29 – Rotation of Post Extension to Lower Roof, Loose Roofing Iron

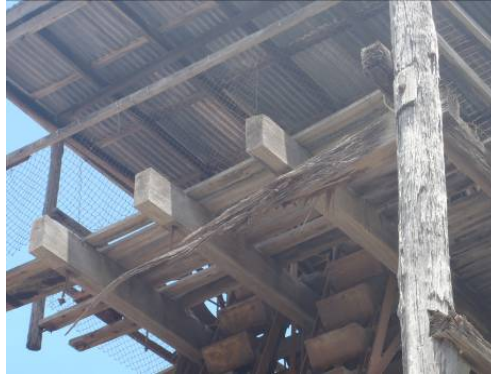
Due to severe decay to one bearer and one joist, the upper machinery platform is in a state of near collapse. These members urgently need replacing. The gantry is leaning towards the road but poles appear to be in a good condition, but are susceptible to termite attack.

Photo 30 – Gantry Platform - Severely Decayed Bearer, Missing Joist

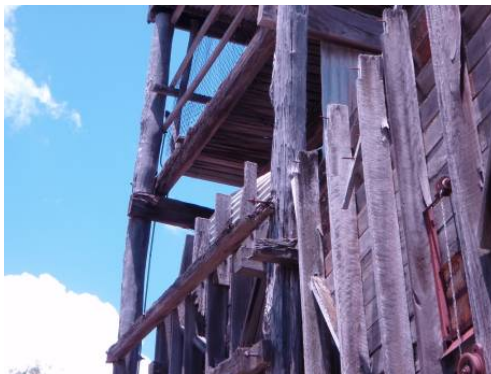
Photo 31 – Gantry - Decayed Exposed Members

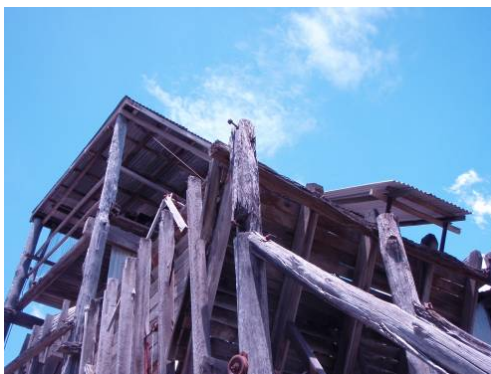
Photo 32 – Hopper - Decayed Exposed Members

The hopper is a timber coal storage bin supported on large timber joists, two of which are cracked as are two supporting bearers and a pole. Exposed timbers are more weathered and decayed than internal protected timbers but the majority of the structural members are in fair to good condition. Generally the framing of the hopper itself is good. With replacement of the damaged or decayed support members the hopper could be returned to a satisfactory structural condition.

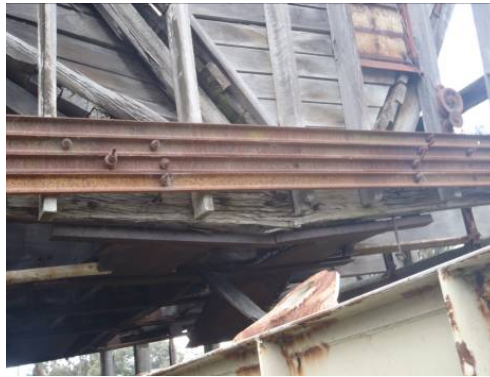
Photo 34 – Broken Hopper Joist, Railway Iron Strengthening

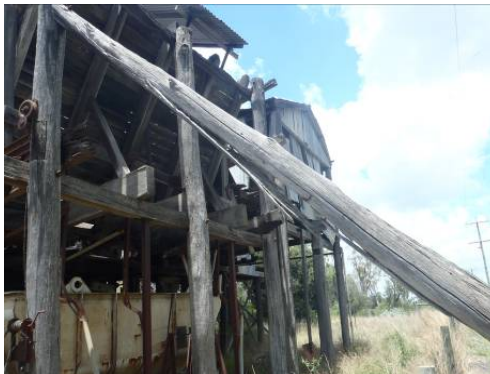
Timber pole props to the hopper show signs of weathering and decay.

Photo 35 – Decay to Hopper Pole Props, Centre Pole Cracked, Bearer Cracked

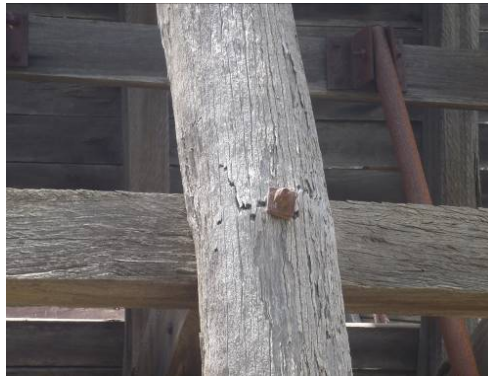
The hopper support pole has cracked through the bolt fixing to the bearer and the same bearer has cracked at the steel props.

Photo 36 – Cracked Centre Support Pole to Hopper

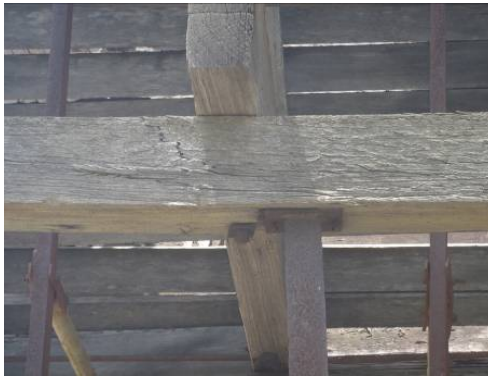
Photo 37 – Cracked Hopper Bearer at Steel Prop

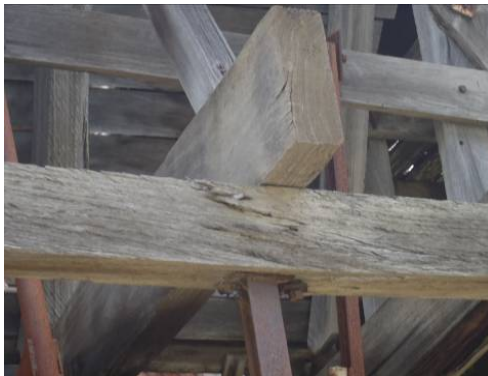
Photo 38 – Cracked Hopper Bearer at Steel Prop

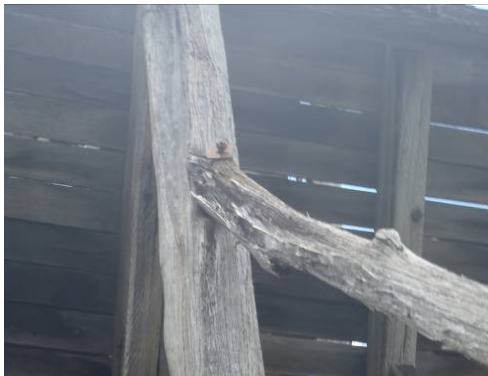
Photo 39 – Decayed Pole Prop

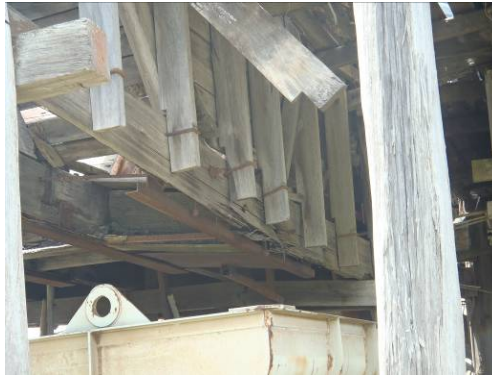
The hopper joist on the internal side has also cracked, as has one interior bearer.

Photo 40 – Broken Hopper Joist and Broken Internal Bearer

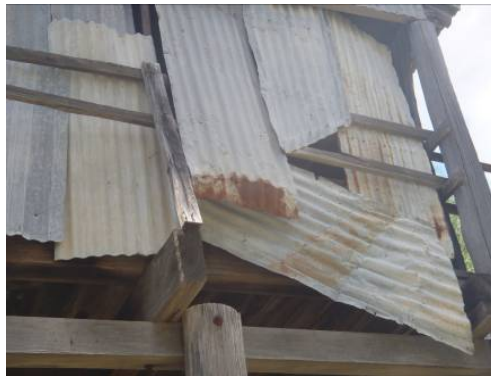
The pit head is similar in construction to the gantry with timber poles and bearers with a floorboard and joist floor to support the railway tracks and coal bins coming from the mine to discharge their load. A newer floor of joists and boards has been laid over the top of the original decayed and weathered floor. The walls are clad in corrugated sheeting as is the roof. Many wall and roofing sheets are loose.

Photo 41 – Loose Sheets at West End of Pit Head

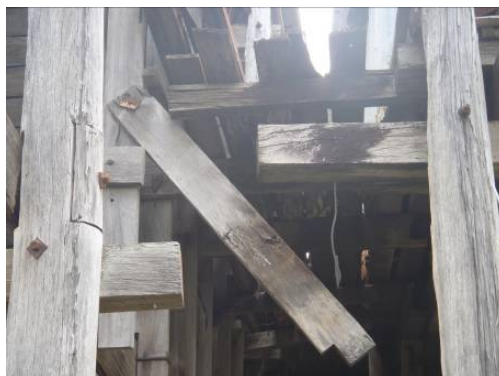
An area of infill between the hopper and pit head has decayed floor boards and a joist that has lost its fixing.

Photo 42 – Failed Joist Connection – Decayed Floor Boards

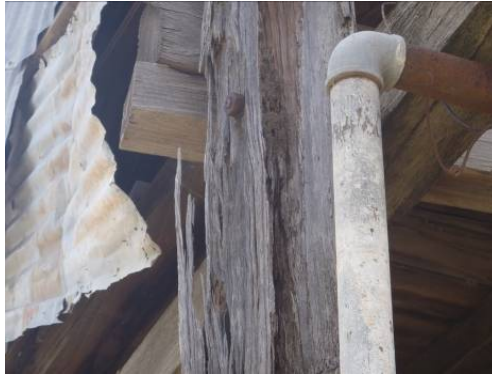
Termite attack was evident in a number of isolated timber poles and braces.

Photo 43 – Termites and Decay to Pole

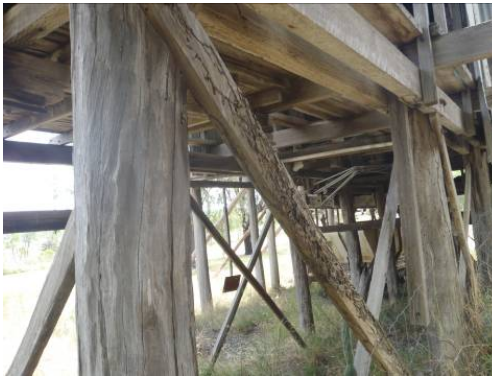
Photo 44 – Termite Tracks and Decay to Brace

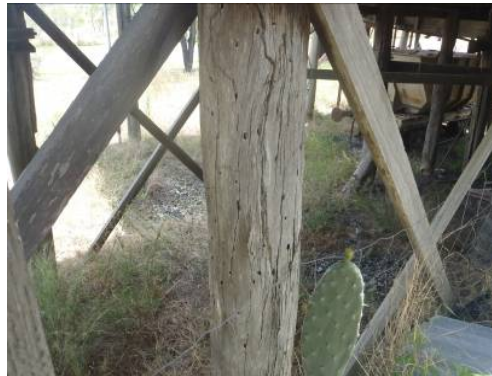
Photo 45 – Termite Tracks and Decay to Pole

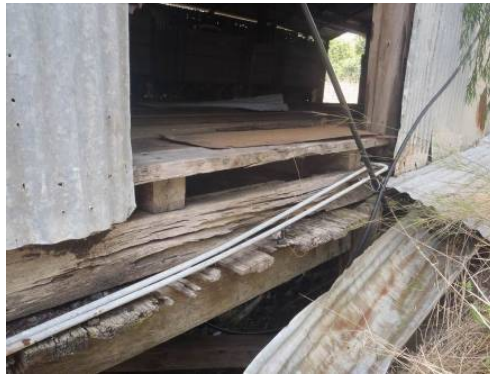
The original floor to the pit head structure has been replaced by overlaying new joists and bearers over the old floor. The older timbers show weathering decay in exposed locations.

**Photo 46 – Newer Floor over Old,
Weathering & Decay of Old Exposed Members, Loose Iron Sheets**

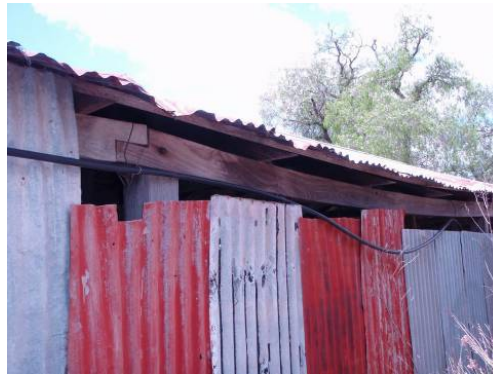
The single storey pit head structure at the rear has a longer span roof beam that is sagging and numerous loose roofing and wall sheets.

Photo 47 – Sagging Roof Beam

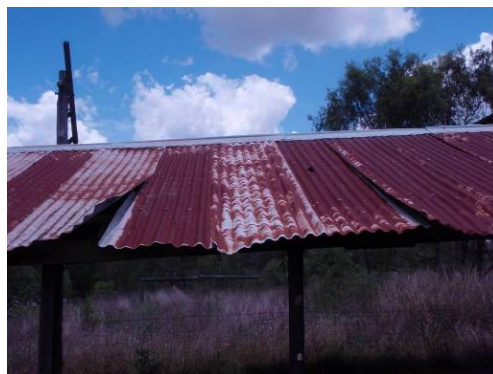
Photo 48 – Loose Roofing Sheets to Pit Head

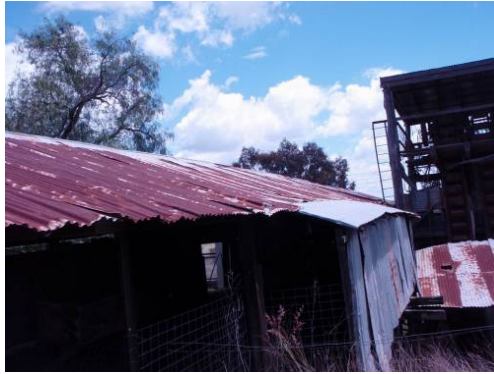
Photo 49 – Loose Roofing on Wall Sheets

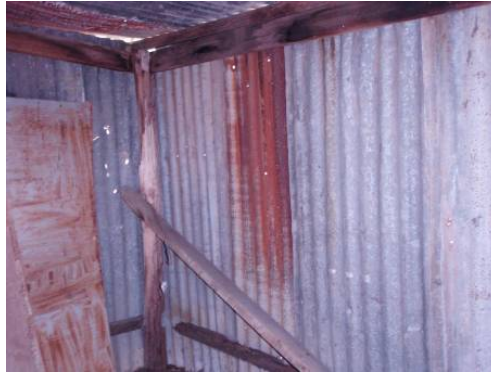
Photo 52 – Termite Damaged Post and Rail, Fallen Rafter

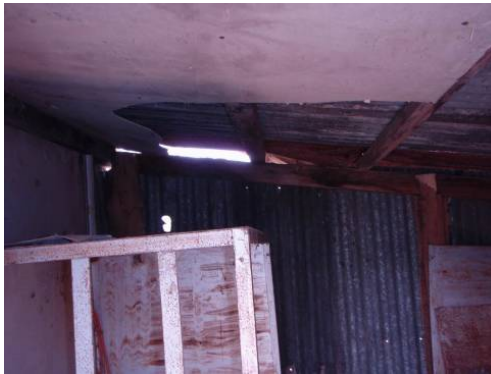
Photo 53 – Decayed Post and Roof Beam

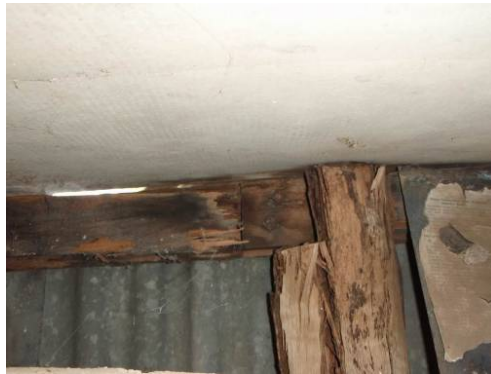
Photo 54 – Decayed Post

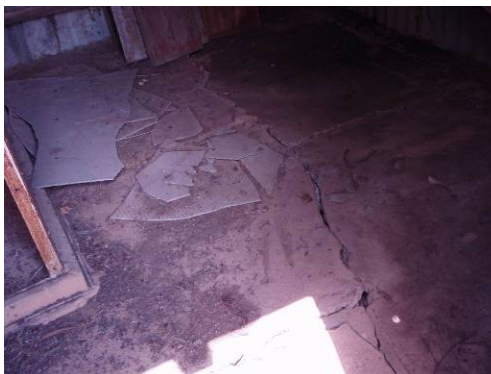
Photo 55 – Cracked Concrete Slab

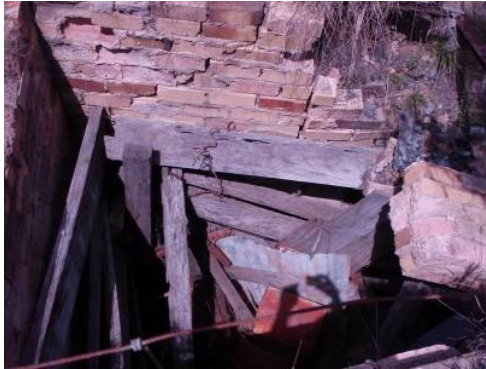
The air shaft comprises brick lined and timber shored shafts that have been partially filled in, a steel fan cowl, and a timber and iron shed. The timber of the shed show signs of severe termite decay. The air shafts have collapsed brick walls and shoring.

Photo 56 – Brick Walls Toppled, Timber Shoring

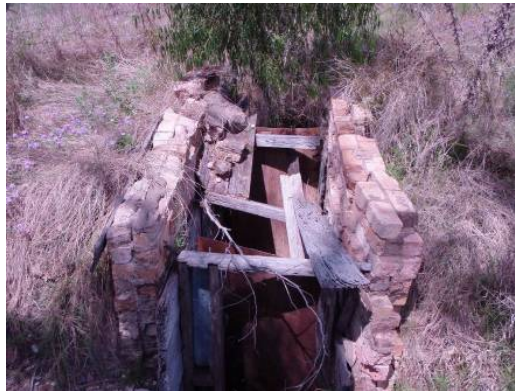
Photo 57 – Brick Walls Falling In, Timber Decaying

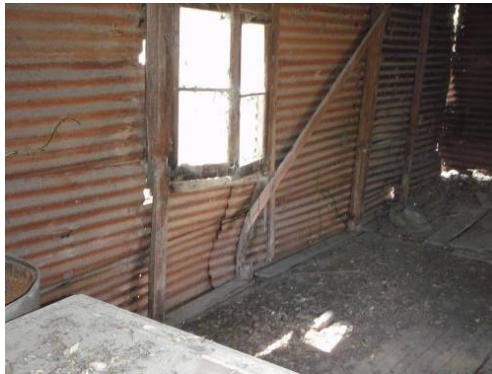
Internal timbers show signs of severe termite attack. Several studs are broken.

Photo 60 – Broken Stud with Termite Decay

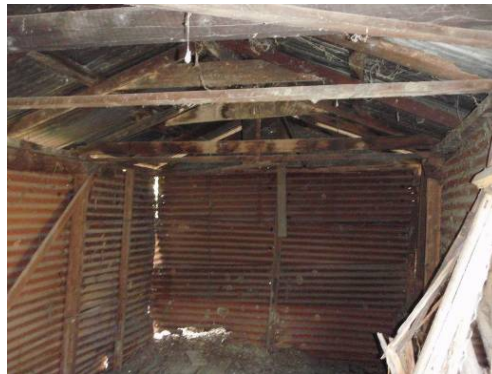
Photo 61 – Internal View Showing Broken Stud in Foreground

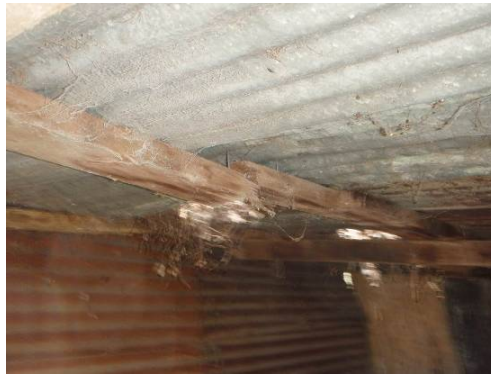
Photo 62 – Broken Purlin to Lean-to Storage

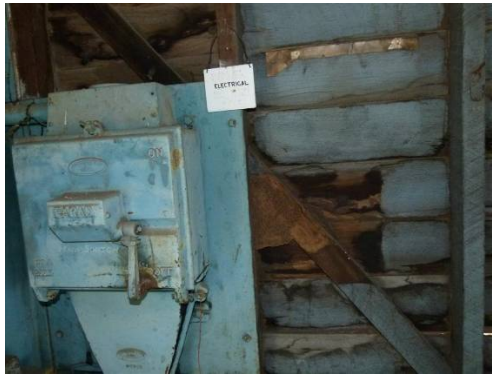
Photo 69 – Termite Nest on Eastern Wall Bracing Member

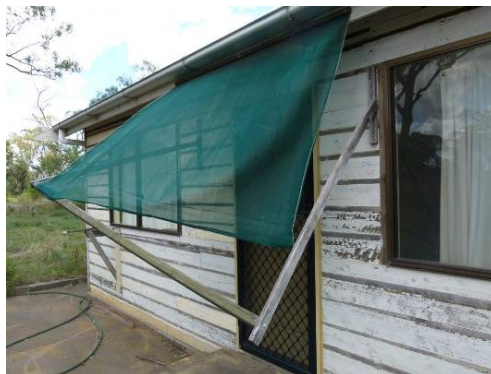
Photo 74 – Timber Awning Collapsed

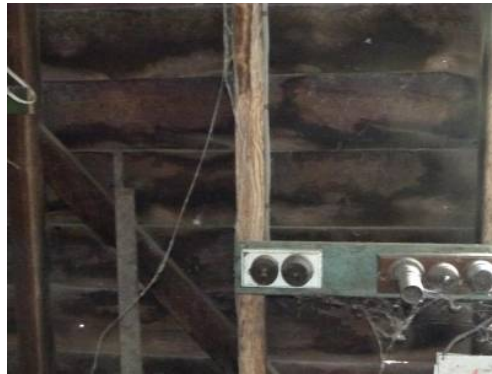
Photo 79 – Termite Damage to Wall Stud in Leccy shed

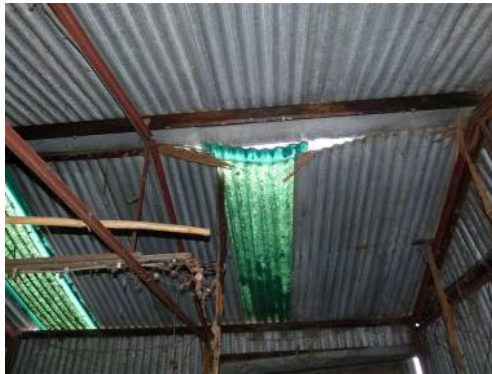
**Photo 80 – Roof Battens Full Termite Attack, Completely Gone in Some Places
– Sheeting has Collapsed Since 2011 Inspection**

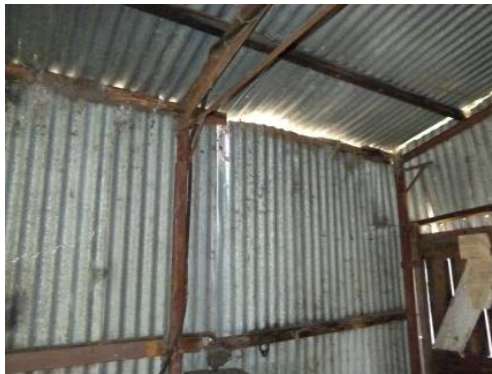
Photo 81 – Timber Top Plate Eaten Away by Termites in Workshop

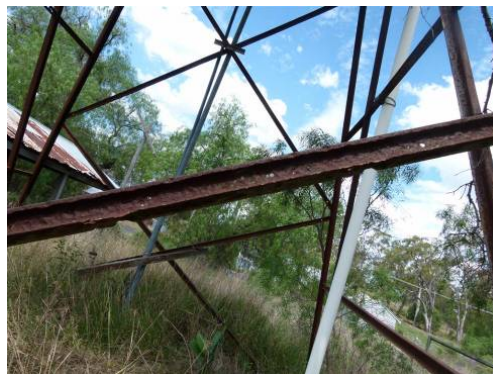
Photo 84 – Low Level Bracing on Western Side Rusted

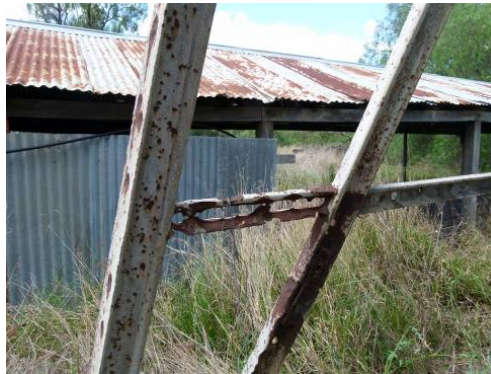
Photo 85 - -Lower Level Bracing on Northern Side Rusted

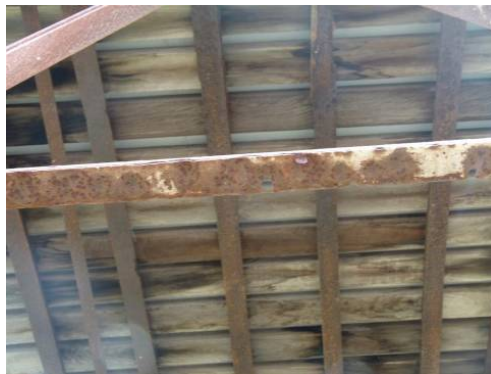
Photo 114 – High Level Bracing on Northern Side Rusted

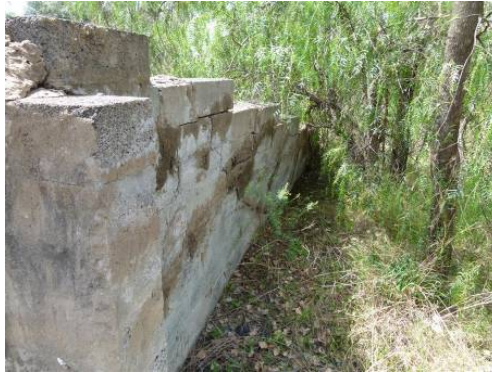
The structure has been deemed unsafe to enter.

Photo 120 – Eastern Wall Cracked and Leaning Outward

Additional temporary propping is recommended to the side walls to prevent collapse of the shaft.

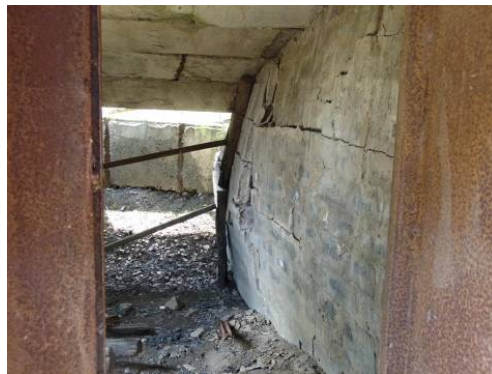
Photo 121 – Eastern Internal Wall Braced
