NEW HOPE COAL AUSTRALIA

New Acland Coal Mine  
2022 Annual Regulated Dam Safety  
Review

111319.19  
November 2022

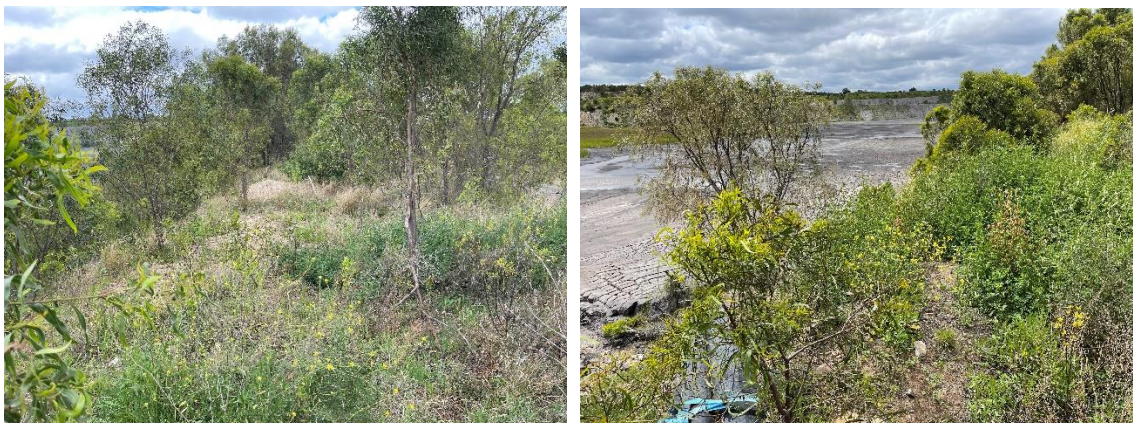
Typical Upstream Embankment Batter Conditions

The upstream batter of the embankment has experienced some erosion over the period of operation, as a result of rainfall and stormwater runoff. Erosion rilling is not severe. Across the length of the upstream batter, a significant growth of shrubs/small trees and grass undergrowth has self-propagated. This growth inhibits a clear view of the exposed portion of the batter, although there is significant exposure to assess batter condition, noting that the exposed (vertical) batter height is now limited to around 6 to 7m.

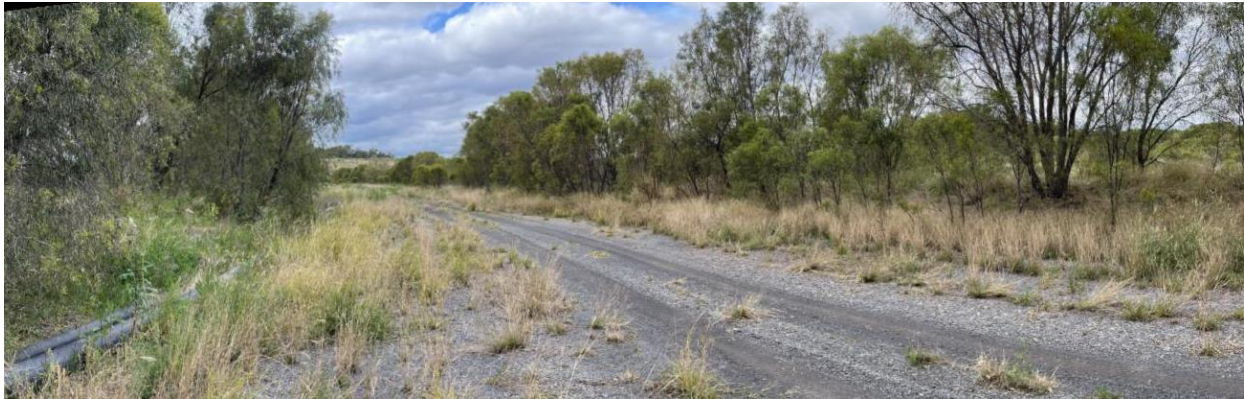
## Typical Condition of Embankment Crest

It is noted that no portion of the as-built downstream batter remains exposed due to the extent of buttressing placed in conjunction with Centre Pit operation.

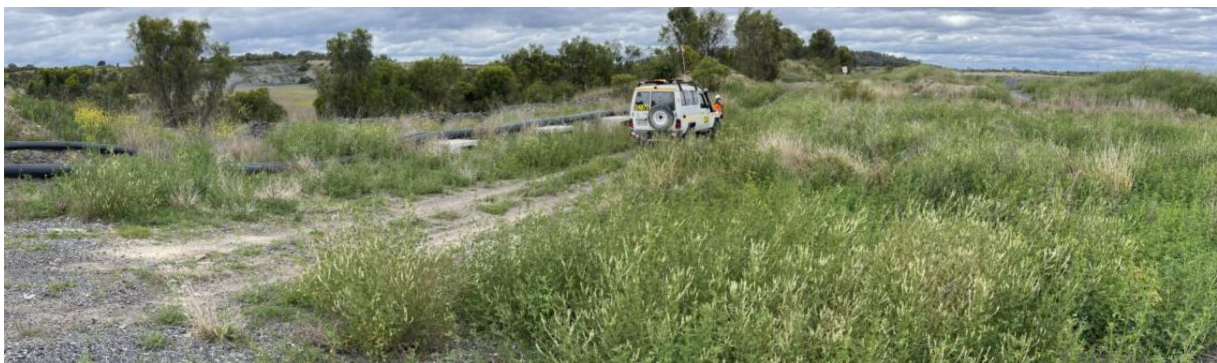
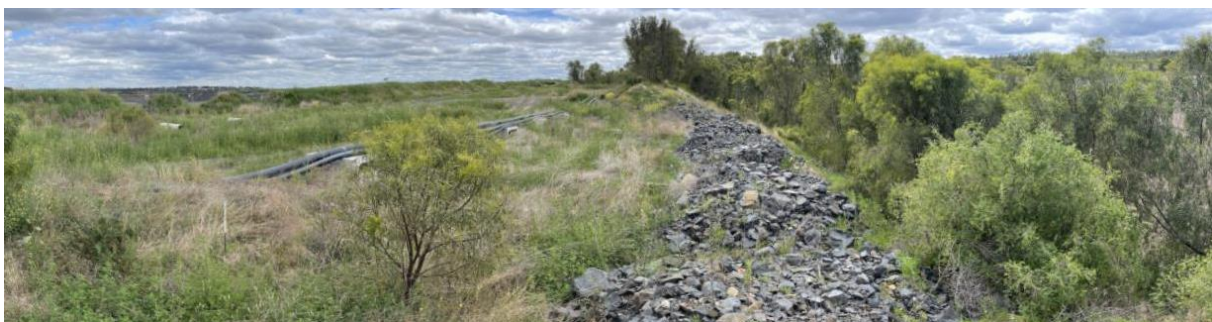
### PHOTO 2: CURRENT CONDITION OF IPT3 EMERGENCY SPILLWAY (FROM NORTHERN EDGE)

The emergency spillway, as described in **Section 2.3**, remains in as-built form. The current condition of the spillway is shown on **Photo 2**, with key observations being:

Regulated Dam	Aspect/Observation	Outcome and Recommended Action
IPT3 (con't)	<u>Embankments and General Containment Landform (con't)</u>	<u>Cracking</u> Cracking is not of current concern given that the tailings surface has risen (i.e., the effective embankment height has reduced) and given that no cracking can now be detected. Periodic inspection to confirm that no further cracking is developing is recommended. It is also recommended that grass established along the crest of the embankment, adjacent to the safety windrow, is cleared to enable greater visibility.
	<u>Emergency Spillway</u> The emergency spillway for IPT3 was constructed in 2020, being delayed given that the portion of embankment crest intersected, was previously being used as a mine haul road to Centre Pit. The initial design dimensions of the spillway (30m wide x 1m deep) were adopted in construction, with analysis confirming compliance with the design criteria.  Considerable shrub/tree growth has established across the spillway inlet on the adjacent upstream embankment batter. This growth extends 4 to 5m above the crest.	It is recommended that the trees and shrubs established across the spillway inlet on the upstream embankment batter be removed, at least to below the spillway crest level.  It is also recommended that in the very unlikely event that the full supply level for the storage is approached, the safety windrow across the crest of the spillway is removed. Although the serviceability of the spillway is not necessarily affected by the presence of the windrow, the efficiency of flow through the spillway would be improved.

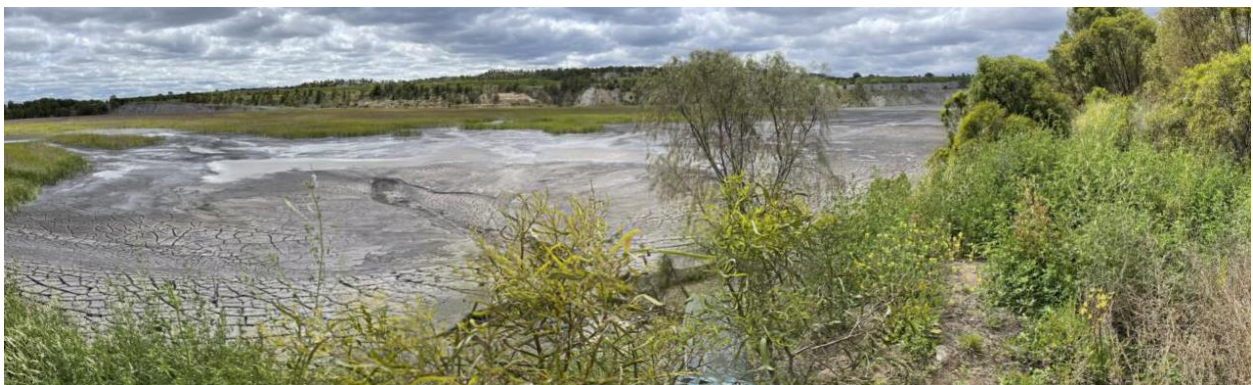
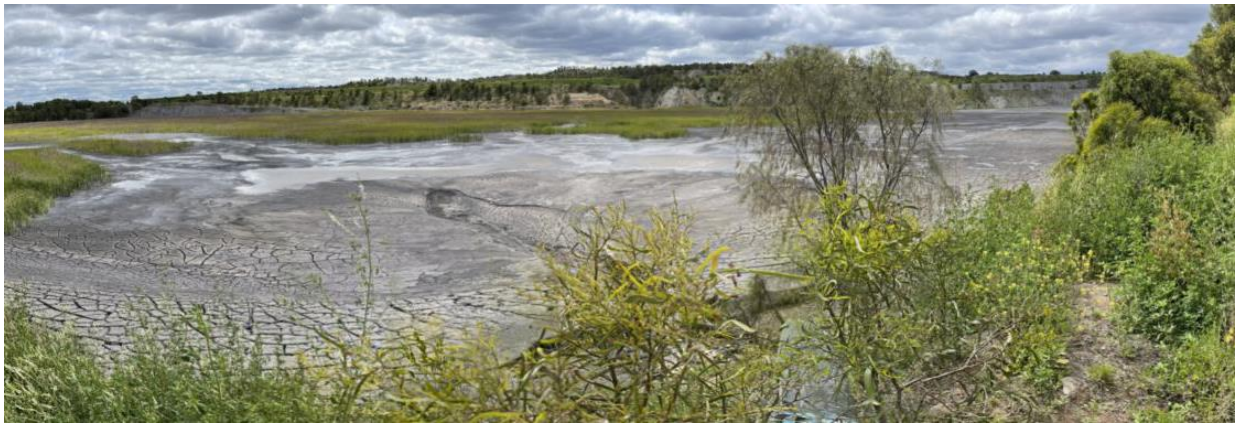
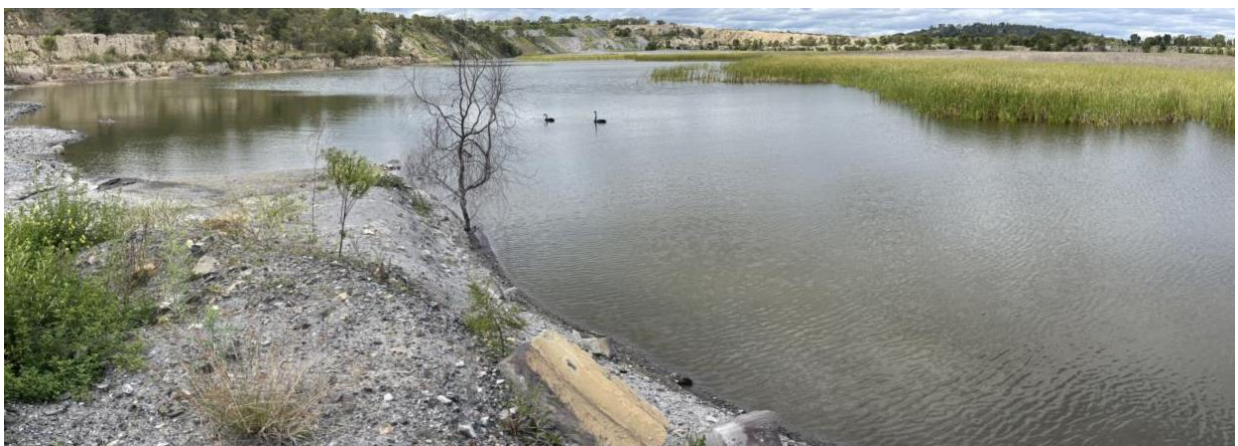
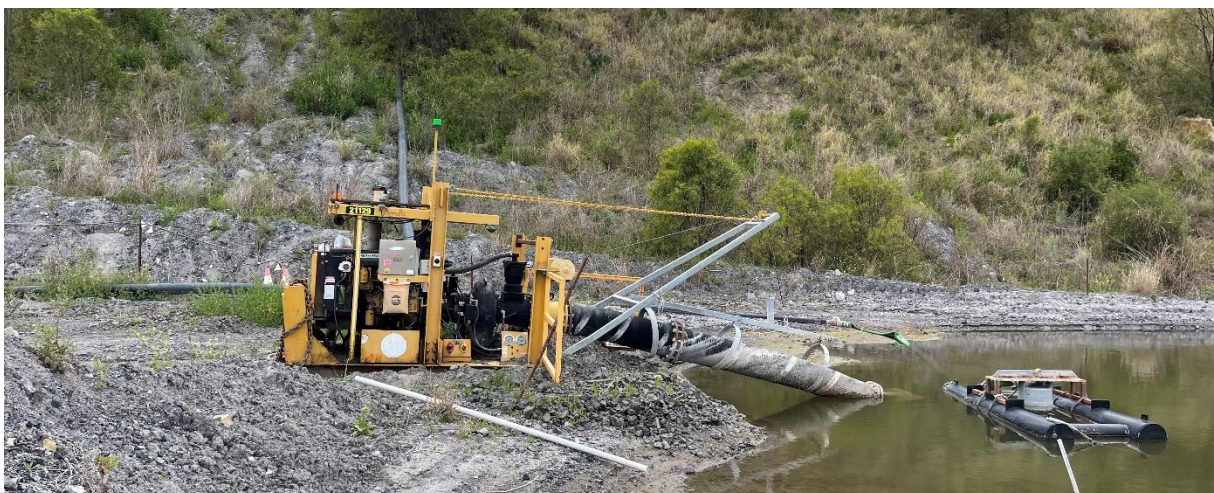
#### **PHOTO 3: CURRENT TAILINGS STORAGE CONDITION OF IPT3**

- Other than the IPT3 embankment, the principal exposure around the storage is the remnant section of highwall. These sequences appear to be subject to considerable surface erosion, however no major displacement or slips across this near vertical batter has been observed.

**Photo 3** shows IPT3 under current conditions showing the tailings beach configuration

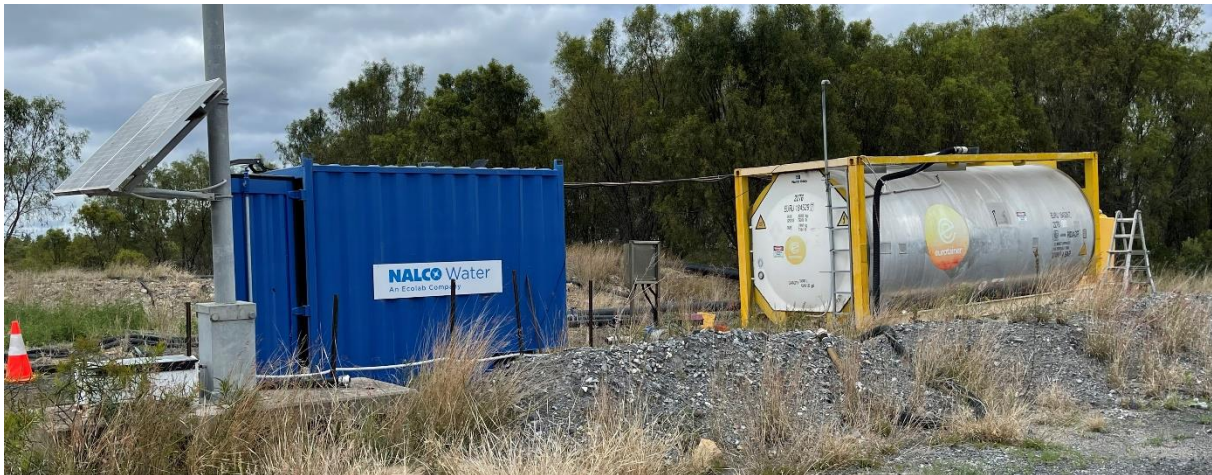
#### PHOTO 4: FLOCCULENT DOSING SYSTEM

As indicated in **Section 2.4.3**, no appreciable deposition has occurred into IPT3 since November 2021.

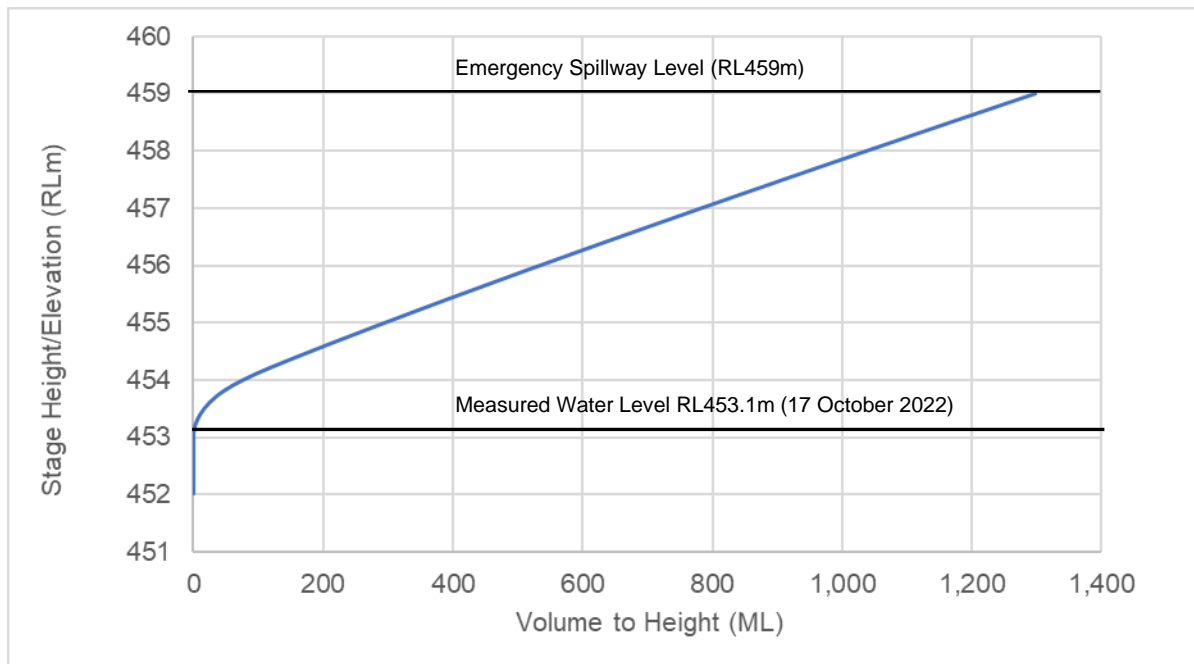
**GRAPH 1: STORAGE ANALYSIS FOR IPT3**

It is noted that survey has been taken to the decant pond surface, therefore ignores the available storage capacity if the pond was dewatered. This is a conservative position.

Based on **Graph 1**, the available storage capacity (above the surveyed tailings beach/decant pond level) to the emergency spillway level of RL459m based on the July 2022 survey is calculated to be

By comparison with the tailings beach survey completed in 2021, it is noted that the IPT3 capacity has increased. Whilst some deposition has occurred over this period, a net increase in storage would have resulted from consolidation of the tailings beach over this period.

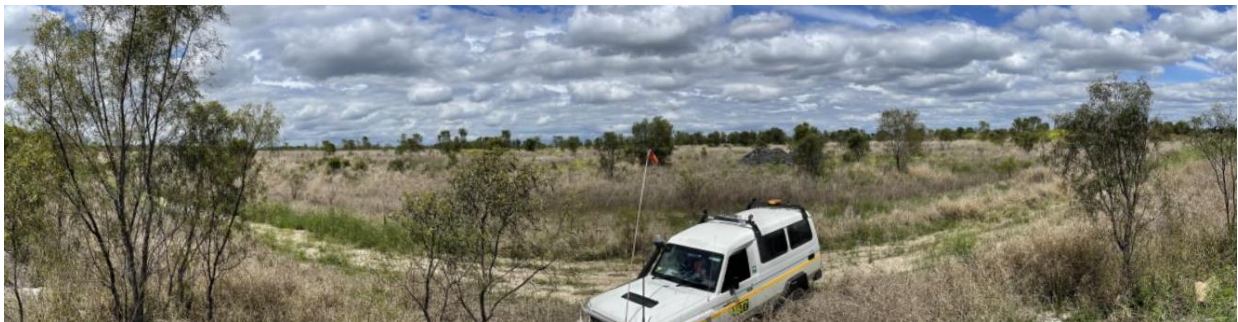
**PHOTO 5: CONDITION OF TSF1 REHABILITATION – FROM WESTERN EDGE**

It is noted that no specific rehabilitation works to external batter slopes of the TSF1 embankments has been undertaken, although these batters remain well grassed.

**Photo 5** shows the typical condition of the rehabilitated surface of TSF1.

Dam (Structure)	Recommended Action
TSF1 and TSF1 Extension	For both TSF1 and TSF1 Extension, it is recommended that drainage batter chutes proposed by NAC are installed to direct stormwater runoff from the rehabilitated surface into the adjacent Centre Pit area. This will enable drainage from TSF1 to be diverted away from the drainage bywash between TSF1 and PRD. These works will also enable placement of the final strip of topsoil adjacent to the outer embankment and to establish vegetation within this area.
	The area where the mine haul road has crossed the TSF1 Extension embankment should be monitored over time. Although no observations of concern exist, it is likely that the excavation has intersected the upper portion of the old tailings beach (or at least the margins of the tailings deposit). It may be prudent as part of final rehabilitation works to backfill this shallow excavation and reform the embankment batter.

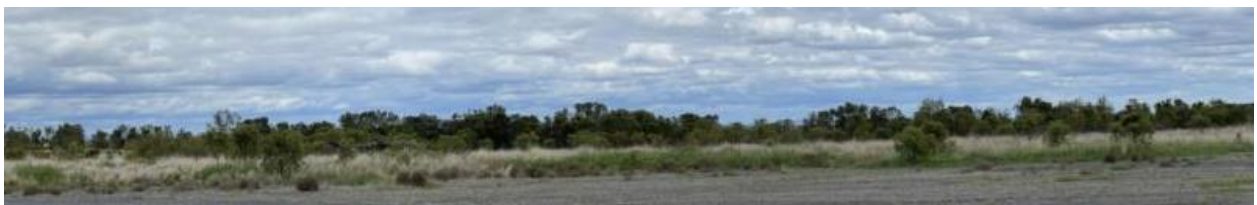
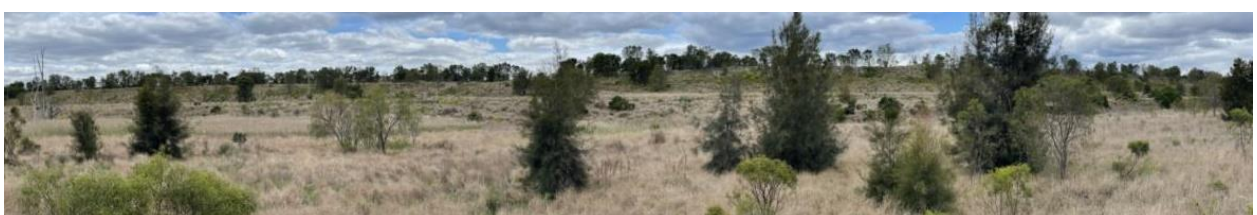
### **PHOTO 6: CURRENT CONDITION OF TSF1 EXTENSION**

**Photo 6** shows the typical condition of the surface of TSF1 Extension.

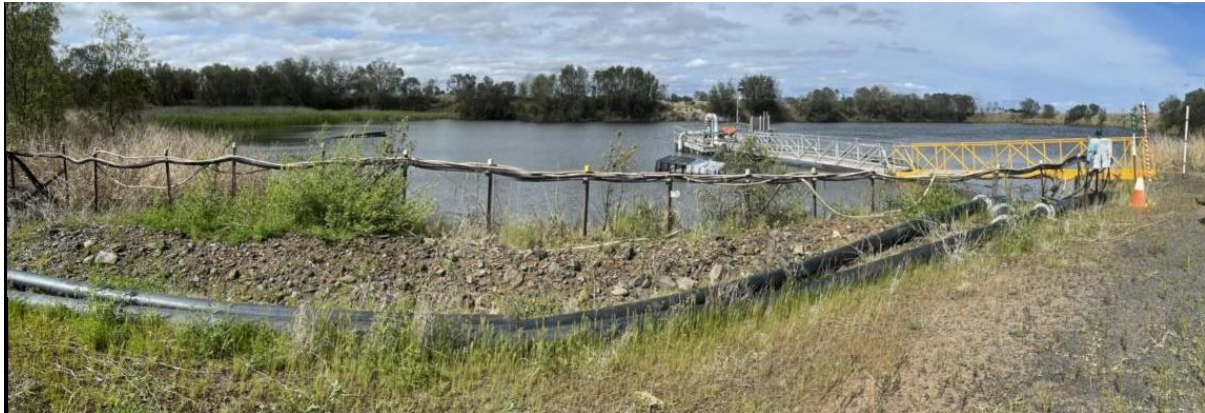
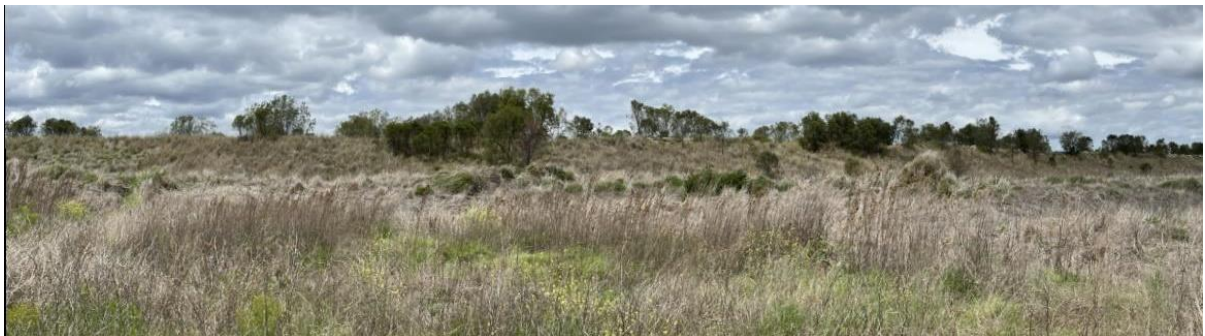
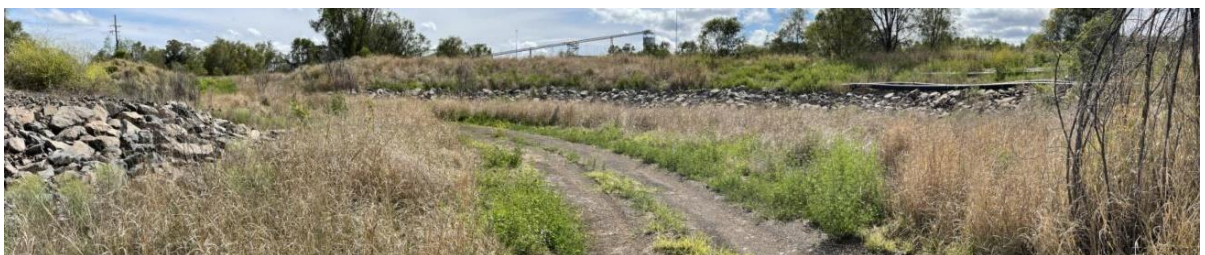
### PHOTO 7: LAYOUT OF PRD

The PRD is shown on **Figure 002**. **Photo 7** shows the current condition of the storage and spillway.

Pond Return Dam (PRD)	Small trees (wattles) have colonised across the spillway at PRD. Although not an issue, it may be prudent to remove these trees to improve access into the PRD area, and to ensure that any drainage through the spillway is not impeded.
IPT1	No actions recommended
IPT2/1	No actions recommended
IPT2/2	Efforts to close out the remaining area of exposed tailings in IPT2/2 should be made as soon as practical. Although not a particular risk if this small area remains exposed, until final capping is completed, rehabilitation of this area will not be possible.

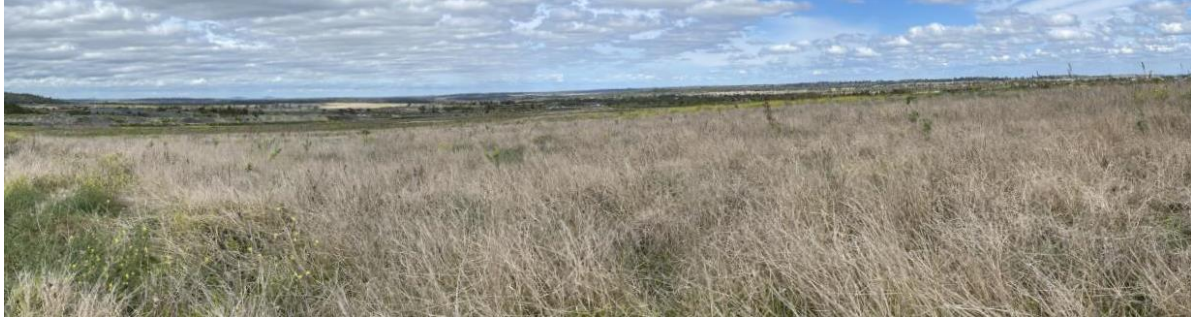
## PHOTO 9: REHABILITATED CONDITION IPT2-1

The current condition of IPT2/1 is shown in **Figure 003**. **Photo 9** shows the general layout of this area.

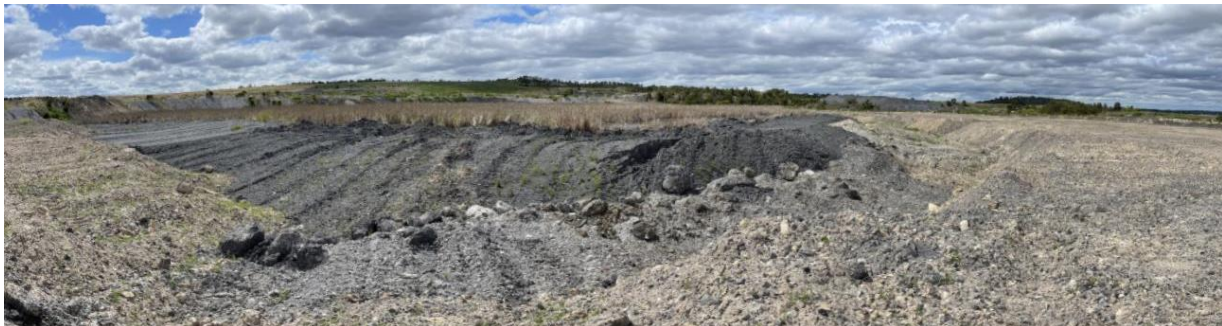
## PHOTO 10: REMAINING PORTION OF CAPPING REQUIRED IN IPT2/2

Capping within IPT2/2 commenced around 2018, at a time soon after the start of capping of IPT2/1, with a similar capping approach to IPT1 and IPT2/1 adopted. Concurrent capping works continued within IPT2/1 and IPT2/2. **Figure 003** indicates that a portion of tailings remains exposed, with these tailings supporting a significant reed growth. The width of exposed tailings is currently less than 300m (east to west), located generally in the centre of the former storage area.

The remaining area of exposed tailings in IPT2/2 as at the time of inspection (October 2022) is shown on **Photo 10**.

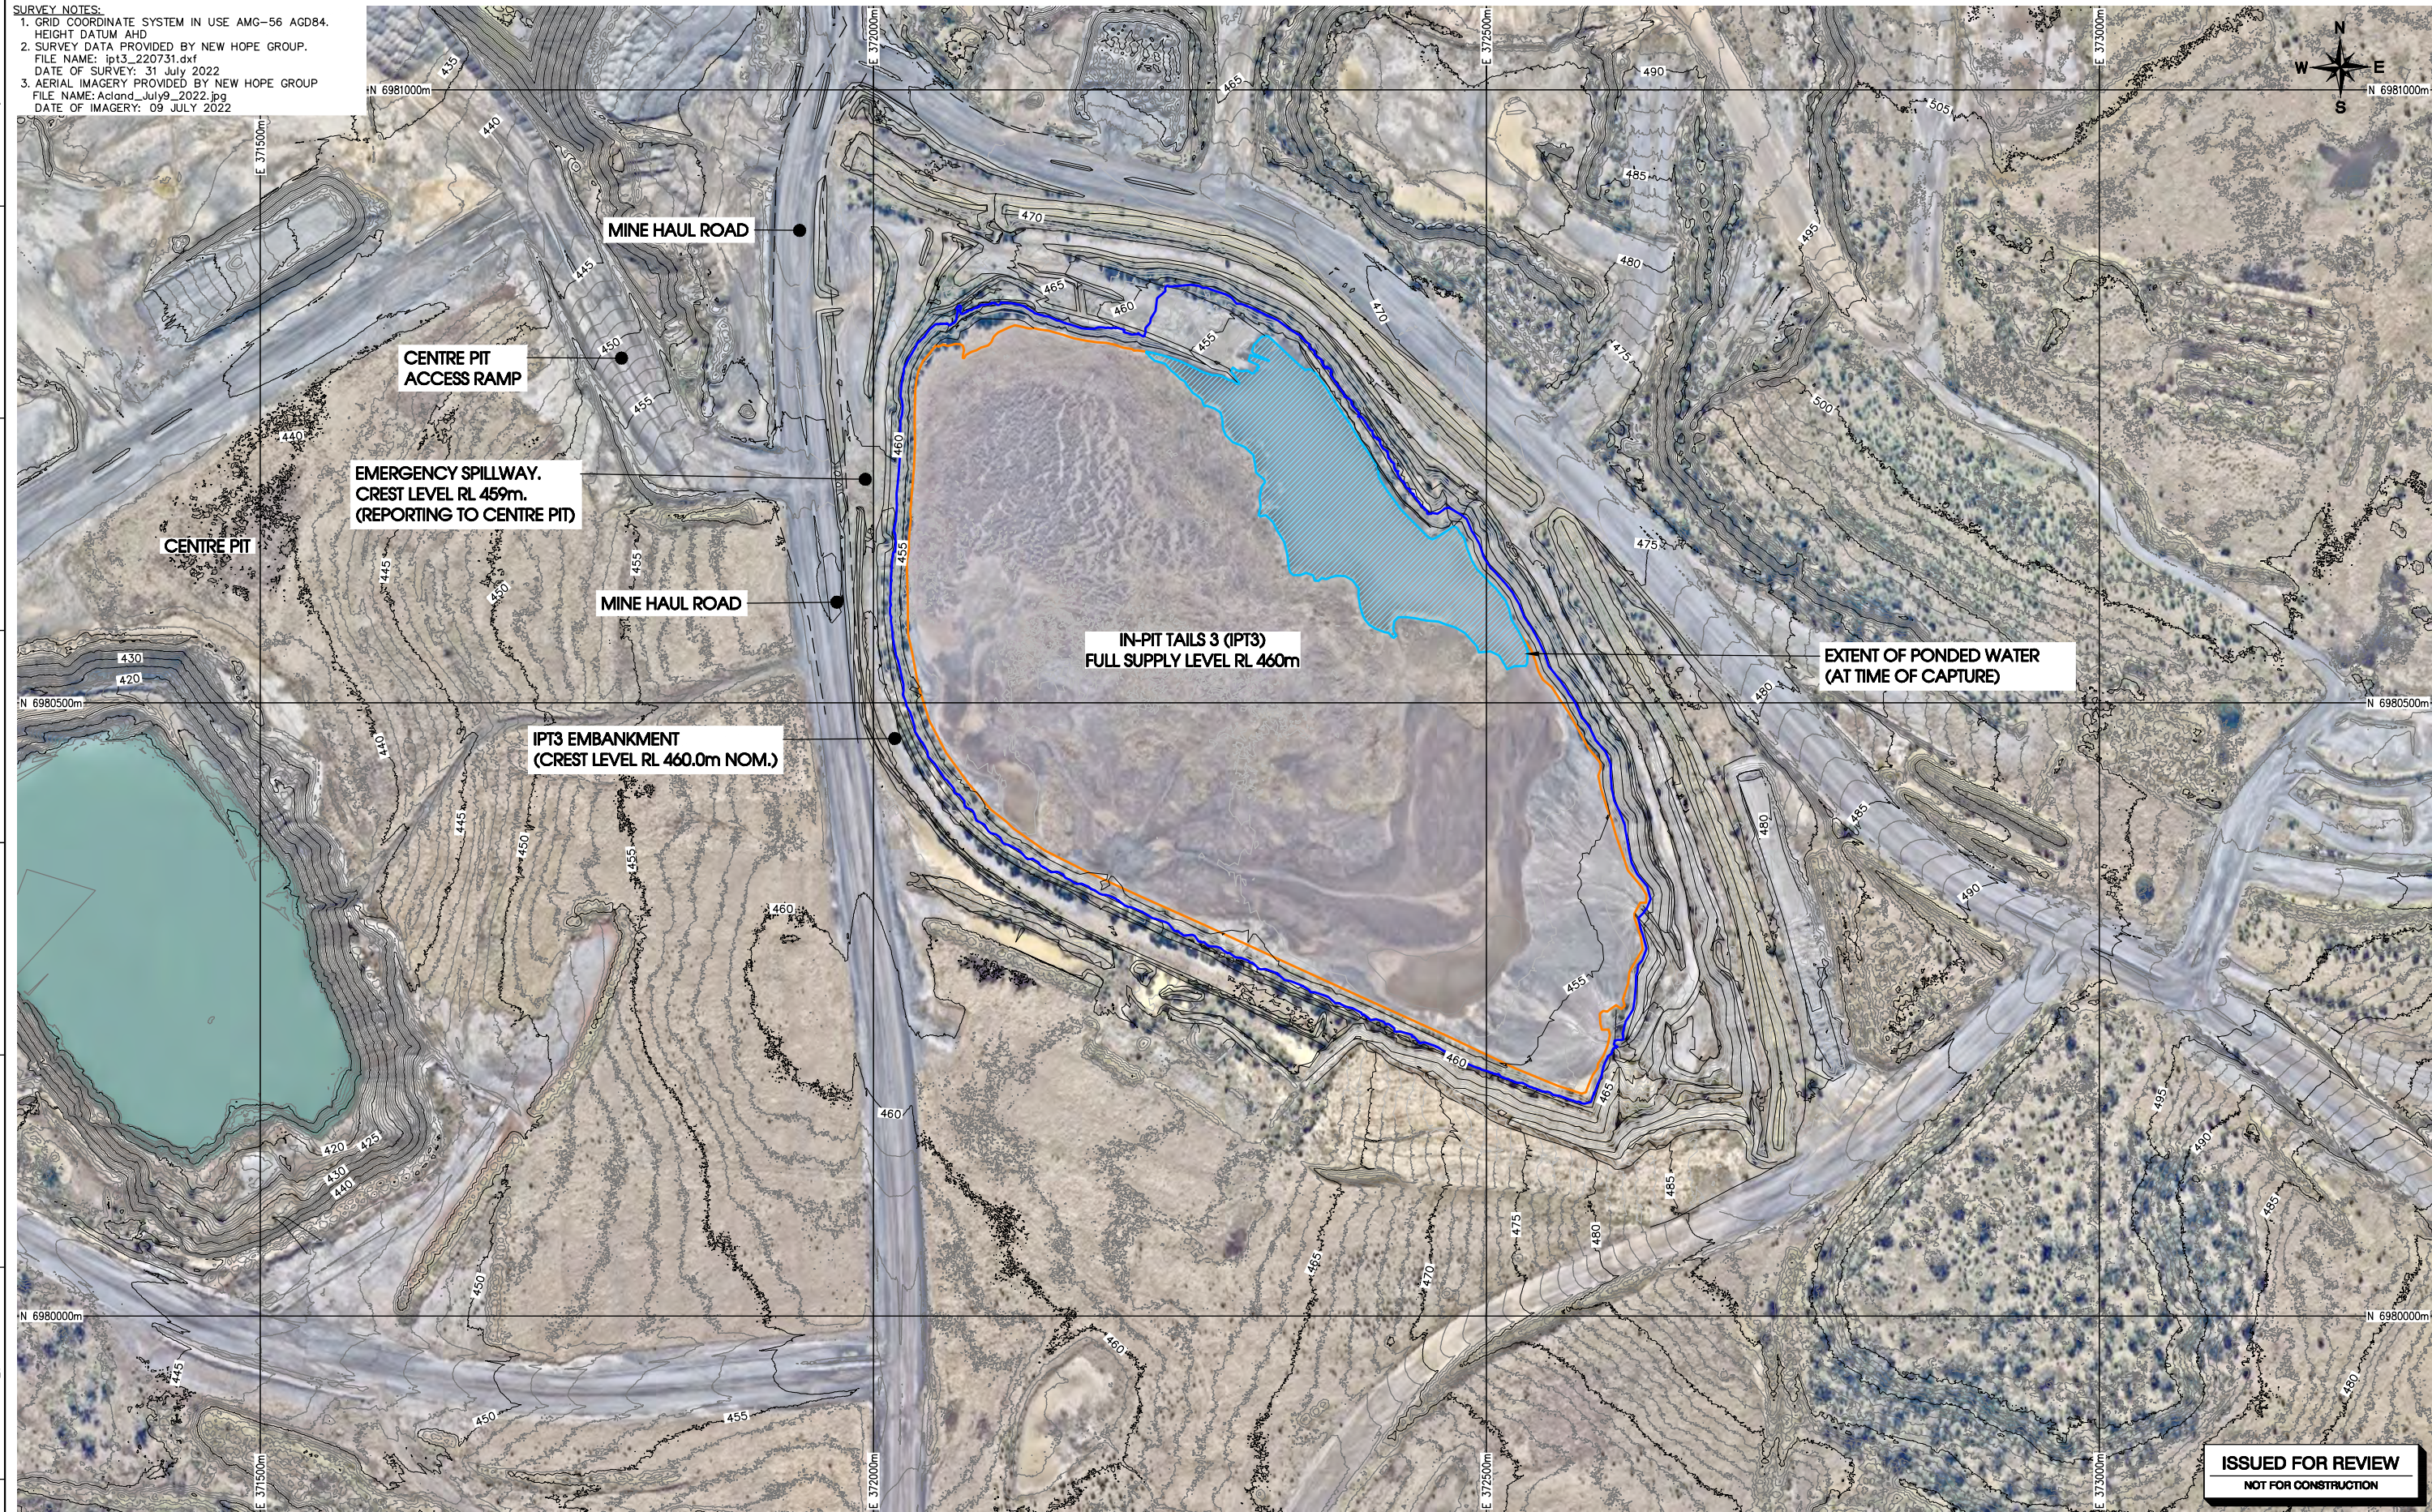
NAC has provided July 2022 survey for the tailings beach in IPT3. This survey is shown on **Figure 004** and given that no deposition has occurred since this time, has been used as a basis for a storage analysis. Results of this analysis are presented in the form of a storage curve provided as **Graph 1**.
