CONSERVATION ZONE MONITORING MAINTENANCE TECHNICAL MEMO

NEW ACLAND COAL MINE

JUNE 2023

**Prepared for
New Hope Group Pty Ltd**

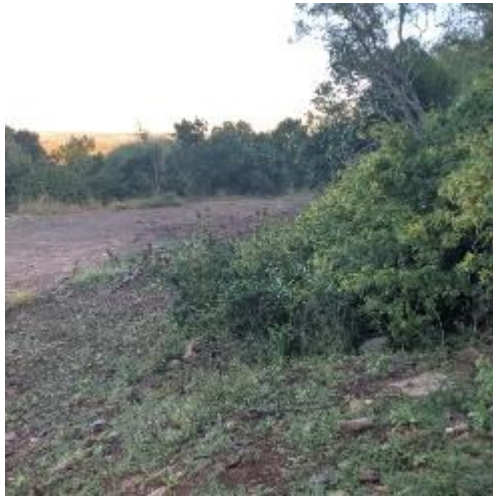
Cape honeysuckle and other garden escapees

All weeds within at least 10 m of the cleared pad should be treated as a priority. Where possible, woody weeds should be treated via cut stump method. Shrubby weeds such as lantana, boxthorn and cape honeysuckle may be cut down using a hedge trimmer or brush cutter and allowed to resprout before a follow up foliar spray treatment of new active growth. Non-native grasses should be brushcut and foliar sprayed when active regrowth is present.

Following weed treatment, topsoil and a layer of weed-free mulch should be installed over the bare pad prior to planting. The existing track up to the house pad should be retained for access. Planting of tube-stock should occur soon after site preparation and receive follow-up watering and weed maintenance to support plant establishment. Species selection and plant density will be based on the predominant RE in this area (RE 11.8.3) and existing species in the locality.

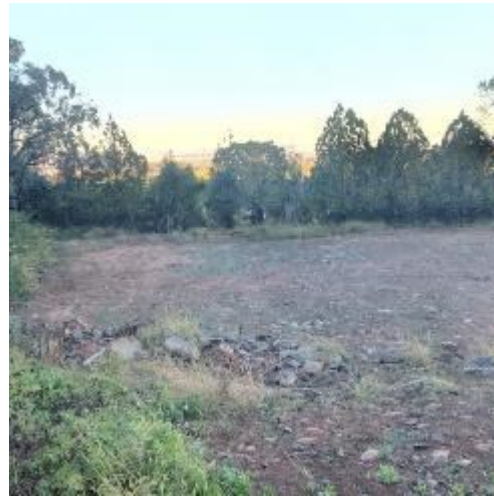
Cleared pad

The demolished house block on the southwestern edge of Bottle Tree Hill represents an ideal area for revegetation. The area currently contains a cleared pad of around 2,000 m² surrounded by a disturbed weedy edge with various woody weeds and non-native grasses. It is recommended that this area be prioritised for treatment to prevent further spread of weeds into the conservation area.

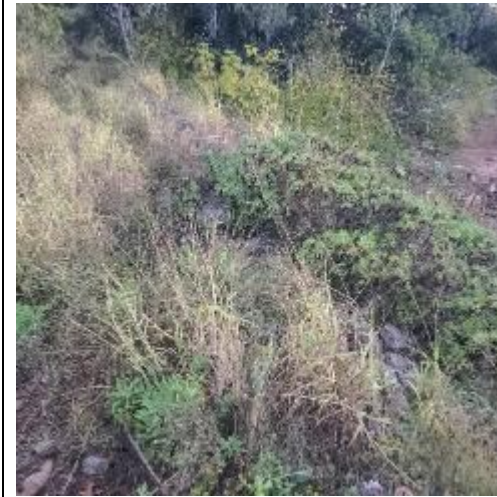
Guinea grass, prickly pear, fleabane, tecoma etc. along outer edges of pad

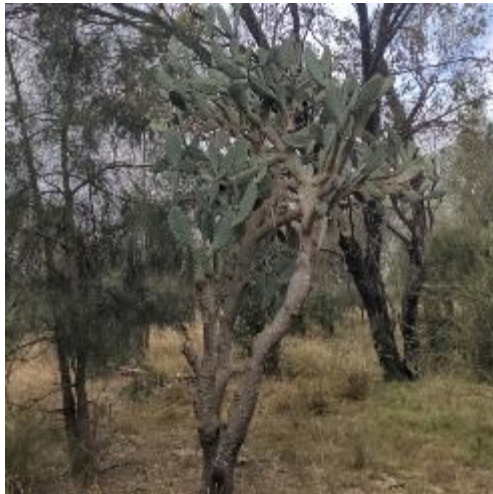
Large opuntias requiring treatment

During the June 2023 survey, only the remnant protection patch on the northern end of the Lagoon Creek conservation area was inspected. This area was generally in good condition and had evidence of Ecological Dominant Layer (EDL) recruitment; however, large prickly pears were observed in this area which should be prioritised for treatment to prevent fruiting and further respread down-stream. Previous treatment of prickly pear at Bottle Tree Hill through stem injection appears to have been largely successful and should be implemented in this area of Lagoon Creek. Any remaining African boxthorn should also be treated as a priority to prevent fruiting and further spread.

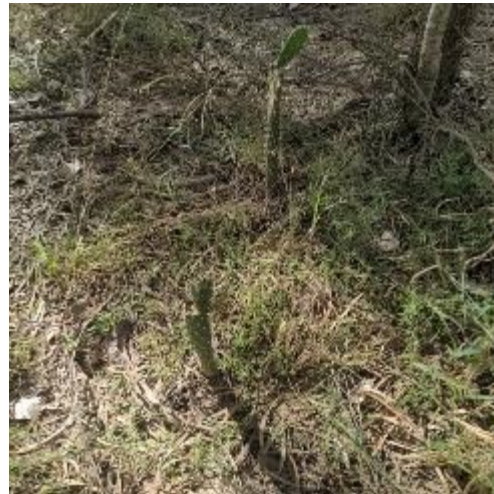
Small opuntia requiring treatment

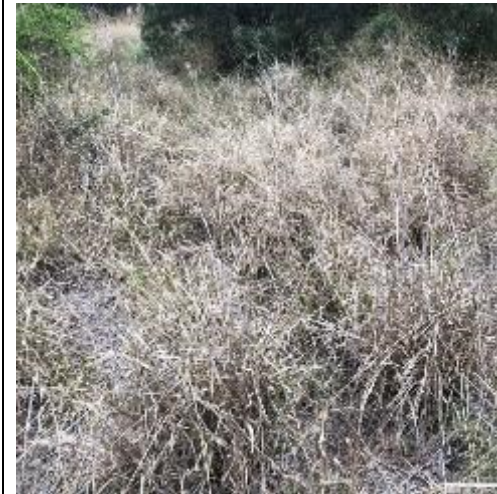
Guinea grass and occasional boxthorn

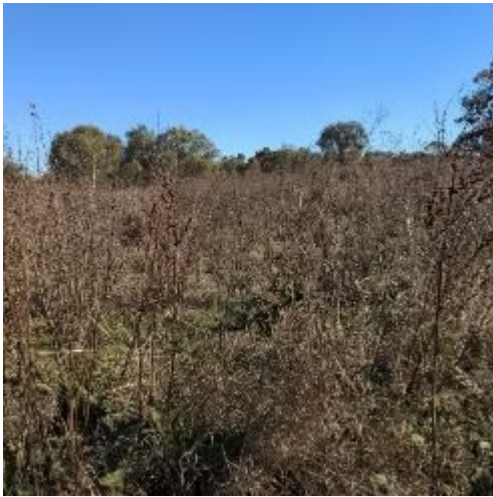
LC05 – ground cover dominated by non-native forbs and grasses

LC05 is identified as occurring in a natural regeneration area according to rehabilitation zone mapping in the CZMP. This area is located adjacent to the existing mine site north of Acland Silverleigh Road. Currently the area consists mostly of open floodplain dominated by non-native groundcover vegetation including Condamine couch (AKA Lippia) *Phyla canescens* and curly

dock *Rumex crispus*. Scattered native trees persist in the area; however, native recruitment is minimal due to the dense groundcover present.

It is recommended that this area be prioritised for weed treatment and revegetation with works progressing from around existing native tree patches and incrementally pushing out into more open areas. *Lippia* is a particularly aggressive weed known to form dense mats and rapidly establish in riparian areas and over bare ground. Effective treatment is likely to involve a combination of mechanical and herbicide control. In areas of little water flow, infestations of *Lippia* can be ploughed or harrowed as a short-term control, followed by herbicide treatment. Revegetation of these areas should occur soon after weed treatment. Direct seeding of native grasses may be a suitable option for these areas in addition to planting tree seedlings.

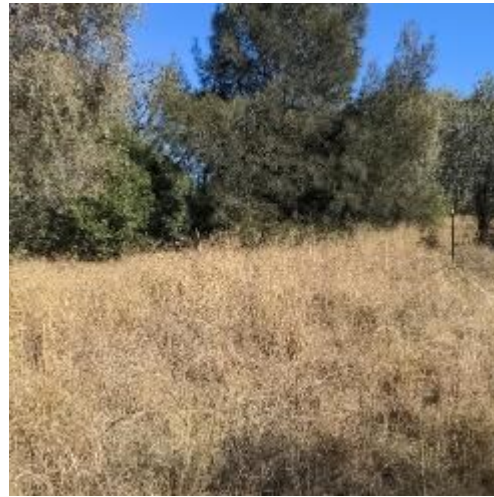
LC02 – Rhodes grass dominating ground cover between remnant area and regrowth

LC02 was observed to be in better condition at the edge of a remnant protection area with good recruitment of *Belah*; however, non-native pasture grasses such as Guinea grass and Rhodes grass is expected to limit future recruitment without treatment. This area should be monitored and treated if non-native cover increases.

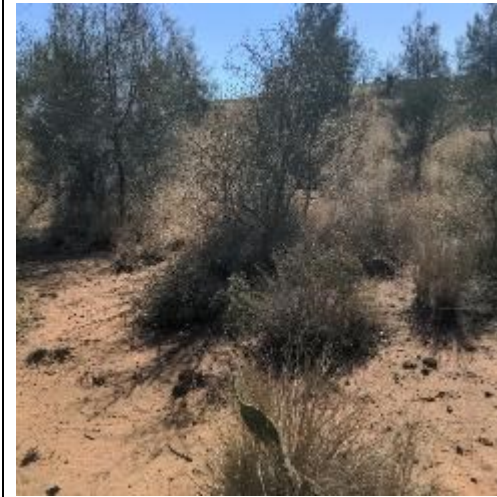
LC02 – Occasional boxthorn and prickly pear

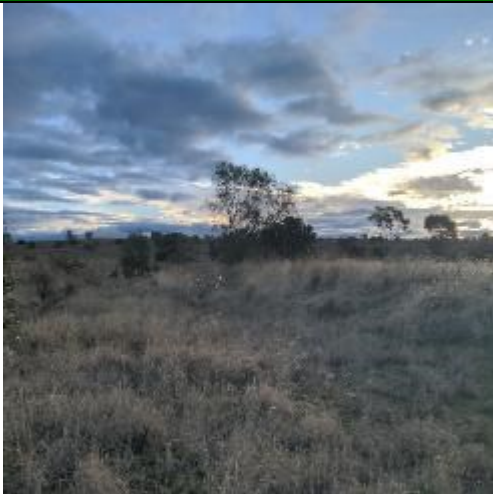
LC04 - Rhodes grass and Condamine couch dominate. Occasional large prickly pear

Occasional large Prickly Pear were also observed (at LC04) which should be prioritised for treatment to avoid further spread.

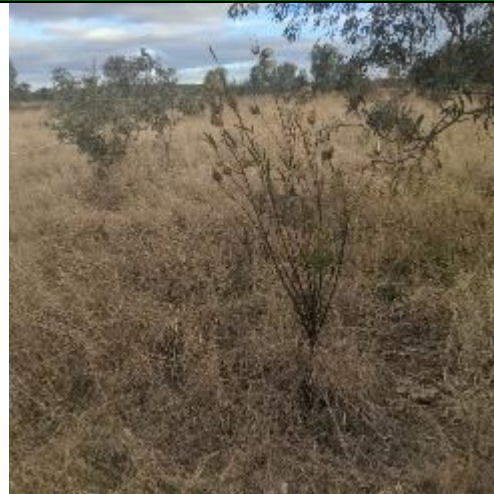
LC01 - Scattered cotton bush and verbena

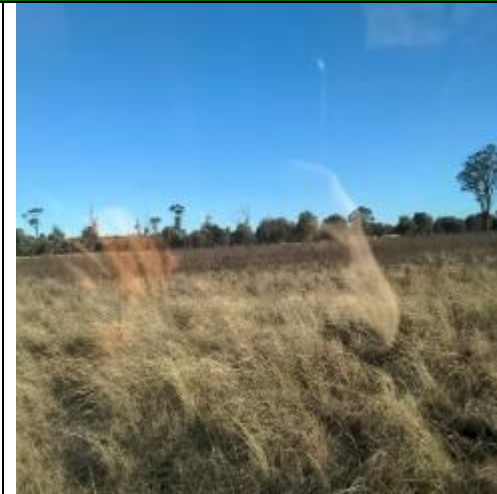
Gap in planting along southern section of Lagoon Creek

Much of the riparian zone of Lagoon Creek has undergone planting activities at various points in time such that most of the creek line is establishing increased habitat connectivity. Future revegetation should focus on connecting gaps between planted areas and supplementary planting of areas not achieving stem density targets before moving restoration actions out further from the creek line. Monitoring to occur in the next few months will aim to determine target areas for planting so that additional planting activities can commence before the end of 2023.
