## **NEW ACLAND COAL MINE**

# **CONSERVATION ZONE MONITORING AND REHABILITATION MONTHLY REPORT**

**NOVEMBER 2023**

**RE: Conservation Zone Monitoring and Rehabilitation Monthly Report – November 2023**

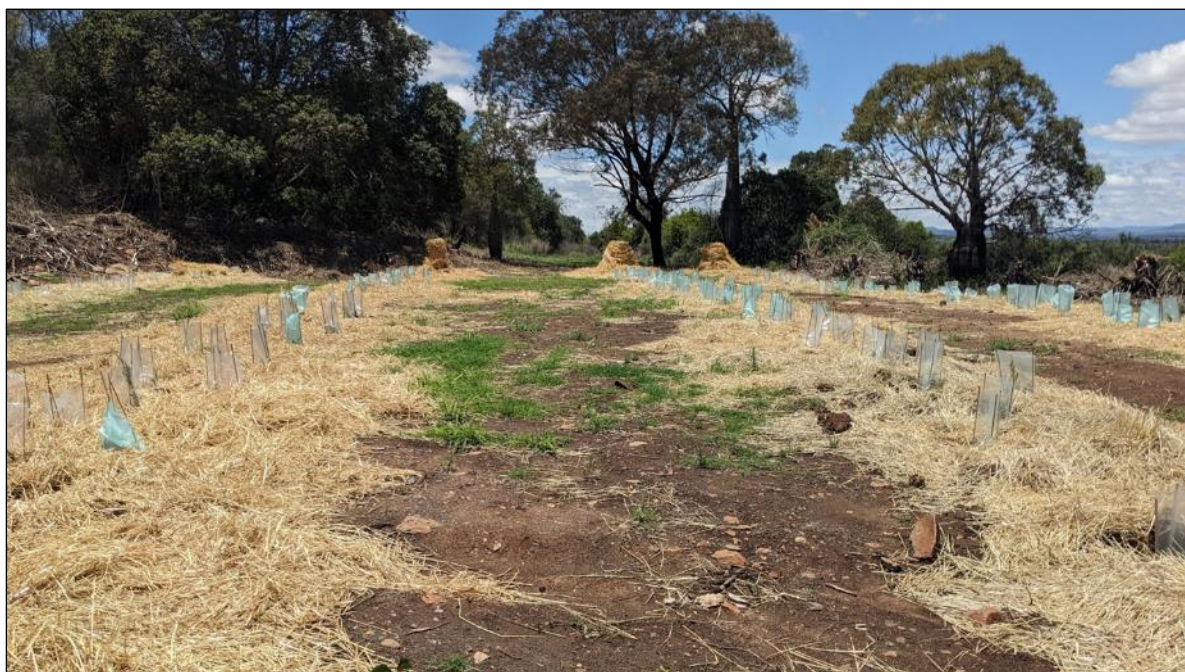
The visual assessment found minimal erosion present, despite significant rainfall events in the days preceding the site visit. Weed presence within the planting site has increased with the increase in rainfall and consists mostly of emerging Green Panic, Couch, Verbena, Fleabane, and Purslane between the planted rows (**Photos 1 and 2**). Regrowth of previously treated weeds surrounding the planting site were also apparent, including Cape Honeysuckle, Orange Trumpet Vine, and Brazilian Nightshade.

Plant survival was assessed through two sample counts taken on opposite sides of the planting. Groundcover species averaged 69% survival and trees and shrubs 79% survival.

Photo 1. Bottle Tree Hill Planting – eastern side

The existing planting at Bottle Tree Hill is currently in good condition; however, on-going weed maintenance is recommended to control weed regrowth and emerging weeds within and surrounding the planting area. Now is an ideal time to conduct herbicide treatments while conditions are favouring active growth.

Targeted spot spraying is recommended to avoid off-target damage to emerging native species. Weeds growing within tree guards should be hand-weeded to reduce competition. Spreading mulch between the planted beds may also assist in weed suppression. This should ideally follow ground cultivation, which will be required for additional revegetation.

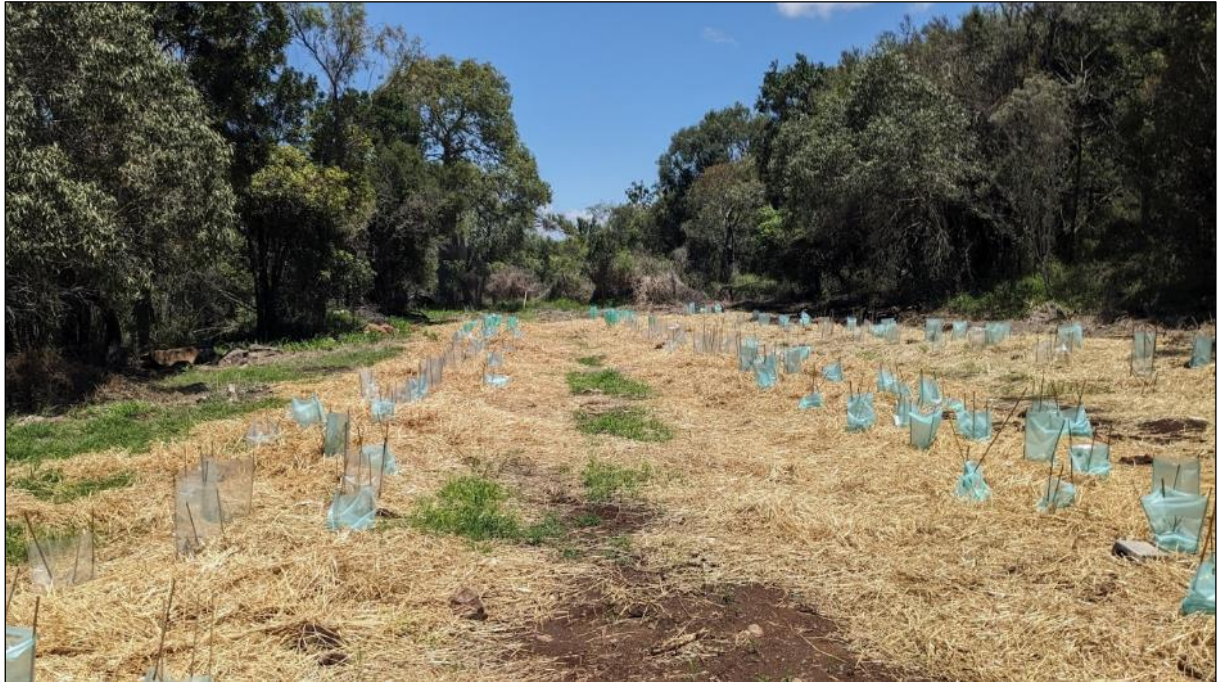
Photo 2. Bottle Tree Hill Planting – western side

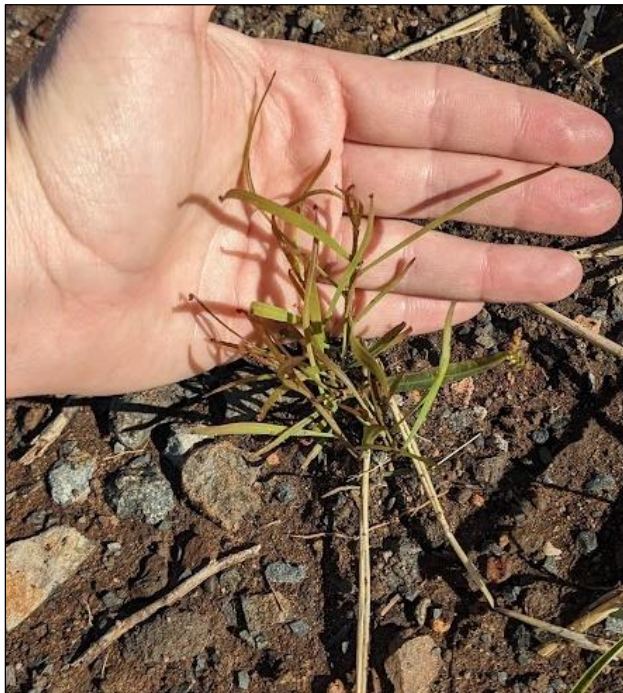
Emerging native plants including an Acacia species (**Photo 3**) and native groundcover Saltbush *Atriplex sp.* (**Photo 4**) were located in some spots between the planted rows. Examples of these plants have been flagged to be referred to by weed control personnel during maintenance works to avoid off-target damage.

Photo 3. Acacia seedling

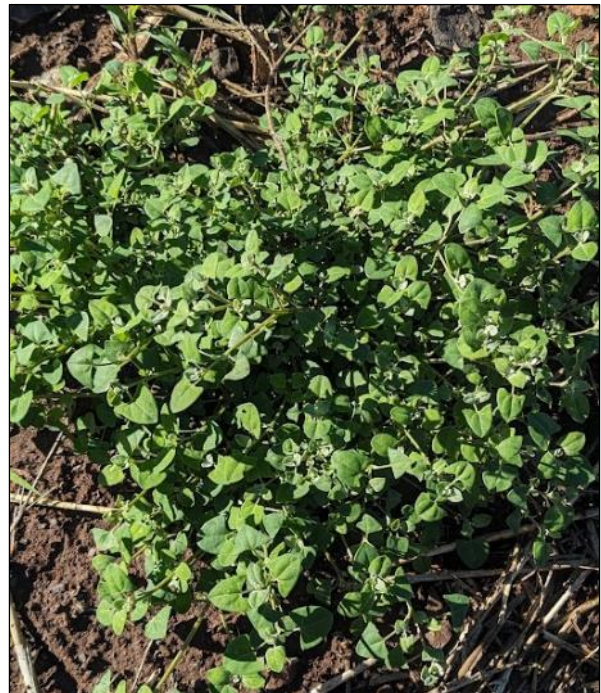
Photo 4. Saltbush *Atriplex* sp.

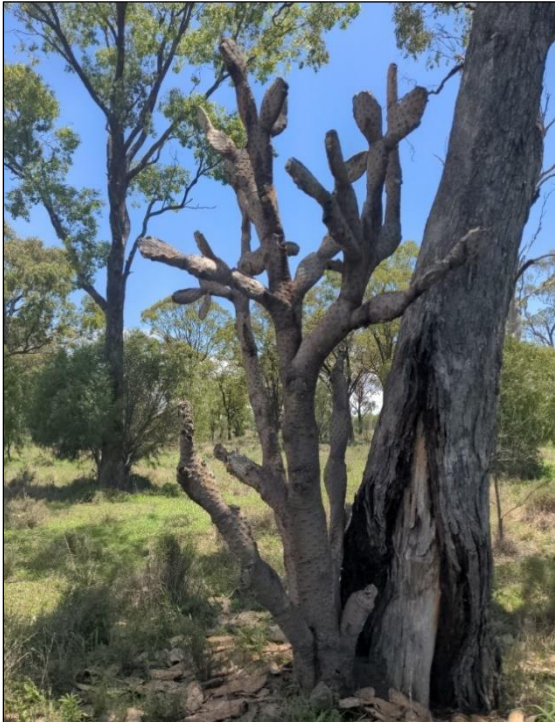
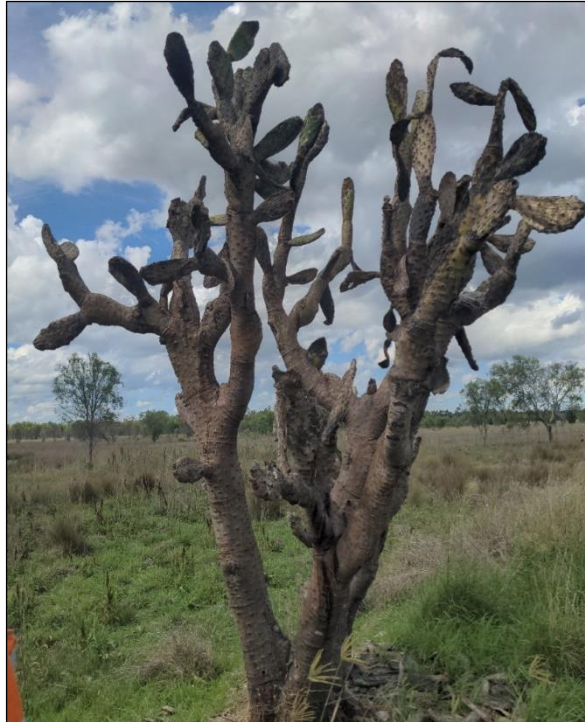
Monitoring along Lagoon Creek focused on assessing the effectiveness of stem injection treatments of Tree Pear (*Opuntia tomentosa*) conducted in August 2023. All treated plants inspected were exhibiting distress and many were found to be completely dead, especially the smaller individuals (**Photo 5 and 6**). New growth was observed on some of the larger treated plants (**Photo 7**), though it is understood this also occurred to some treated plants at Bottle Tree Hill, which eventually succumbed to the herbicide treatment despite evidence of new growth.

Photo 5. Treated tree pear near LC10

Photo 6. Treated tree pear near LC04

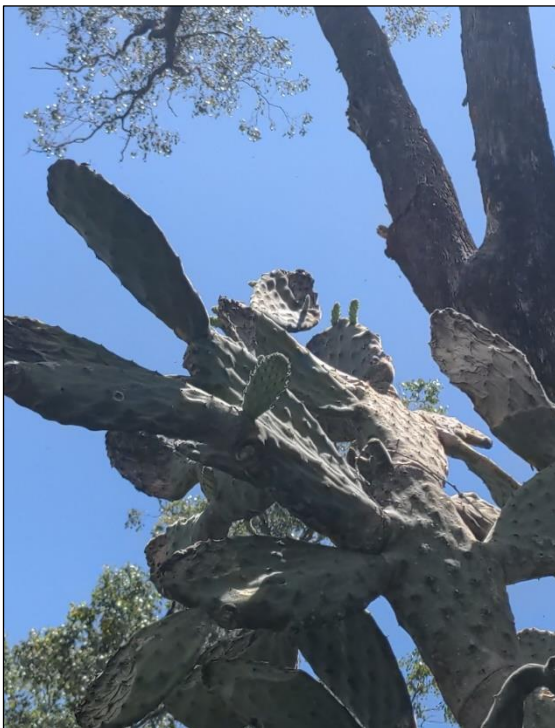
Photo 7. New pads shooting from treated plant

These individuals will continue to be monitored during on-going maintenance works to determine any requirement for further treatment. New growth from dropped pads on the ground surrounding treated plants was also commonly observed (**Photo 8**). These and other emergent Tree Pear will be targeted for treatment in the new year.

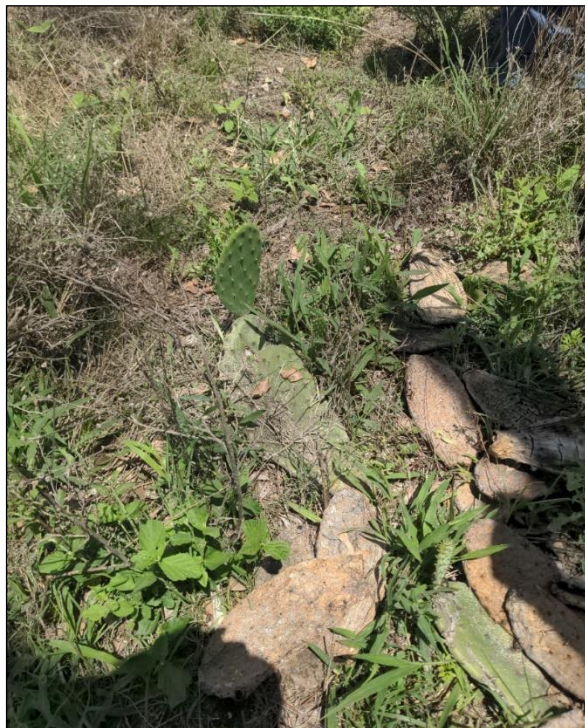
Photo 8. New pads shooting from dropped pads

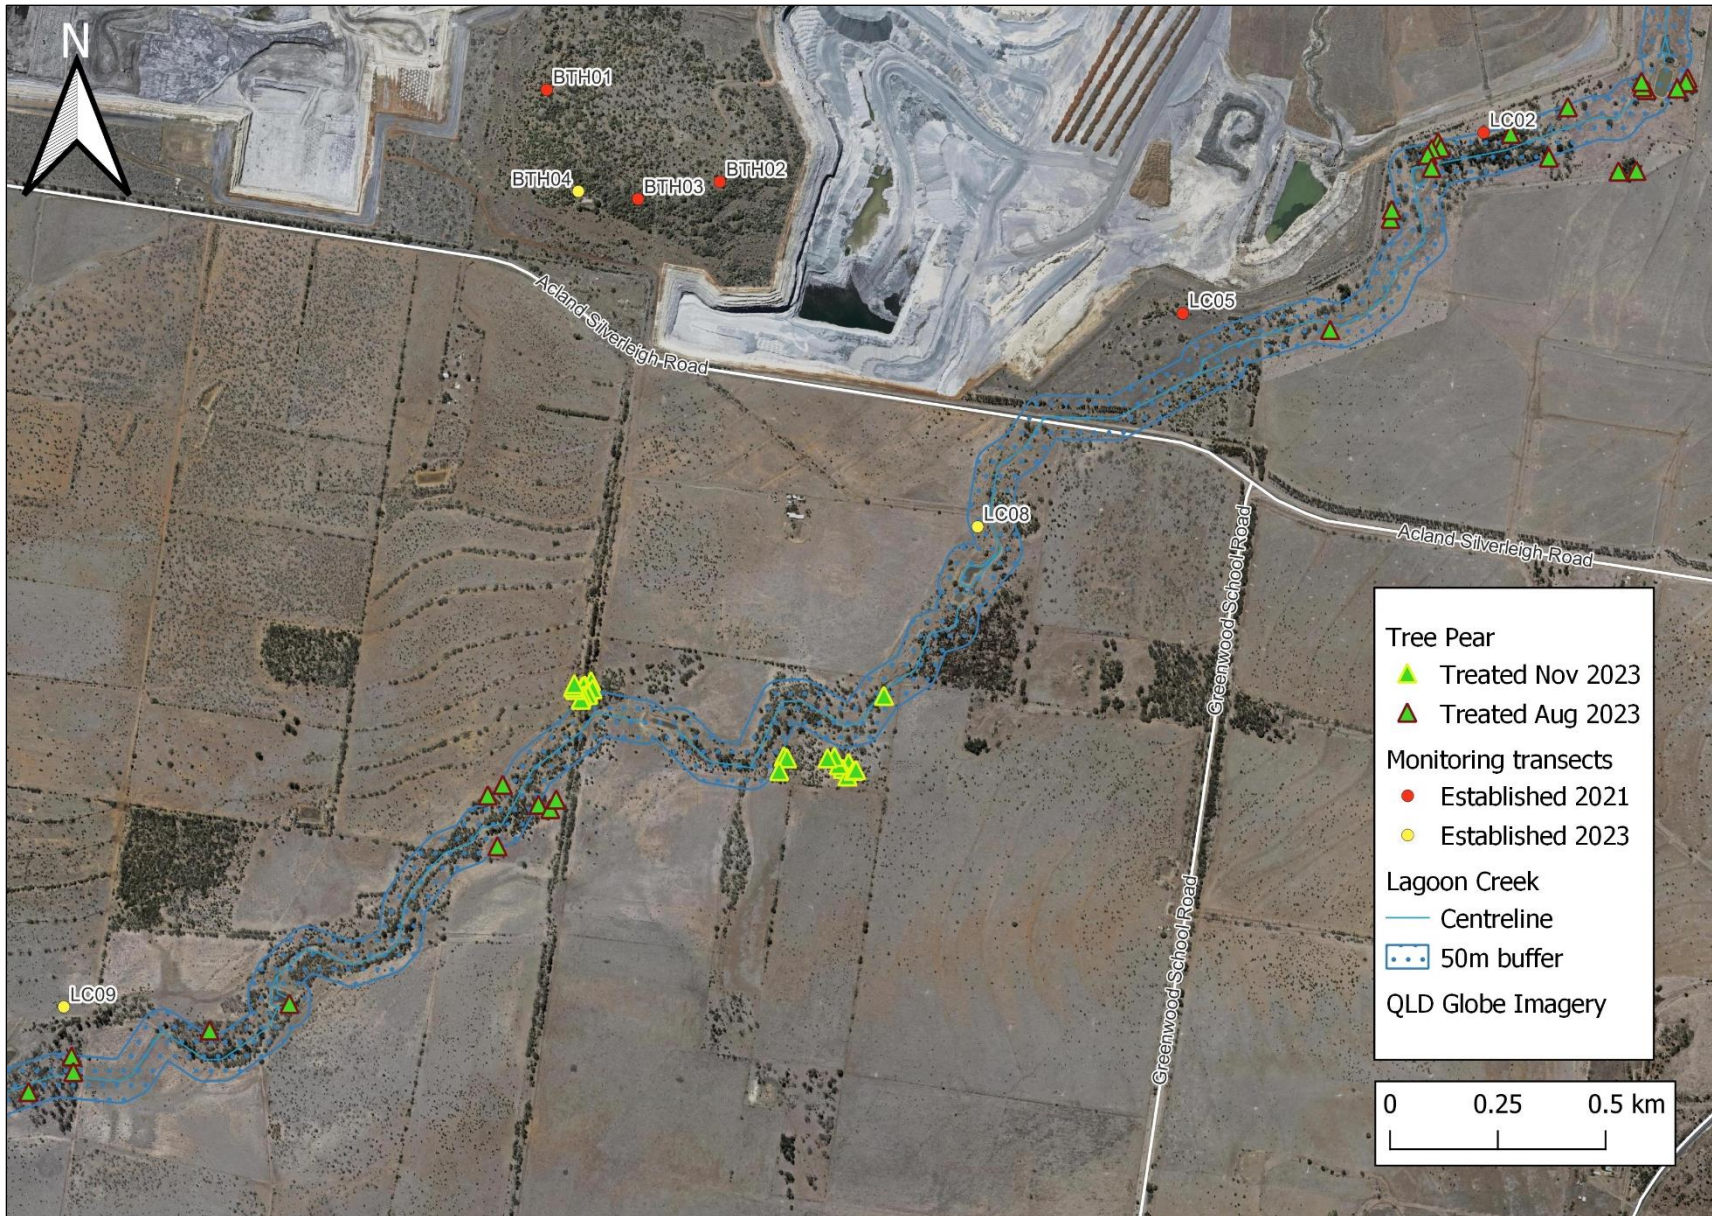
During the November site visit, BAAM personnel continued stem injection treatment of mature Tree Pear within the Lagoon Creek Conservation Area. About 30 mature plants were stem injected between areas of previous treatment undertaken in August (see **Figure 1**). Several large individuals were treated in the vegetated fence line connecting to Willeroo Mine Road.

Figure 1. Tree Pear treatment locations

Further stem injection of mature Tree Pear along Lagoon Creek is required to complete primary treatment throughout the conservation area. It is anticipated all remaining primary treatment of Tree Pear will be completed in the following month's visit.
