NEW ACLAND COAL MINE

CONSERVATION ZONE MONITORING AND REHABILITATION MONTHLY REPORT

DECEMBER 2023

RE: Conservation Zone Monitoring and Rehabilitation Monthly Report - December 2023

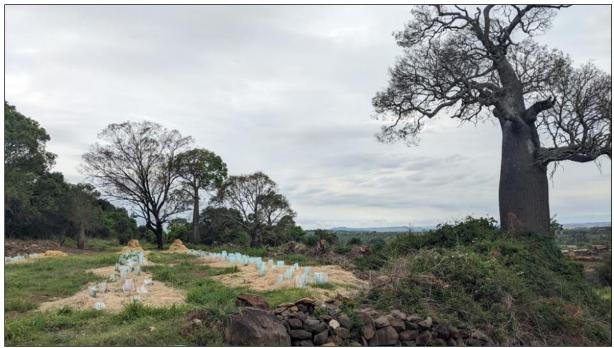
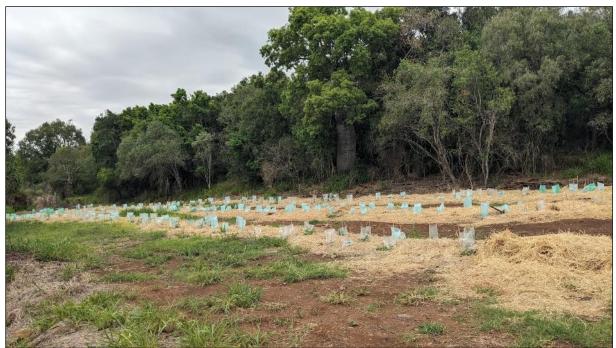
Weed presence within the planting site has continued to increase since the November 2023 inspection, with greater cover of Green Panic and other weeds recorded in November (**Photos 1 and 2**).

Photo 1: Eastern side of BTH planting

Photo 2: Western side of BTH planting

On-going weed maintenance is recommended to control weed regrowth and emerging weeds within and surrounding the planting area. Targeted spot spraying is recommended to avoid off-target damage to emerging native species. Weeds growing within tree guards should be handweeded to reduce competition. Spreading mulch between the planted beds may also assist in weed suppression. This should ideally follow ground cultivation, which will be required for additional revegetation.

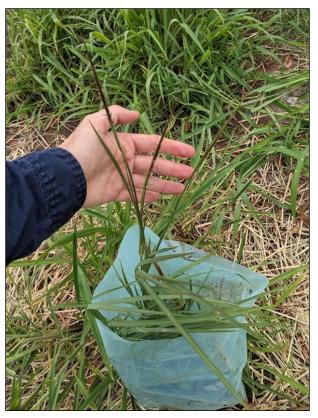
Seedling establishment was assessed through two sample counts taken on opposite sides of the planting (same rows counted in November 2023). The survival of planted trees and shrubs decreased from an estimated 79% in November 2023 to 55% in December 2023. In contrast, groundcover survival increased from 69% on November 2023 to 72% in December 2023. The causes are unclear; however, there appeared to be more impact of grazing on the planted trees and shrubs in comparison to the grass species. The planted grasses had grown significantly between the November and December monitoring events, with many beginning to form seedheads (**Photo 3**).

Photo 3: Planted *Heteropogon contortus* producing seedheads.

Grazing by wallabies and hares appears to be restricted to planted trees and shrubs and surrounding non-native grass species rather than the planted native grasses. As such, it is recommended that the tree guards around planted grasses be removed to encourage outward growth of these groundcovers. Removed guards may be placed around naturally regenerating plants (e.g. Acacia species) within the planting area to prevent grazing.

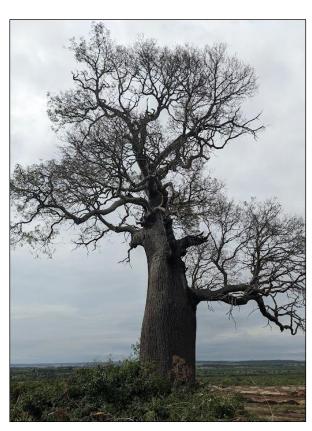
Of concern was the apparent off-target damage to three existing Bottle Trees (*Brachychiton rupestris*) and a *Eucalyptus sideroxylon* tree around the outside of the planting, which were found to have suffered significant defoliation since the November 2023 monitoring event (**Photo 4** and **5**). It is possible that the defoliation is a delayed response to the application of Tordon® (applied by a contractor approx.12 weeks ago) to the mulched stems of Cape Honeysuckle and Thuja Pines in the vicinity of these trees. Given that Tordon® is a residual herbicide known to impact native vegetation, and with the extensive rainfall which has occurred since the application, it is likely that the herbicide has leeched into the soil and been absorbed through the roots of the affected trees resulting in plant damage. On-going planting monitoring will aim to assess the recovery of these trees and the requirement for replacement should plant death occur.

Photo 4: Defoliated Bottle Tree

Due to the off-target impacts of Tordon®, this herbicide is NOT to be applied within the Bottle Tree Hill or Lagoon Creek conservation zones. The use of other residual herbicides (including Grazon®) must be carefully considered in the context of the landscape (e.g. proximity to waterways, natural regeneration presence) and prevailing weather conditions, and in strict accordance with the product label and SDS to avoid environmental damage.

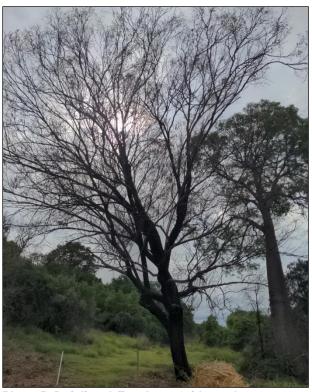
Photo 5: Defoliated Eucalyptus sideroxylon

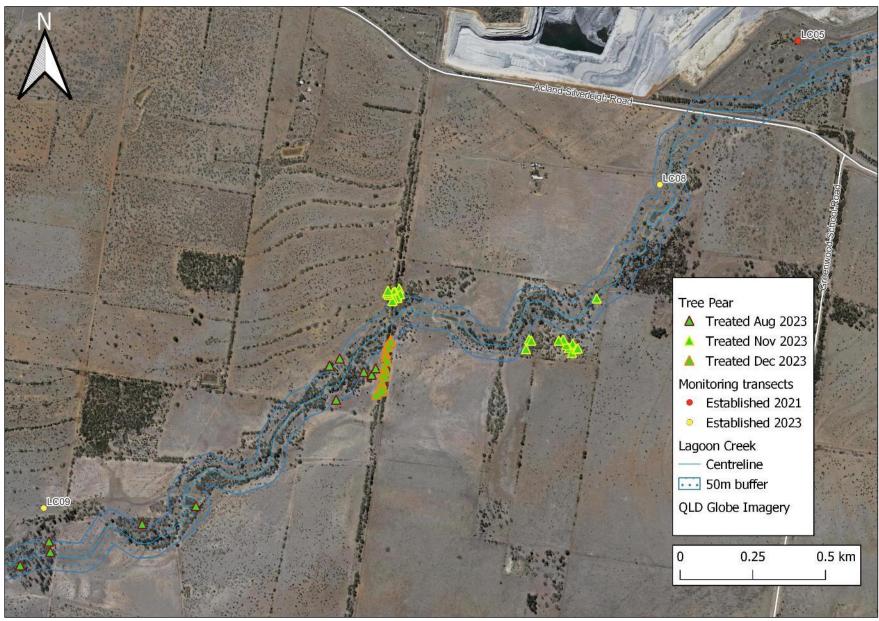
During the December 2023 visit, BAAM personnel continued stem injection treatment of mature Tree Pears within the Lagoon Creek Conservation Area in the vegetated fence line connecting to Willeroo Mine Road and in the southern portion of the conservation area. About 66 plants were stem injected, completing the primary treatment of all *Opuntia* within the Lagoon Creek conservation zone (see **Figure 1** and **2**).

Figure 1. Tree Pear treatment locations in central portion of Lagoon Creek

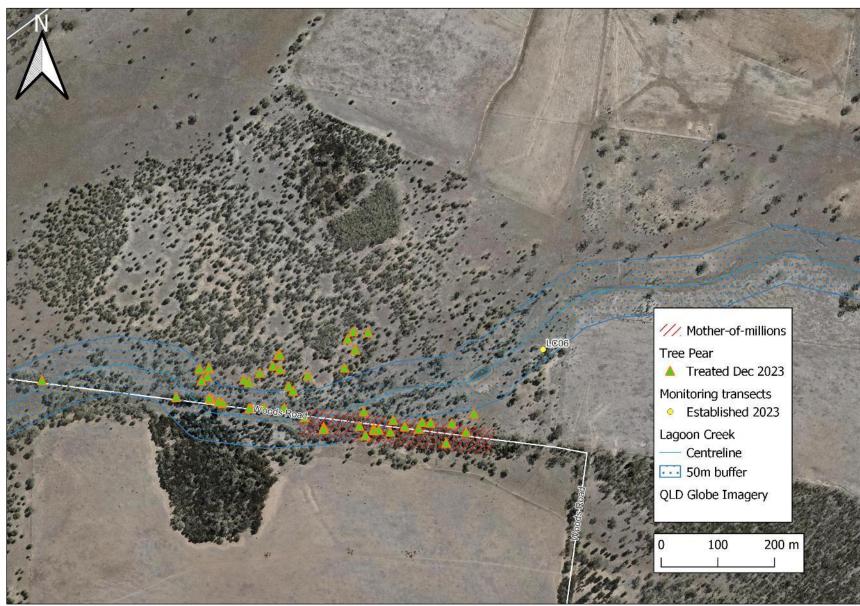
An infestation of the invasive weed 'Mother-of-millions' (*Bryophyllum delagoense*) was located in the southernmost portion of the Lagoon Creek conservation area. This was the first record of the species at Lagoon Creek.

Figure 2. Tree Pear treatment locations and Mother-of-Millions in southern portion of Lagoon Creek

As a Category 3 restricted invasive plant under *Queensland's Biosecurity Act 2014*, it is strongly recommended that NAC incorporate the control of Mother-of-millions into the maintenance program for Lagoon Creek to prevent any further spread. A rough depiction of the infestation area noted during stem injection of Tree Pear is given in **Figure 2**.
