# BENGALLA MINE ANNUAL REVIEW 2023

**BENGALLA MINING COMPANY PTY LIMITED**  
LOCKED BAG 5  
MUSWELLBROOK NSW 2333

March 2024

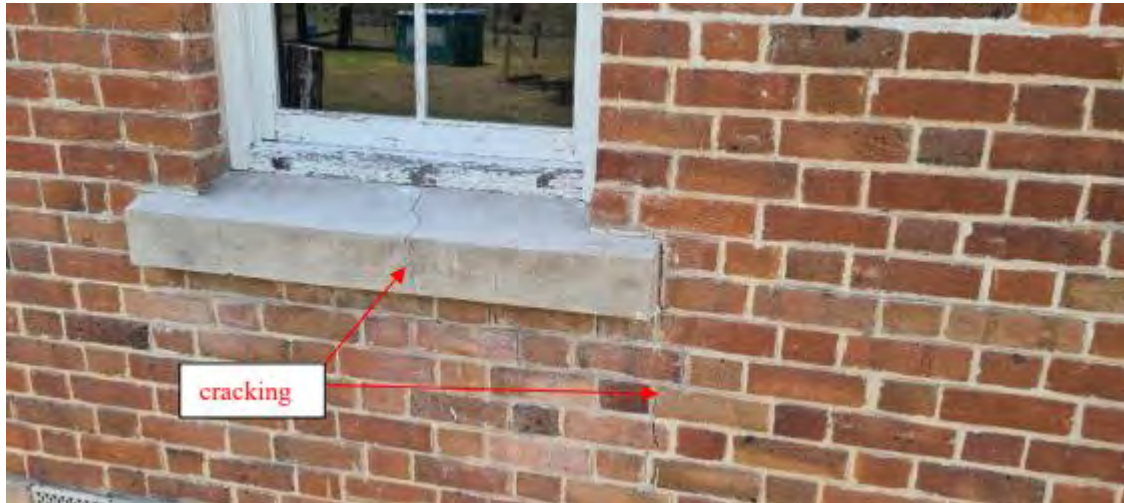
Example of brick and mortar repairs needed

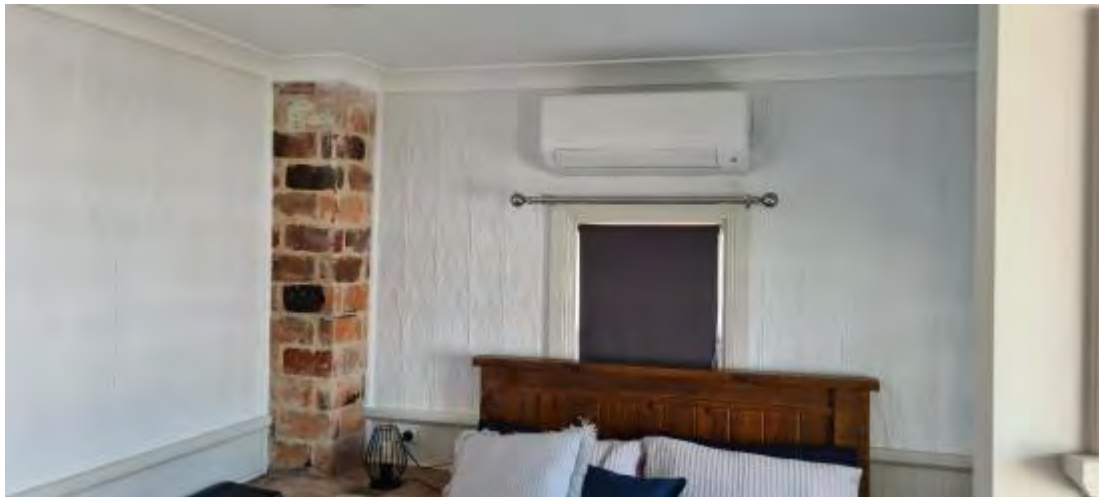
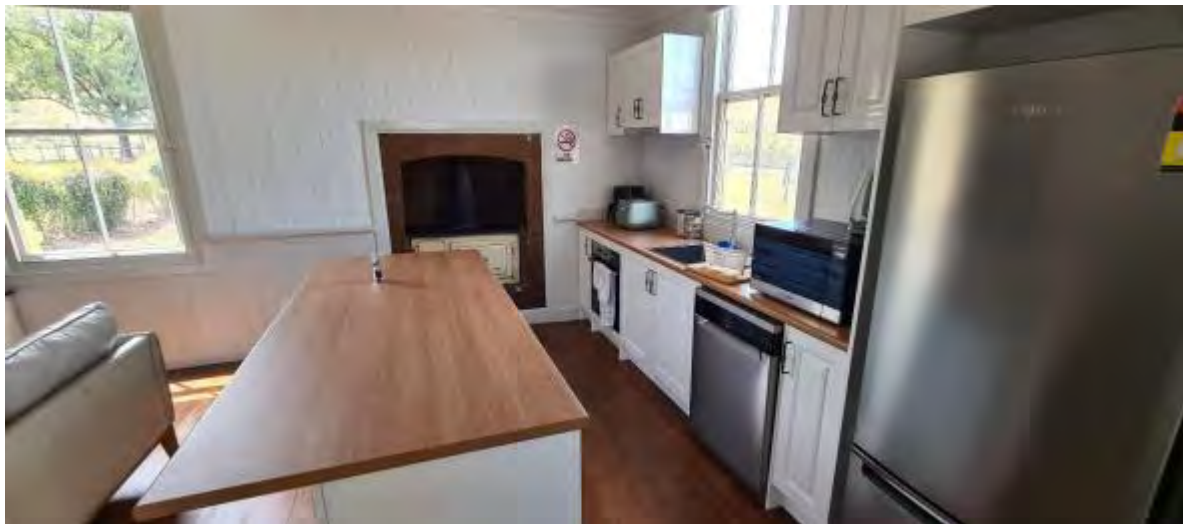
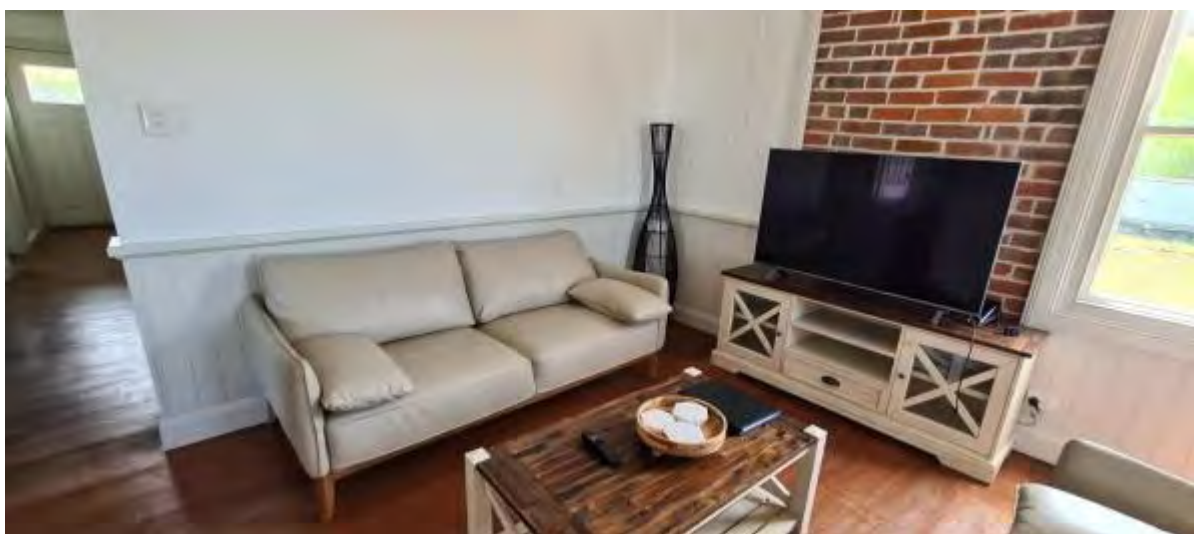
Book Keepers Cottage

Full renovation of the interior of the book keepers cottage has been undertaken and externally the building is generally in a good state of repair.

Images of internal repairs of book keepers cottage

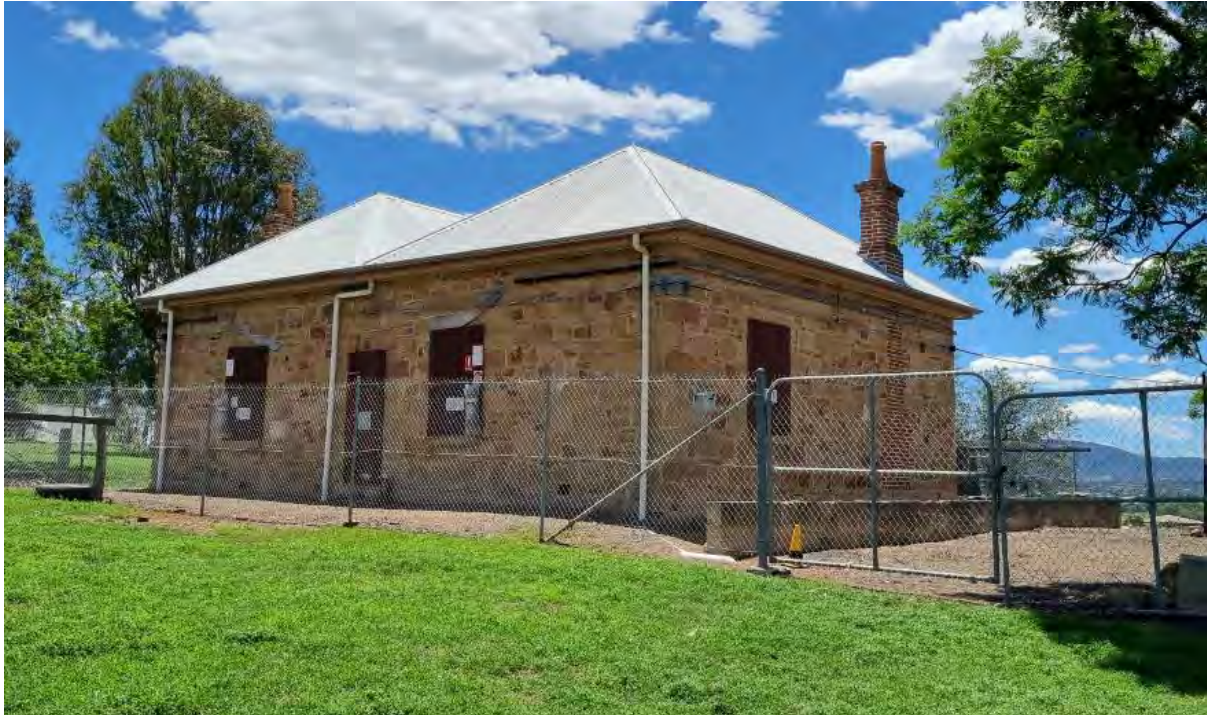
***Overdene Homestead***

The works carried out in the previous years have been successful. The replacement of the roof sheeting and diversion of stormwater away from the building and the previous restoration of the sandstone and brickwork has stabilised the deterioration.

The remaining outstanding items for the external part of the building included the replacement of missing pipe props from the tie rod ends to assist in continually stabilising the structure. The verandah flooring and roof framing, sheeting and flashings still require reinstatement.

External view
