**NEW HOPE**  
GROUP

## Appendix G Supporting Technical Reports and Data

## G.1.4 Soil Sampling Site Assessment Report – Mining Area

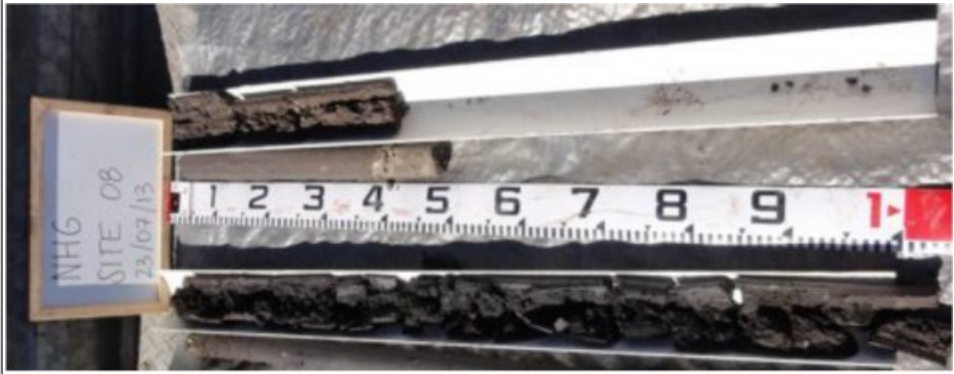
### Site 8: Soil Profile Description

0-250	A1	Medium Clay 10YR2/1 No mottles, segregations or coarse fragments Structure is polyhedral, weak grade and weak consistence Many medium roots	8.7	0.021	0-100 6.5	0-100 60	0-100 30	0-100 3.92	0-100 1.85	0-100 10.2
	250-1000	B21	Medium Heavy Clay 10YR2/2 No mottles or coarse fragments 2-10% carbonates Structure is polyhedral, strong grade and firm consistence Common fine roots	8.1	0.274	500-600 8.4	500-600 533	500-600 580	500-600 16.67	500-600 1.55	500-600 9.6
	1000-1300+	B22	Medium Heavy Clay 10YR3/2, mottle 7.5YR7/2 (2-5%) <2% carbonates, no coarse fragments Structure is angular blocky, moderate grade and firm consistence Few and very fine roots	8.4	0.428	800-900 7.6	800-900 3870	800-900 1650	800-900 8.33	800-900 2.23	800-900 10.8

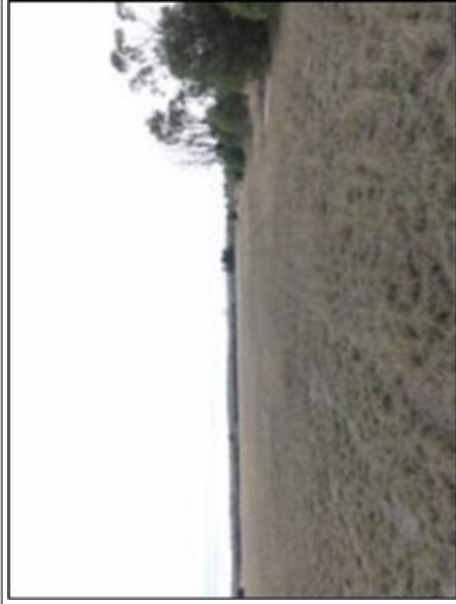
**Soil Mapping Unit B1**

<b>Site No.</b>	1	<b>Vegetation (woody)</b>	Isolated clumps (<0.2%)
<b>AMG Reference</b>	-	<b>Vegetation (non-woody)</b>	Dense (>70%) Unidentified Grasses (grazed and no inflorescence)
<b>ASC</b>	Dermosol	<b>Land Use</b>	Grazing
<b>Landform Element</b>	Lower	<b>Depth of sample (mm)</b>	0-100, 200-300, 500-600, 800-900, 1000 - 1100
<b>Landform Pattern</b>	Flat Plain	<b>Land Suitability</b>	Class 2 (Grazing) Class 2 (Rainfed Cropping)
<b>Slope %</b>	0.5	<b>General Comments</b>	Soil surface condition was recorded under moist conditions. Landform was flat with a gentle slope. Classified as a Kandosol due to weak structure of the B Horizon. The structure of these soils will become more obvious in drier conditions so suspect it may grade into a Dermosol.
<b>Microrelief</b>	Nil		
<b>Drainage</b>	Moderately well-drained		
<b>Land Condition</b>	Good condition		
<b>Surface Condition</b>	Soft

**General Description:** the SMU consists of deep, well structured, self-mulching and cracking softwood scrub soils on undulating plains. A highly productive cropping soil. The major features of the soil mapping unit include;

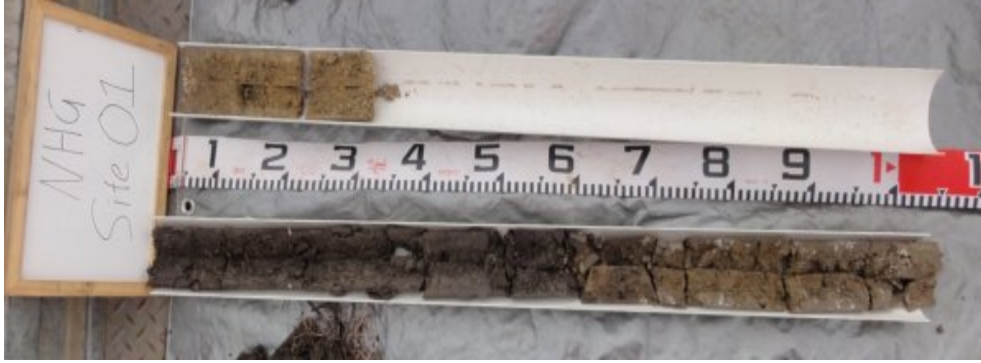
## Site 1 Soil Profile Description

0-600	A1	Medium Heavy Clay 7.5YR2.5/1, mottled 10YR6/2 2-6mm, Distinct 2% <2% Iron and <2% 0-2mm coarse fragments Structure is subangular blocky with moderate grade and weak consistence Many fine roots	9.8	0.212	0-100 8.4 200-300 9.1	0-100 100 200-300 206	0-100 <10 200-300 30	0-100 1.41 200-300 8.79	0-100 5.38 200-300 3.88	0-100 21.3 200-300 9.1
	600-1000	B2	Medium Heavy Clay 10YR4/3, no mottles 2-10% carbonates and 2-10% 0-2mm coarse fragments Structure is subangular blocky with weak grade and firm consistence Few fine roots	9.5	0.687	800-900 7.9	800-900 3780	800-900 930	800-900 0.83	800-900 25.85	800-900 144
	1000-1300+	B3	Medium Heavy Clay 10YR4/2, mottled 10YR5/4 Weathered parent material and 10-20% 0-2mm coarse fragments Structure is subangular blocky with weak grade and firm consistence Few very fine roots	9.7	0.642	1000-1100 9.0	1000-1100 1260	1000-1100 1140	1000-1100 26.92	1000-1100 1.59	1000-1100 7.8

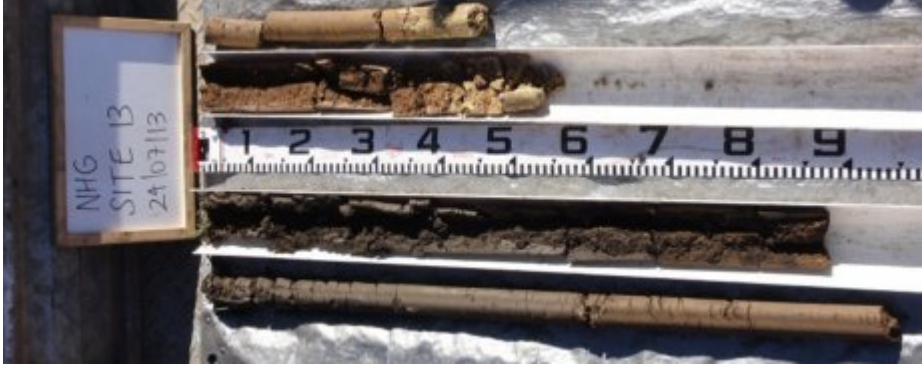
## Site 13 Soil Profile Description

0-850	A1	Medium Clay 10YR2/2, no mottle No segregations or coarse fragments Structure is polyhedral with weak grade and weak consistence Common very fine roots	9.0	0.422	0-100 8.5 200-300 8.9	0-100 156 200-300 211	0-100 10 200-300 20	0-100 2.27 200-300 13.27	0-100 3.34 200-300 2.27	0-100 13.2 200-300 9.8
	850-1300	B2	Medium Heavy Clay 10YR3/3, no mottles No segregations or coarse fragments Structure is subangular blocky with weak grade and firm consistence Few very fine roots	9.5	0.877	800-900 9.1 1000-1100 9.2	800-900 899 1000-1100 926	800-900 440 1000-1100 560	800-900 10.98 1000-1100 25.74	800-900 3.20 1000-1100 1.11	800-900 440 1000-1100 560
	1300-1500	BC	Light Clay 2.5YR6/3, no mottles No segregations or coarse fragments Coarse fragments include 0-2mm at 20-50% Structure is apedal with massive grade and firm consistence No roots evident	9.6	11.5	-	-	-	-	-	-

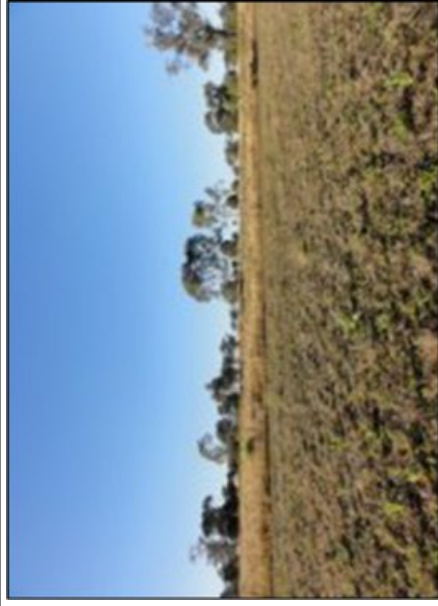
**Soil Mapping Unit Ba3**

<b>Site No.</b>	17	<b>Vegetation (woody)</b>	n/a
<b>AMG Reference</b>	-	<b>Vegetation (non-woody)</b>	Unidentified grasses and weed species
<b>ASC</b>	Kandosol	<b>Land Use</b>	Grazing
<b>Landform Element</b>	-	<b>Depth of sample (mm)</b>	0-100, 200-300, 500-600
<b>Landform Pattern</b>	Midslope	<b>Land Suitability</b>	Class 3 (Grazing) Class 5 (Rainfed Cropping)
<b>Slope %</b>	1.5	<b>General Comments</b>	Stones present on surface 10 cm by 5cm, approximately 15%. Soil surface is firm under moist conditions. Surface is uneven, may have a history of cultivation).
<b>Microrelief</b>	No microrelief evident		
<b>Drainage</b>	Well-drained		
<b>Land Condition</b>	Good condition		
<b>Surface Condition</b>	Firm

**General Description:** the SMU consists of generally shallow basaltic clay and clay loam uplands. The major features of the soil mapping unit include:

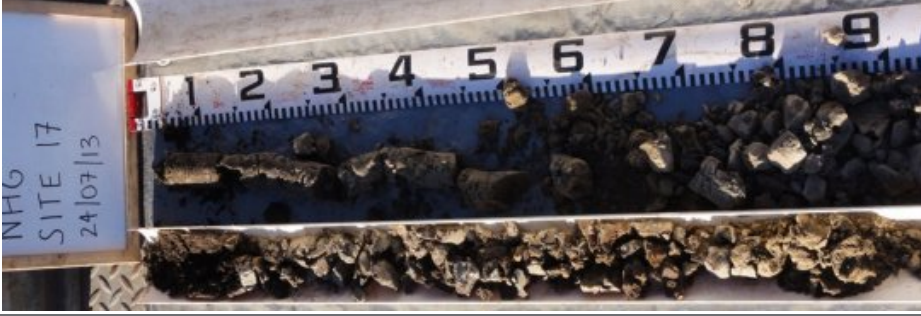
## Site 17 Soil Profile Description

0-180	A1	Clay Loam 7.5YR3/1, no mottle No segregations and 10-20% 2-6mm coarse fragments Structure is polyhedral with weak grade and weak consistence Common fine roots	9.1	0.040	0-100 7.1	0-100 35	0-100 <10	0-100 0.35	0-100 2.58	0-100 28.5
	180-650	B2	Medium Heavy Clay 7.5YR3/4, no mottles No segregations and 50-90% 20-60mm coarse fragments Structure is angular blocky with weak grade and firm consistence Few very fine roots	8.2	0.073	200-300 7.70	200-300 24.00	200-300 <10	200-300 1.01	200-300 2.59	200-300 9.90
	650-950 (refusal)	C	n/a	-	-	-	-	-	-	-	-

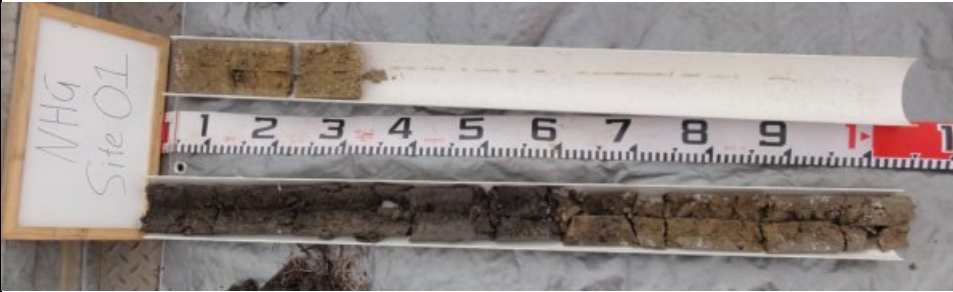
Horizon	Depth (mm)	Profile Photo	Boundary	Texture	Moist Colour	Mottle (colour, abundance)	Segregations (abundance, nature)	Coarse fragments (abundance, size)	Structure (type)	Structure (grade)	Consistence (soil water status)	Roots (abundance, size)	pH	EC (dS/m)	Depth of Sample (mm)
A1	0-600

Abrupt	Medium Heavy Clay	7.5YR 2.5/1	10YR 6/2 2-6 mm Distinct 2%	<2% Iron	<2% 0-2 mm	Subangular blocky	Moderate	Weak (moist)	Many (25-200) Fine (1-2 mm)	9.8	0.212	0-100 200-400
B2	600-1000		Clear	Medium Heavy Clay	10YR 4/3	None evident	2-10% Carbonates	2-10% 0-2 mm	Subangular blocky	Weak	Firm (moderately moist)	Few (1-10) Fine (1-2 mm)	9.5	0.687	400-800 800-900
B3	1000-1300+		N/A	Medium Heavy Clay	10YR 4/2	10YR 5/4	Weathered parent material	10-20% 0-2 mm	Subangular blocky	Weak	Firm (moderately moist)	Few (1-10) Very fine (<1 mm)	9.7	0.642	1000-1100
<p>Other information                  Very fine orange/red mottles (distinct) at 1000 mm. Other mottles of different colours red/yellow/brown (fine) increasing from 450-600 mm depth in A horizon. Increase in coarse fragments in A horizon to 2-10% 0-2 mm at 400-600 mm in depth. High EC in B horizon (high salinity rating from 600 mm).</p>

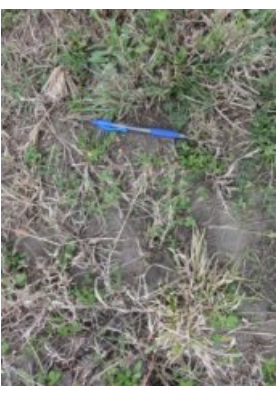
Soil Surface Condition Photo

Other Information	Soil surface condition was recorded under moist conditions. Landform was flat with a gentle slope. Classified as a kandosol due to weak structure of the B Horizon. The structure of these soils will become more obvious in drier conditions so suspect it may grade into a Dermosol.

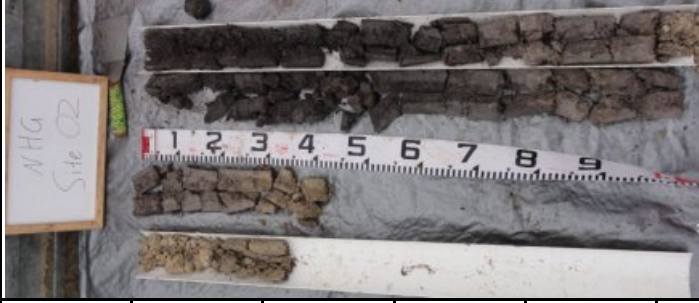
Horizon	Depth (mm)	Profile Photo	Boundary	Texture	Moist Colour	Mottle (colour, abundance)	Segregations (abundance, nature)	Coarse fragments (abundance, size)	Structure (type)	Structure (grade)	Consistence (soil water status)	Roots (abundance, size)	pH	EC (dS/m)	Depth of Sample (mm)
A1	0-600

Gradual	Medium Clay	10YR 2/1	None evident	None evident	None evident	Polyhedral	Moderate	Weak (moist)	Common (10-25) Fine (1-2 mm)	9.1	0.213	N/A
B2	600-900		Abrupt	Medium Heavy Clay	10YR 4/1	None evident	<2% Carbonates	<2% 2-6mm	Subangular blocky	Weak	Strong (moist)	Few (1-10) Fine (1-2 mm)	9.3	0.359	N/A
BC	900-1300+		N/A	Light Medium Clay (fine sandy)	10YR 6/3	10YR 7/8 Fine, Distinct 0-2mm	None evident	None evident	10-20% 2-6mm	Subangular blocky	Weak	Firm (moderately moist)	Few (1-10) Fine (1-2 mm)	8.5	0.987
Other information Very wet (surface water). High EC in BC horizon (medium to high salinity rating from 600 mm depth).

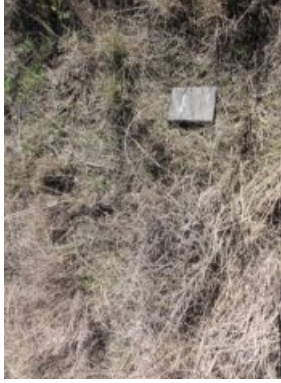
Soil Surface Condition Photo

Other Information Soil surface is soft and moist. Cracking and self-mulching evident in dry sections (pedes 2-6 mm in size).

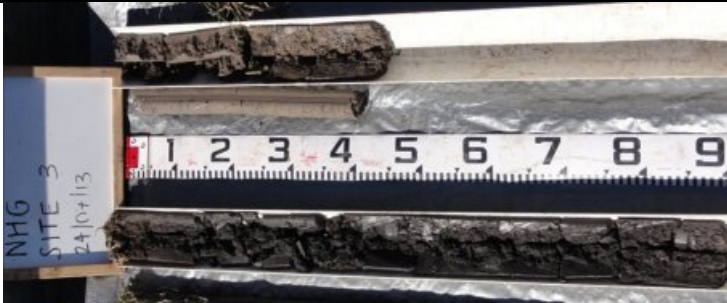
Horizon	Depth (mm)	Profile Photo	Boundary	Texture	Moist Colour	Mottle (colour, abundance)	Segregations (abundance, nature)	Coarse fragments (abundance, size)	Structure (type)	Structure (grade)	Consistence (soil water status)	Roots (abundance, size)	pH	EC (dS/m)	Depth of Sample (mm)
A1	0-800

Diffuse	Medium Clay	10YR 3/1	None evident	<2% Carbonates	None evident	Polyhedral	Weak	Weak (moist)	Many (25-200) Medium (2-5 mm)	7.4	0.551	0-100 200-300 500-600 800-900
B2	800-1450+		N/A	Medium Clay	10YR 4/2	None evident	2-10% Carbonates	None evident	Polyhedral	Weak	Firm (moderately moist)	Common (10-25) Fine (1-2 mm)	7.0	3.68	1000-1100

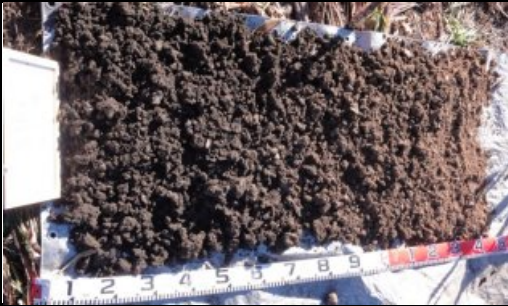
Horizon	Depth (mm)	Profile Photo	Boundary	Texture	Moist Colour	Mottle (colour, abundance)	Segregations (abundance, nature)	Coarse fragments (abundance, size)	Structure (type)	Structure (grade)	Consistence (soil water status)	Roots (abundance, size)	pH	EC (dS/m)	Depth of Sample (mm)
A1	0-450

Clear	Medium Clay	10YR 2/2	None evident	None evident	None evident	Polyhedral	Moderate	Weak (moist)	Many (25-200) Fine (1-2 mm)	7.5	0.019	0-100 200-300
B22	450-900		Clear	Medium Heavy Clay	7.5YR 3/2	None evident	2-10% Carbonates	None evident	Polyhedral	Moderate	Weak (moderately moist)	Common (10-25) Fine (1-2 mm)	9.1	0.132	500-600 800-900
B23	900-1400+		N/A	Medium Heavy Clay	10YR 3/3	7.5YR 8/2 Few, medium and distinct	<2% Carbonates	None evident	Polyhedral	Moderate	Weak (moderately moist)	Few (1-10) Fine (1-2 mm)	9.5	0.165	1000-1100
Other information - Soil was sticky to touch in A1 and B22 horizon. Roots in A1 were very fine, fine, medium and coarse in size. Mottling was evident in B23 horizon.

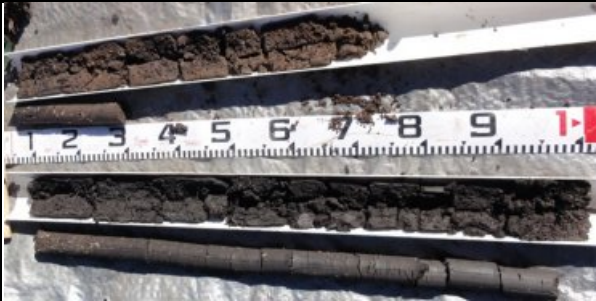
Horizon	Depth (mm)	Profile Photo	Boundary	Texture	Moist Colour	Mottle (colour, abundance)	Segregations (abundance, nature)	Coarse fragments (abundance, size)	Structure (type)	Structure (grade)	Consistence (soil water status)	Roots (abundance, size)	pH	EC (dS/m)	Depth of Sample (mm)
A1	0-50

Abrupt	Light Medium Clay	10YR 3/1	None evident	None evident	<2% 0-2mm	Subangular blocky	Moderate	Weak (moist)	Common (10-25) Fine (1-2 mm)	9.0	0.079	N/A
B21	50-950		Gradual	Medium Clay	10YR 3/1	None evident	None evident	<2% 0-2mm	Subangular blocky	Moderate	Weak (moderately moist)	Few (1-10) Fine (1-2 mm)	8.6	0.055	N/A
B22	950-1700+		N/A	Medium Heavy Clay	10YR 3/2	Faint mottling 2-5mm fragments	2-10% Carbonates	2-10% 0-2mm	Subangular blocky	Moderate	Weak (moderately moist)	Few (1-10) Very fine (<1 mm)	7.8	4.05	N/A
<p>Other information                      There are obvious cracks that appear in the profile once it began to dry out. It appears that the darker material from the A1 and B21 horizons has moved down the profile through the cracks in the B22 below. Cracks that are visible are approx 1-2 mm in size and abundant. Clay coatings (slickensides?) covers the ped faces (smooth-faced peds). Very large increase in EC from B21 to B22 horizon (extreme salinity from 950 mm).</p>

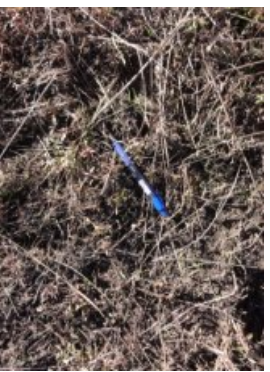
Soil Surface Condition Photo

Other Information Soil surface condition is moist and soft. There is some soil surface cracking evident and the surface is also poached.

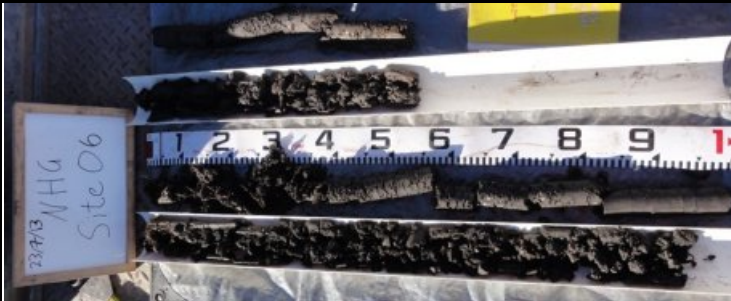
Horizon	Depth (mm)	Profile Photo	Boundary	Texture	Moist Colour	Mottle (colour, abundance)	Segregations (abundance, nature)	Coarse fragments (abundance, size)	Structure (type)	Structure (grade)	Consistence (soil water status)	Roots (abundance, size)	pH	EC (dS/m)	Depth of Sample (mm)
A1	0-300

Clear	Medium Clay	10YR 2/1	None evident	None evident	<2% 0-2mm	Polyhedral	Weak	Weak (moist)	Abundant (>200) Medium (2-5 mm)	8.5	0.190	N/A
B21	300-1000		Clear	Medium Heavy Clay	7.5YR 2.5/1	None evident	<2% Carbonates	<2% 0-2mm	Polyhedral	Moderate	Firm (moderately moist)	Many (25-200) Medium (2-5 mm)	7.6	4.06	N/A
B22	100-1500+		N/A	Medium Heavy Clay	7.5YR 2.5/1	None evident	None evident	<2% 0-2mm	Angular blocky	Strong	Strong (moderately moist)	Few (1-10) Medium (2-5 mm)	8.1	1.51	N/A
<p>Other information                      Macropores evident. Stones present on surface (10 cm by 4 cm) approx 2-10%. Cracking occurs in the soil as it dries, leadin to structure becoming more prominent. Significant increase in EC in B horizon (extreme salinity between 300 mm and 1000 mm).</p>

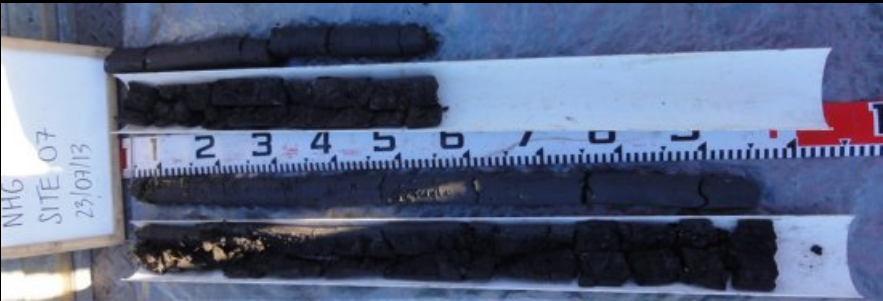
Horizon	Depth (mm)	Profile Photo	Boundary	Texture	Moist Colour	Mottle (colour, abundance)	Segregations (abundance, nature)	Coarse fragments (abundance, size)	Structure (type)	Structure (grade)	Consistence (soil water status)	Roots (abundance, size)	pH	EC (dS/m)	Depth of Sample (mm)
A1	0-300

Abrupt	Medium Clay	10YR 2/1	None evident	None evident	None evident	Polyhedral	Weak	Weak (moist)	Many (25-200) Fine (1-2 mm)	8.2	0.039	0-100 200-300
B21	300-1300		Clear	Medium Heavy Clay	10YR 2/1	None evident	2-10% Carbonates	None evident	Polyhedral	Moderate	Firm (moderately moist)	Common (10-25) Fine (1-2 mm)	8.6	0.132	500-600 800-900
B22	1300+		N/A	Medium Heavy Clay	10YR 2/2	None evident	<2% Carbonates	None evident	Polyhedral	Weak	Firm (moderately moist)	Few (1-10) Fine (1-2 mm)	7.9	2.85	1000-1100
Other information Gligal microrelief. This site was sampled on a mound. Tough to tell if carbonate or coarse fragments, recorded as carbonate. Macropores are evident. Significant increase in EC from B21 to B22 horizon (extreme salinity rating from 1000 mm).

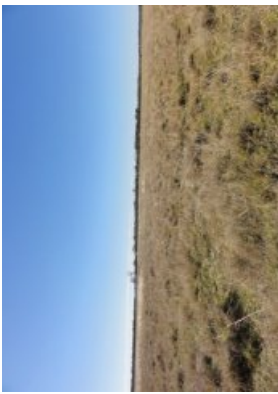
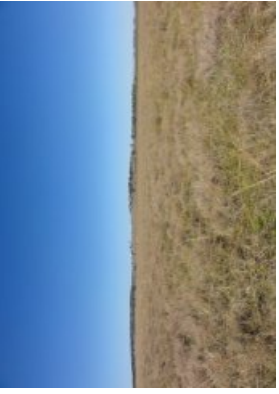
Project NHG	Date 23/07/2013	Scribe I. Kelder/K. Brown	Location Site 08	Observation	Drill boring	Easting/ Latitude 0366022	Zone	ASC Mapped	
Dominant Vegetation Form	Non-woody		Ground Cover %	Dense (>70%)	Aspect N/A	Northing/ Longitude 6975760	Scale	ASC Ground Truth Vertosol	
Secondary Vegetation Form	Non-woody		Ground Cover %	Slope %	0.0	Rock Outcrop	Erosion Type	None evident	
Vegetation (species)	Unidentified grasses					Drainage (site)	Erosion Extent	None evident	
Landform	Flat		Soil Surface Condition (dry)			Land Use	Erosion State	None evident	
Landscape Photo (North)

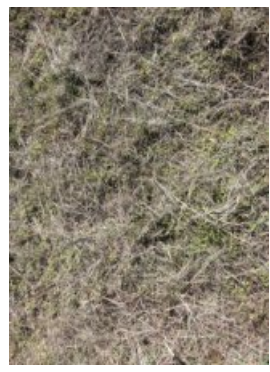
Soil Surface Condition Photo

Microrelief Gilgai are evident, 1.5 m, 1.0 m depth of 20 cm and estimate >75% of the inland areas is affected.
Landscape Photo (South)

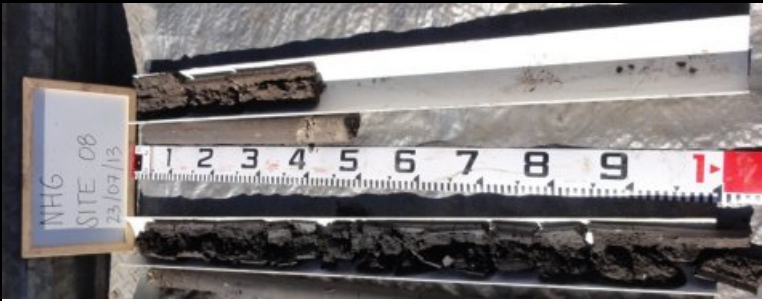
Horizon	Depth (mm)	Profile Photo	Boundary	Texture	Moist Colour	Mottle (colour, abundance)	Segregations (abundance, nature)	Coarse fragments (abundance, size)	Structure (type)	Structure (grade)	Consistence (soil water status)	Roots (abundance, size)	pH	EC (dS/m)	Depth of Sample (mm)
A1	0-250

Clear	Medium Clay	10YR 2/1	None evident	None evident	None evident	Polyhedral	Weak	Weak (moist)	Many (25-200) Medium (2-5 mm)	8.7	0.021	0-100
B21	250-1000		Abrupt	Medium Heavy Clay	10YR 2/2	None evident	2-10% Carbonates	None evident	Polyhedral	Strong	Firm (moderately moist)	Common (10-25) Fine (1-2 mm)	8.1	0.274	300-400 500-600 800-900
B22	1000-1300+		N/A	Medium Heavy Clay	10YR 3/2	7.5YR 7/2 (2-5%)	<2% Carbonates	None evident	None evident	Angular blocky	Moderate	Firm (moderately moist)	Few (1-10) Very fine (<1 mm)	8.4	0.428
Other information Carbonates start at 800 mm. Fe/Mn segregations in B22. Increase in EC from B21 to B22 horizon (medium to extreme salinity rating from 250 mm to 1300 mm) and a faint orange mottle (2-5%)

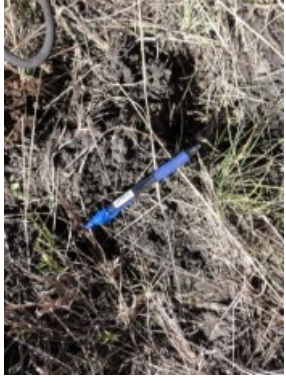
Soil Surface Condition Photo

Microrelief There is minor gilgai present, broader than Site 08 and not as deep (2 m, 1.5 m by 5-10 cm deep).	
Landscape Photo (South)

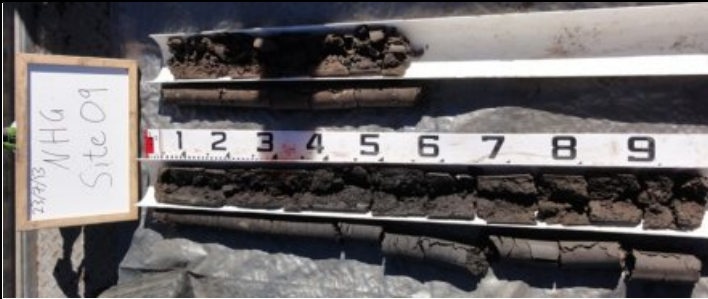
Horizon	Depth (mm)	Profile Photo	Boundary	Texture	Moist Colour	Mottle (colour, abundance)	Segregations (abundance, nature)	Coarse fragments (abundance, size)	Structure (type)	Structure (grade)	Consistence (soil water status)	Roots (abundance, size)	pH	EC (dS/m)	Depth of Sample (mm)	
A1	0-350

Abrupt	Medium Clay	10YR 2/1	None evident	None evident	None evident	Polyhedral	Weak	Weak (moist)	Many (25-200) Fine (1-2 mm)	8.0	0.053	N/A	
B21	350-750		Clear	Medium Heavy Clay	10YR 3/1	None evident	<2% Carbonates	2-10% 0-2mm	Polyhedral	Moderate	Firm (moderately moist)	Few (1-10) Fine (1-2 mm)	7.9	1.33	N/A	
B22	750-1600+		N/A	Medium Heavy Clay	7.5YR 3/2	7.5YR 7/2 2-5% and a faint orange mottle (2-5%)	<2% Carbonates	<2% 0-2mm	Angular blocky	Strong	Strong (moderately moist)	Few (1-10) Very fine (<1 mm)	7.7	2.41	N/A	
Other information Smooth-faced peds present. Coarse fragments/carbonate at 600 mm (unidentified). Significant increase in EC in B horizon (medium salinity rating from 750 mm).

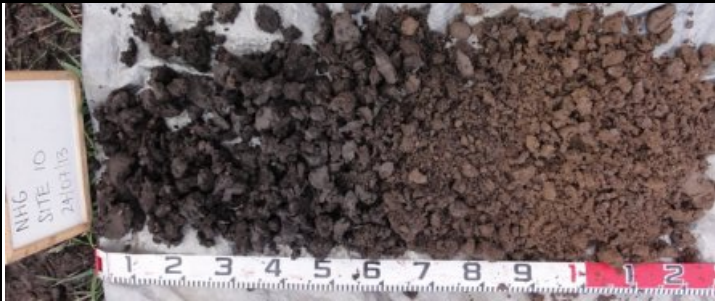
Horizon	Depth (mm)	Profile Photo	Boundary	Texture	Moist Colour	Mottle (colour, abundance)	Segregations (abundance, nature)	Coarse fragments (abundance, size)	Structure (type)	Structure (grade)	Consistence (soil water status)	Roots (abundance, size)	pH	EC (dS/m)	Depth of Sample (mm)
A1	0-700

Clear	Medium Clay	7.5YR 2.5/1	None evident	None evident	None evident	Polyhedral	Weak	Weak (moist)	Common (10-25) Fine (1-2 mm)	8.8	0.173	N/A
B1	700-850		Gradual	Medium Heavy Clay	7.5YR 3/2	None evident	None evident	None evident	Angular blocky	Weak	Firm (moist)	Few (1-10) Fine (1-2 mm)	8.4	1.89	N/A
B2	850-1250+		N/A	Medium Heavy Clay	10YR 3/6	None evident	None evident	None evident	Angular blocky	Weak	Firm (moist)	Few (1-10) Fine (1-2 mm)	8.4	2.75	1000
Other information															
A1 ribbon does not break (plastic clay). Course fragments start 300 mm (unidentified may be hard carbonate, approximately 5% and 0-2 mm in size) increasing to 2-10% in the B2 horizon. B horizons are less plastic than A1. Roots go from common to fine from the top to bottom of A1. Structure is likely to be moderate to strong when dry as seen in Sites 8 and 9. Smooth-faced peds. Significant increase in EC in B horizon (medium salinity rating from 850 mm).

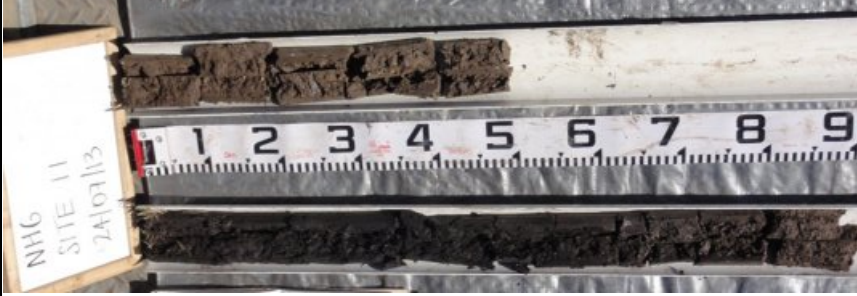
Clear	Medium Clay	10YR 3/1	None evident	None evident	None evident	Polyhedral	Moderate	Weak (moderately moist)	Many (25-200) Fine (1-2 mm)	8.8	0.361	0-100 200-300 500-600
B1	650-800		Gradual	Medium Heavy Clay	10YR 3/2	None evident	None evident	None evident	Polyhedral	Weak	Firm (moderately moist)	Common (10-25) Fine (1-2 mm)	7.8	3.32	800-900
B2	800-1500+		N/A	Medium Clay	10YR 3/3	None evident	None evident	None evident	None evident	Angular blocky	Moderate	Very firm (moderately moist)	Few (1-10) Fine (1-2 mm)	7.8	1.44
<p>Other information</p> <p>Coarse fragments (2-10%, 0-2mm to 2-6mm) recorded at 400 mm coinciding with a firm consistence (moist soil water status). As observed at Site 10 (and others), these coarse fragments may be carbonates (segregations) and are yet to be identified). Coarse fragments/ segregations increase to 15-25% (2-6 mm) at 600 mm. This continues throughout the profile (into B1, B2).</p>

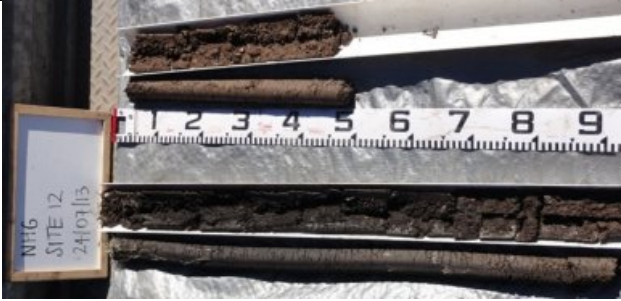
Gradual	Medium Clay	10YR 2/1	None evident	None evident	None evident	Polyhedral	Moderate	Weak (moist)	Many (25-200) Fine (1-2 mm)	7.9 7.8	0.676 1.63	200-300 500-600
B2	800-1500+		N/A	Medium Heavy Clay	10YR 3/3	None evident	None evident	None evident	None evident	Angular blocky	Weak	Firm (moderately moist)	Common (10-25) Fine (1-2 mm)	8.7	2.52
<p>Other information Smooth-faced peds present throughout the profile, however soil is friable. Cracks become more prominent as the profile dries due to exposure and structure becomes more obvious (increase in structure grade from weak to moderate to strong). Coarse fragments/ segregations? present at 400 mm (2-6 mm, 5%), increasing at 600 mm (2-6 mm, 10%) and (2-6 mm and 0-2 mm, 15-25%) in the B. Some orange, red and white coarse fragments/segregations throughout (red appears to be iron).</p>

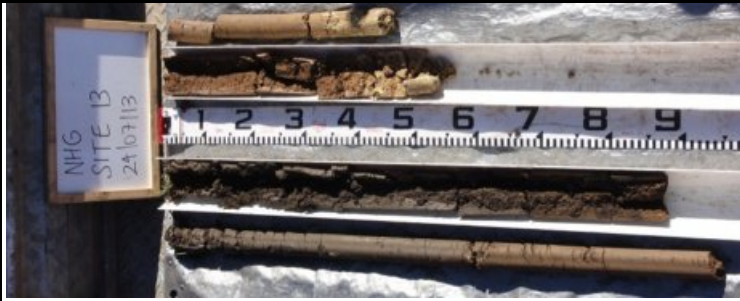
Sharp	Medium Clay	10YR 2/2	None evident	None evident	None evident	Polyhedral	Weak	Weak (moist)	Common (10-25) Very fine (<1 mm)	9.0	0.422	0-100 200-300 500-600
B2	850-1300		Abrupt	Medium Heavy Clay	10YR 3/3	None evident	None evident	None evident	Subangular blocky	Weak	Firm (moderately moist)	Few (1-10) Very fine (<1 mm)	9.5	0.877	850-950 1000-1100
BC	1300-1500+		N/A	Light Clay	2.5Y 6/3	None evident	None evident	None evident	20-50% 0-2mm	Apedal	Massive	Firm (moderately moist)	None evident	1.15	N/A
<p>Other information                      Macropores and faunal channels observed in the top 100 mm. Refer to "other information" recorded for Sites 10, 11 and 12. Fewer smooth-faced peds in this profile compared to others, not as well structured. At 500 mm coarse fragments / segregations? present (0-2 mm, 2-5%). Increasing in B2 horizon (0-2 mm, 5-10%), increasing to approximately 20-50% in BC horizon (0-2mm). Iron and manganese nodules present. Increase in EC from A1 to B2 horizon. Salinity rating ranges from medium (0-850 mm) to high (850-1300 mm) to extreme from 1300 mm.</p>

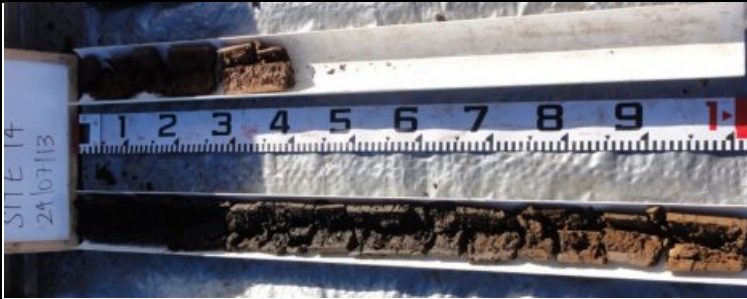
Gradual	Medium Clay	10YR 2/1	None evident	2-10% Unidentified	<2% 0-2mm	Polyhedral	Weak	Weak (moist)	Common (10-25) Fine (1-2 mm)	9.0 9.2	0.219 0.158	200-300 600-700
B2	700-1400+		N/A	Medium Heavy Clay	7.5YR 3/4	None evident	<2% Unidentified	<2% 0-2mm	Angular blocky	Weak	Firm (moderately moist)	Few (1-10) Fine (1-2 mm)	9.1	1.30	1000-1100
<p>Other information Smooth-faced peds more prominent than at Site 13, no evidence of BC. Refer to "other information" recorded for Sites 10, 11 and 12. Slickensides in B2. Coarse fragments/ segregations(?) start at 500 mm (0-2 mm, 2-10%) decreasing to (0-2 mm, &lt;2%) in the B horizon. Some iron segregations evident. Consistence increases to firm as the profile dries. Significant increase in EC in B horizon (from low to extreme at 700 mm).</p>

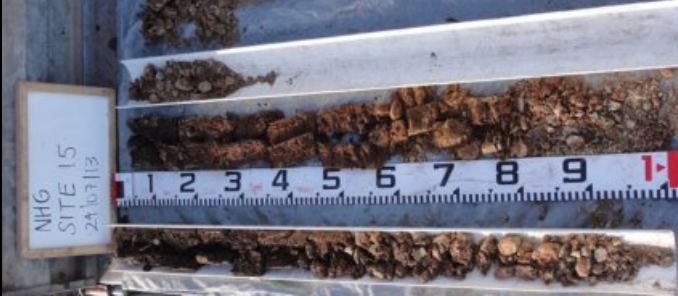
Clear	Medium Clay	10YR 2/2	None evident	None evident	None evident	Polyhedral	Weak	Weak (moist)	Many (25-200) Fine (1-2 mm)	8.7	0.038	0-100 200-300	
B2	350-450		Abrupt	Medium Heavy Clay	10YR 3/3	None evident	None evident	20-50% 6-20mm	Angular blocky	Weak	Weak (moist)	Common (10-25) Fine (1-2 mm)	8.1	0.058	500-600	
Gravel layer	450-700		N/A	N/A	N/A	N/A	N/A	50-90% 6-20mm	N/A	N/A	N/A	N/A	N/A	N/A	N/A	N/A
BC	700-1200		N/A	N/A	N/A	N/A	N/A	50-90% 60-200mm	Apedal	Massive	N/A	N/A	Few (1-10) Very fine (<1 mm)	N/A	N/A	N/A
	Refusal															
Other information Segregations <2% and 0-2 mm in the A and B horizon starting at 150 mm depth.

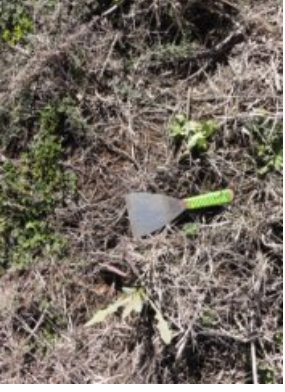
Soil Surface Condition Photo

Microrelief	No evidence of microrelief	
Landscape Photo (South)

Other Information	Stones present on surface 10 cm by 5 cm, approximately 15%. Soil surface is firm under moist conditions. Surface is uneven, may have a history of cultivation.

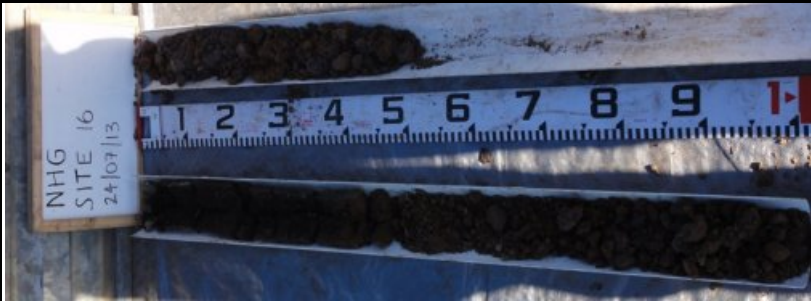
Clear	Light Clay	7.5YR 2.5/2	None evident	None evident	2-10% 0-2mm	Polyhedral	Weak	Weak (moderately moist)	Common (10-25) Fine (1-2 mm)	7.4	0.051	N/A
B2	150-400		Abrupt	Light Medium Clay	7.5YR 3/3	None evident	None evident	2-10% 0-2mm	Polyhedral	Weak	Weak (moderately moist)	Few (1-10) Very fine (<1 mm)	7.3	0.040	N/A
BC	400-1500		N/A	Sandy Clay Loam	7.5YR 3/4	None evident	None evident	50-90% 6-20mm	Apedal	Massive	Weak (moderately moist)	None evident	7.1	0.049	N/A
	Refusal														
Other information															
Slickensides and smooth-faced peds evident in B horizon. Both A and B horizon textures are sticky (indicates plasticity).

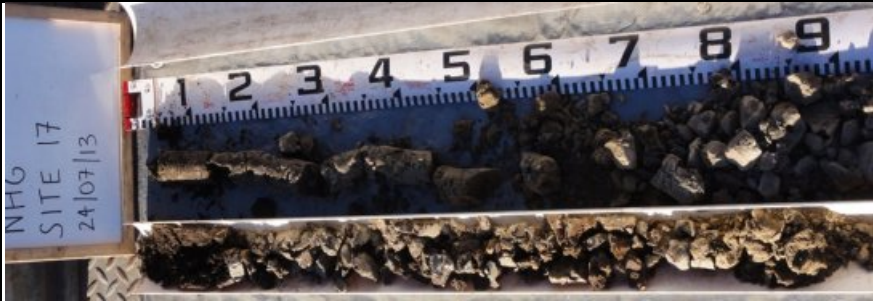
Abrupt	Clay Loam	7.5YR 3/1	None evident	None evident	10-20% 2-6mm	Polyhedral	Weak	Weak (moderately moist)	Common (10-25) Fine (1-2 mm)	9.1	0.040	0-100
B2	180-650		Clear	Medium Heavy Clay	7.5YR 3/4	None evident	None evident	50-90% 20-60mm	Angular blocky	Weak	Weak (moderately moist)	Few (1-10) Very fine (<1 mm)	8.2	0.073	200-300 500-600 Jars only
C	650-950		N/A	N/A	N/A	N/A	N/A	N/A	N/A	N/A	N/A	N/A	N/A	N/A	N/A
	Refusal														
<p>Other information                      A horizon is sticky (indicates plasticity). BC horizon has smooth-faced peds (15%). The gravel is similar to what was seen in Site 15. Clay accumulation in the B horizon amongst the gravel. C horizon is parent material (no clay present).</p>

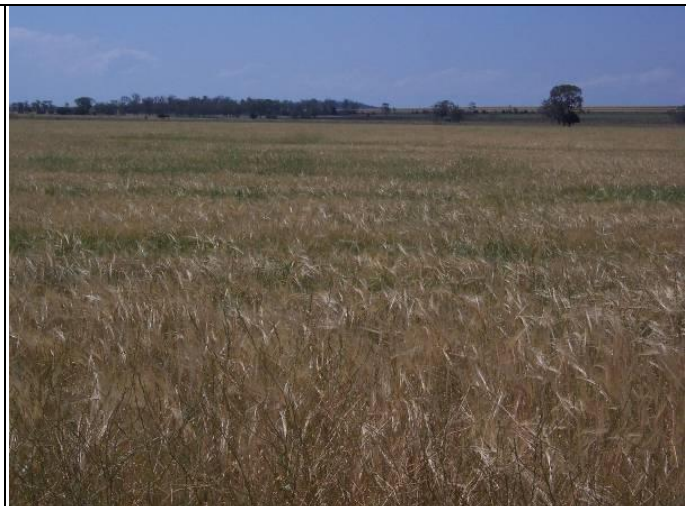
### Soil Type: A1

<p><b><u>CONCEPT</u></b></p> <p><b>Old Alluvial Plains of dark grey brown deep well structured cracking clays over dark grey brown heavy clay subsoil</b></p> <p>Productive cropping soil.</p>

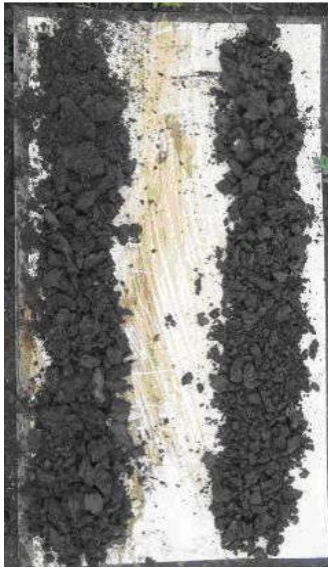
60 cm	AP	0 – 20	Very dark greyish brown (10YR3/2), medium clay, strong granular, field pH 8.0, no inclusions, dry, abrupt to;
20 cm		80 cm	B21	20 – 40	Very dark greyish brown (10YR3/2), medium heavy clay, moderate angular blocky, field pH 8.5, some carbonate nodules 2-5mm, moist, gradual to,
40 cm		100 cm	B22	40 -120	Dark brown (10YR4/2), medium heavy clay, strong sub-angular blocky, field pH 9.0, common soft calcareous concretions, moist
		120 cm

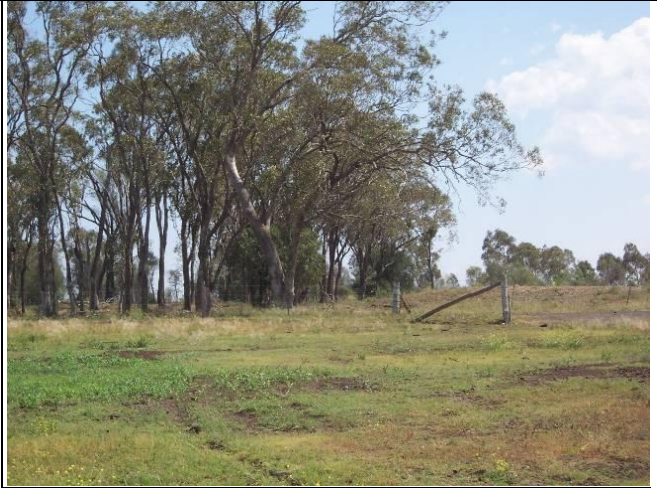
**Deep Grey brown uniform clay over hard yellowish brown alkaline subsoils**

Marginal cropping land.

- Deep grey brown cracking clays which are coarser structured than A1.
- The surface is moderate to coarse granular structure and self mulching.
- The upper 60 cm layer is dark grey/brown, alkaline with a hard angular structure which overlies coarse blocky yellowish brown clay subsoils.
- Strongly saline and sodic below 50cm depth.
- PAWC is restricted by the hard clay subsoil and salinity ( calculated at 94mm ).
- Overall fertility is quite good. Fertiliser inputs are indicated.

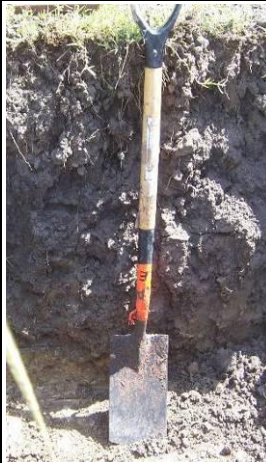
A1 0 – 20	Dark brown (10YR3/3), medium heavy clay, granular, field pH 7.5, no inclusions, moist, abrupt to;
	B21 20 – 60	Very dark greyish brown (10YR3/2), medium heavy clay, no bleach, coarse angular blocky, field pH 7.5, moist, gradual to,
	B22 60 – 120	Yellowish brown (10YR5/4), medium heavy clay, hard and dense angular blocky, field pH 9.0, common calcareous nodules, moist

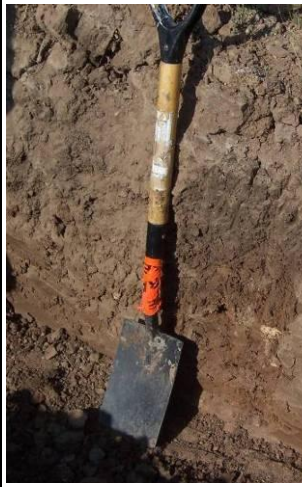
A11	0 – 20	Brown (7.5YR4/2), Light sandy clay, angular, field pH 6.5, no inclusions, dry, clear to;
	A12	20 – 22	Sporadic bleach, abrupt to;
	B21	22 – 50	Dark brown (10YR3/3), sandy clay, very hard and coarse angular blocky, field pH 9.0, common calcareous nodules, moist, gradual to;
	B22	50 – 100+	Reddish brown (5YR4/3), medium heavy clay, very hard and dense angular blocky, field pH 9.0, common calcareous nodules, moist

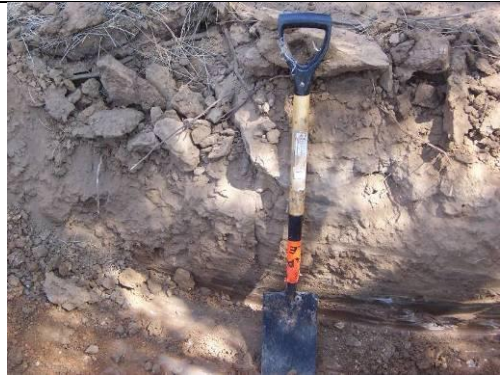
A11	0 – 20	Dark Brown (7.5YR4/4), weak structure, fine sandy loam, field pH 6.0, no inclusions, dry, clear to;
	B21	20 – 50	Yellowish brown (10YR5/6), sandy clay, very hard and coarse columnar, field pH 8.5, few orange mottles and calcareous nodules, dry, gradual to;
	B22	50-100+	Reddish brown (5YR4/3), medium clay, very hard blocky, field pH 8.5, yellow and grey mottles common, some rounded ironstone gravels to 10mm.

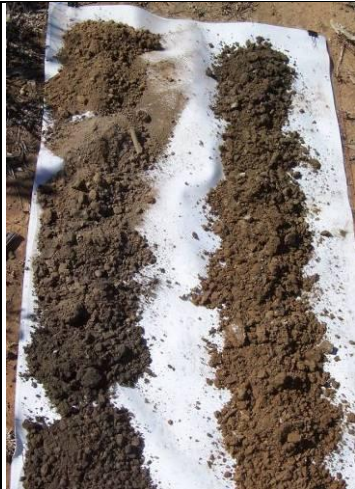
A1 0 – 20	Brownish grey (10YR4/3), medium clay, granular, field pH 8.5, some carbonate concretions to 5 mm, dry, clear to,
20 cm		60 cm	B21 20 – 70	Dark greyish brown (10YR4/2), medium clay, sub-angular blocky, field pH 8.5, some carbonate nodules 2-5 mm, moist, gradual to,
		80 cm	B22 60 -120	Brown (10YR5/3), medium heavy clay, strong sub-angular blocky, field pH 8.5, increasing carbonate nodules 2-5 mm, moist.
50 cm		100 cm

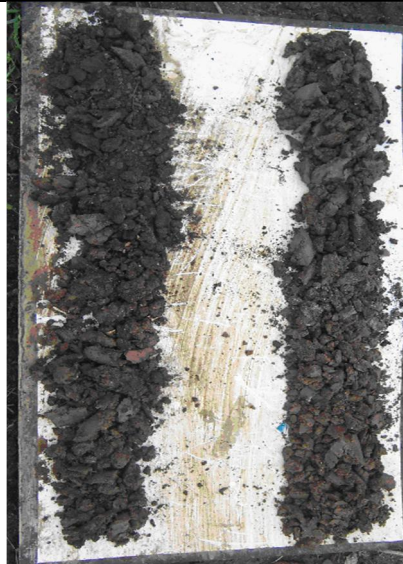
A1 0 – 30	Very dark greyish brown (10YR3/2), medium heavy clay, fine granular, field pH 8.5, no inclusions, dry, abrupt change to,
	B21 30 – 50	Dark grey (10YR4/1), medium heavy clay, strong sub-angular blocky, field pH 9.0, some calcareous concretions, moist, gradual change to;
	B22 50 - 120	Greyish brown (10YR5/2. heavy clay, strong lenticular structure, some manganese and carbonate concretions, field pH 9.0.

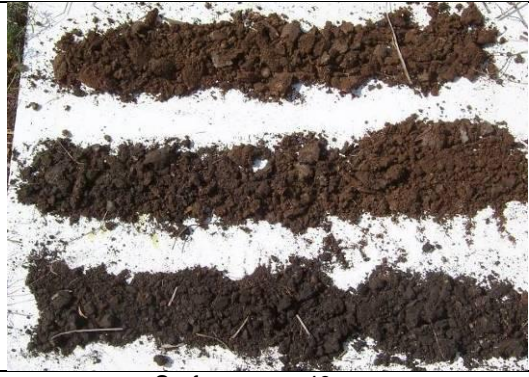
Horizon Depth (cm)	Description
80cm	120 cm	A1 0 – 0.5	Very dark grey (10YR3/1), medium heavy clay, fine granular, field pH 8.5, no inclusions, dry, abrupt to,  Very dark greyish brown (10YR3/2), medium heavy clay, , field pH 8.5, some carbonate nodules 2-5mm, moist, gradual to,  Brown (10YR4/4), medium clay, strong subangular blocky, field pH 6.5, no inclusions, moist.

B21 0.5 – 45	
		B22 45 -120	
Surface	40 cm

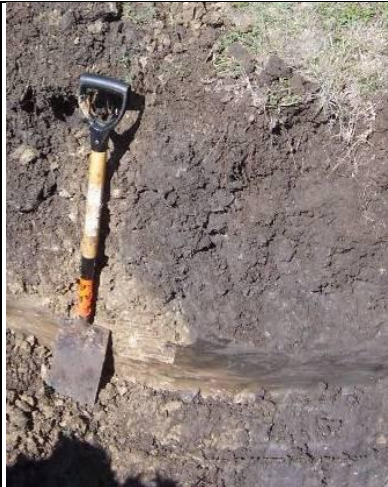
A1	0 – 20	Very dark greyish brown (10YR3/2), clay loam, strong granular, field pH 7.0, no inclusions, dry, abrupt change to,
	B21	20 –60	Very dark grey (10YR3/1), medium heavy clay, strong angular blocky, field pH 8.0, some 2-5mm, moist, gradual change to,
	B22	60 -150	Pale brown (10YR5/3), medium heavy clay, strong sub-angular blocky, field pH 9.0, carbonate nodules increasing with depth, moist. Sandstone gravels common and increasing with depth
	BC	150+	Sandstone bedrock

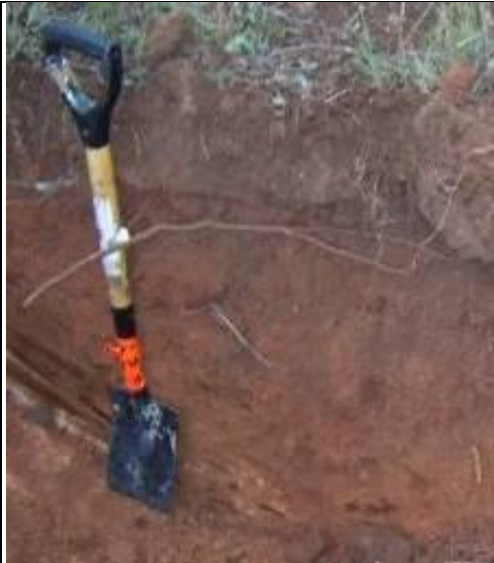
A1	0 – 20	Dark reddish brown (5YR3/2), clay loam, gravelly, granular, field pH 7.5, no inclusions, dry, abrupt change to,
	B21	20 –70	Dark red (2.5YR3/6), light clay, strong angular blocky, field pH 7.5, some small ironstone gravels, gradual change to,
	B22	70 -100	Yellowish red (5YR5/6), medium clay, strong sub-angular blocky, field pH 8.0, calcareous nodules increasing with depth, moist. Sandstone gravels increasing with depth

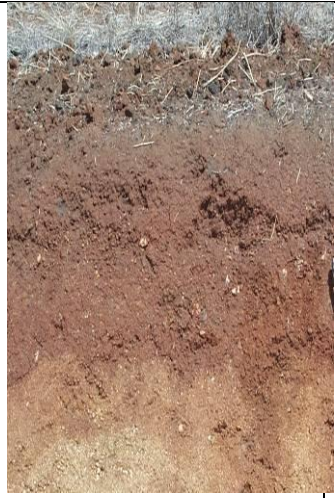
Ap		0 – 40	Dark reddish brown (5YR3/3), fine sandy clay, granular, field pH 7.5, no inclusions, dry, abrupt change to,
	B21		40 –70	Yellowish red (5YR4/6), medium clay, strong sub-angular blocky, field pH 8.5, moderate calcareous concretions and manganese, clear change to,
	BC		70 -120	Weathered basalt. Field pH 9.0

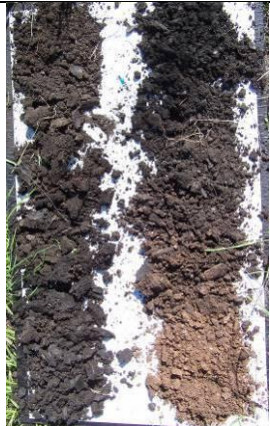
Ap	0 – 40	Very dark grey (10YR3/1) medium clay, strong subangular blocky, field pH 8.0, some calcareous nodules to 3mm, moist, abrupt change to,
	B21	40 – 75	Dark greyish brown (10YR4/2 medium heavy clay, calcareous nodules common, strong lenticular structure, field pH 8.5, clear change to,
	BC	75 +	Basalt bedrock

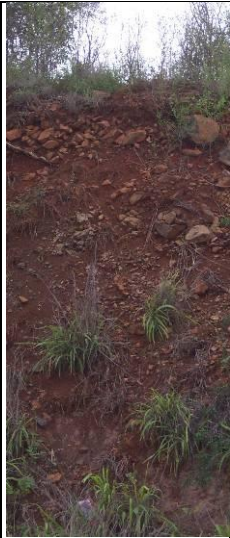
A1	0 – 20	Dark reddish grey (5YR4/2) light medium clay, strong granular, field pH 8.0, some calcareous nodules to 3mm, moist,
	B21	20 – 60	Dark red brown (5YR3/2) medium clay, calcareous nodules common, strong blocky structure, field pH 8.5, clear change to,
	C	60+	Basalt bedrock

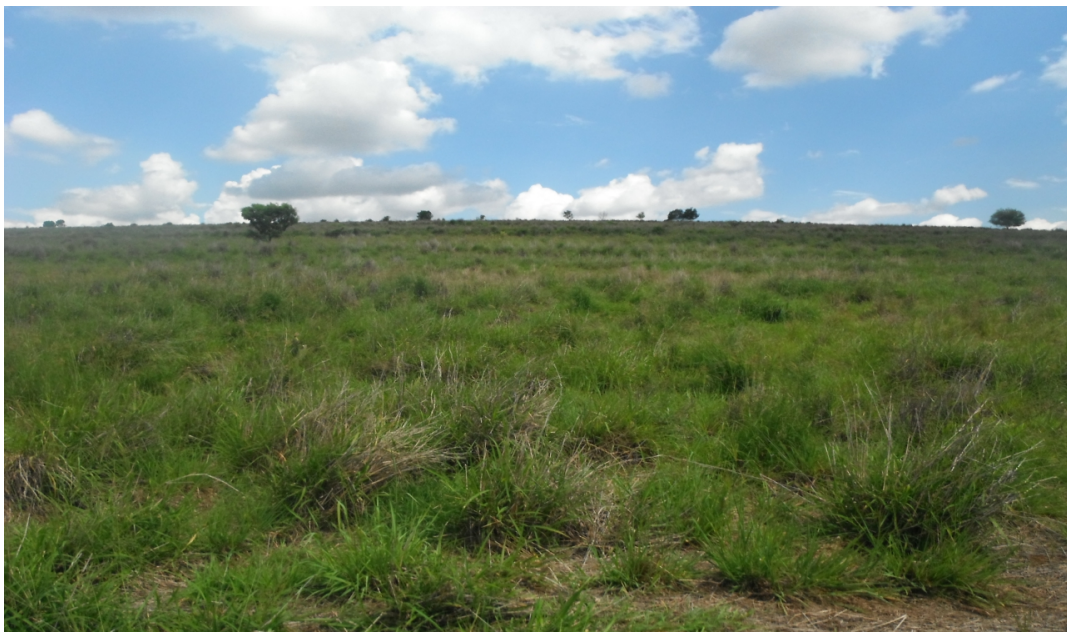
**Photograph 4-1 Slope of the North Pit's out of pit dump**

The revised Project's elevated landforms have been designed such that the angle on the face of the dumps will be 8.5 to 17 degrees. This slope is based on the current out of pit dumps angles that have successfully been constructed within the existing ML50170 (Stage 1) and ML50216 (Stage 2). A 8.5 to 17 degree batter is believed to be safe and sustainable, and there is evidence on-site currently to suggest that this batter is geotechnically stable. **Figure 4-1** depicts a cross section of the North Pit's out of pit dump. **Photograph 4-1** illustrates the slope of the North Pit's out of pit dump. The North Pit's out of pit dump has been established for over five years and has experienced prolonged drought conditions and extreme rainfall events. No evidence of geotechnical failure or significant erosion is present.

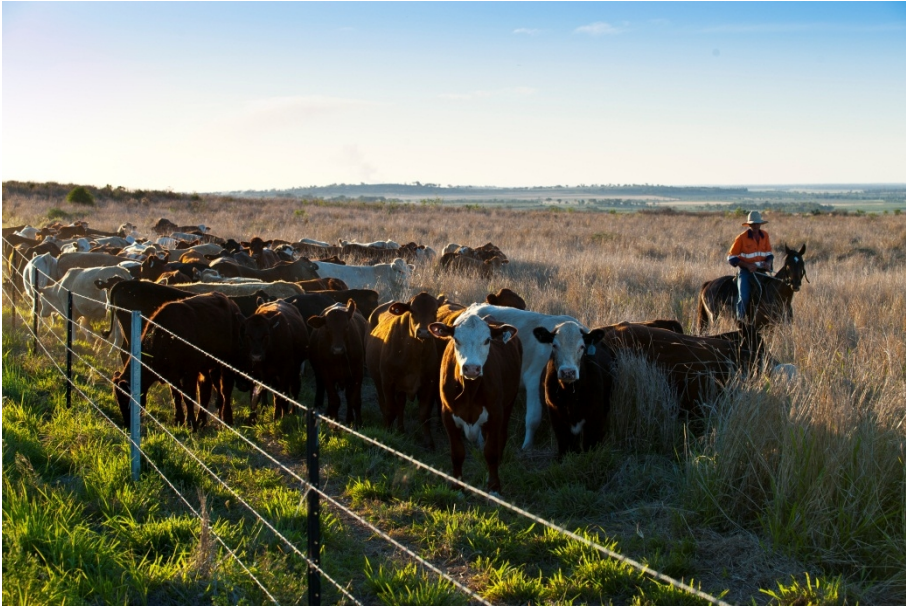
**Photograph 4-2 Grazing trial – North Pit's elevated landform, New Acland Coal Mine**

NAC is currently undertaking a formal long term grazing trial within a rehabilitate area of the North Pit's Elevated Landform on ML 50170 at the Mine as presented in **Photograph 4-2**. This grazing trial includes slope areas and will involve a comparison process with an analogue site in the vicinity of the Mine. The grazing trial program is being managed by the APC and will involve a formal study and report by a professional third party agricultural consultancy and local university. This grazing trial program will be a continuous process with new areas progressively added to the original trial area each year. The grazing trial program will be expanded to include the revised Project's rehabilitation areas designated for grazing. NAC believes the grazing trial program will be a critical assessment tool for demonstrating long term success of its grazing based rehabilitation for the revised Project's future mine closure and mining lease surrender requirements.

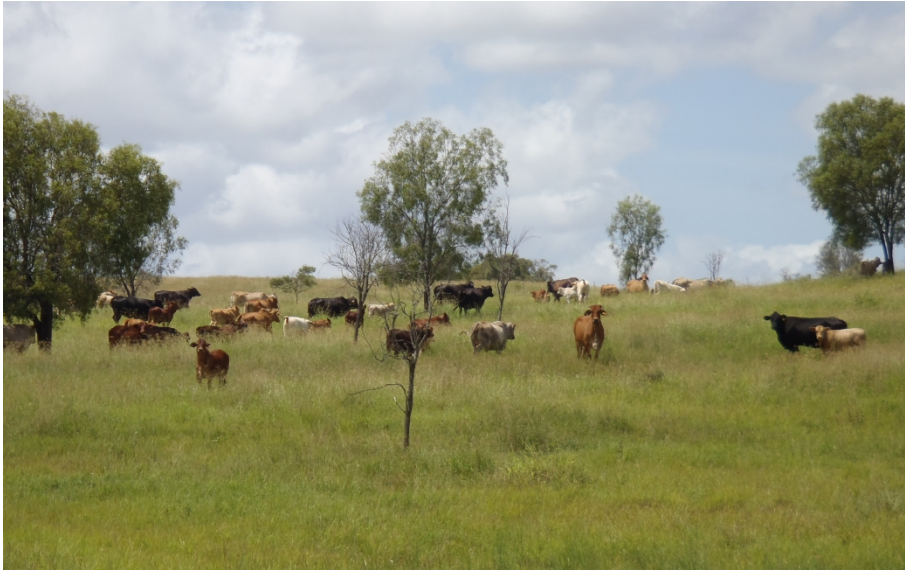
**Photograph 4-3 Long term grazing – Elevated landform on ML 4710, West Moreton Operations**

NAC is confident from the current grazing trial process and the grazing activities conducted at the NHCL's West Moreton mining operation that it can demonstrate with full scientific rigor that the revised Project's constructed landforms will be able to support grazing (beef production) as the proposed final land use in a long term sustainable manner. The current grazing trials are presented in **Photograph 4-3**.
