Aboriginal Archaeology Assessment

RE: Aboriginal Archaeological Due Diligence Assessment for Bengalla Development Consent Modification

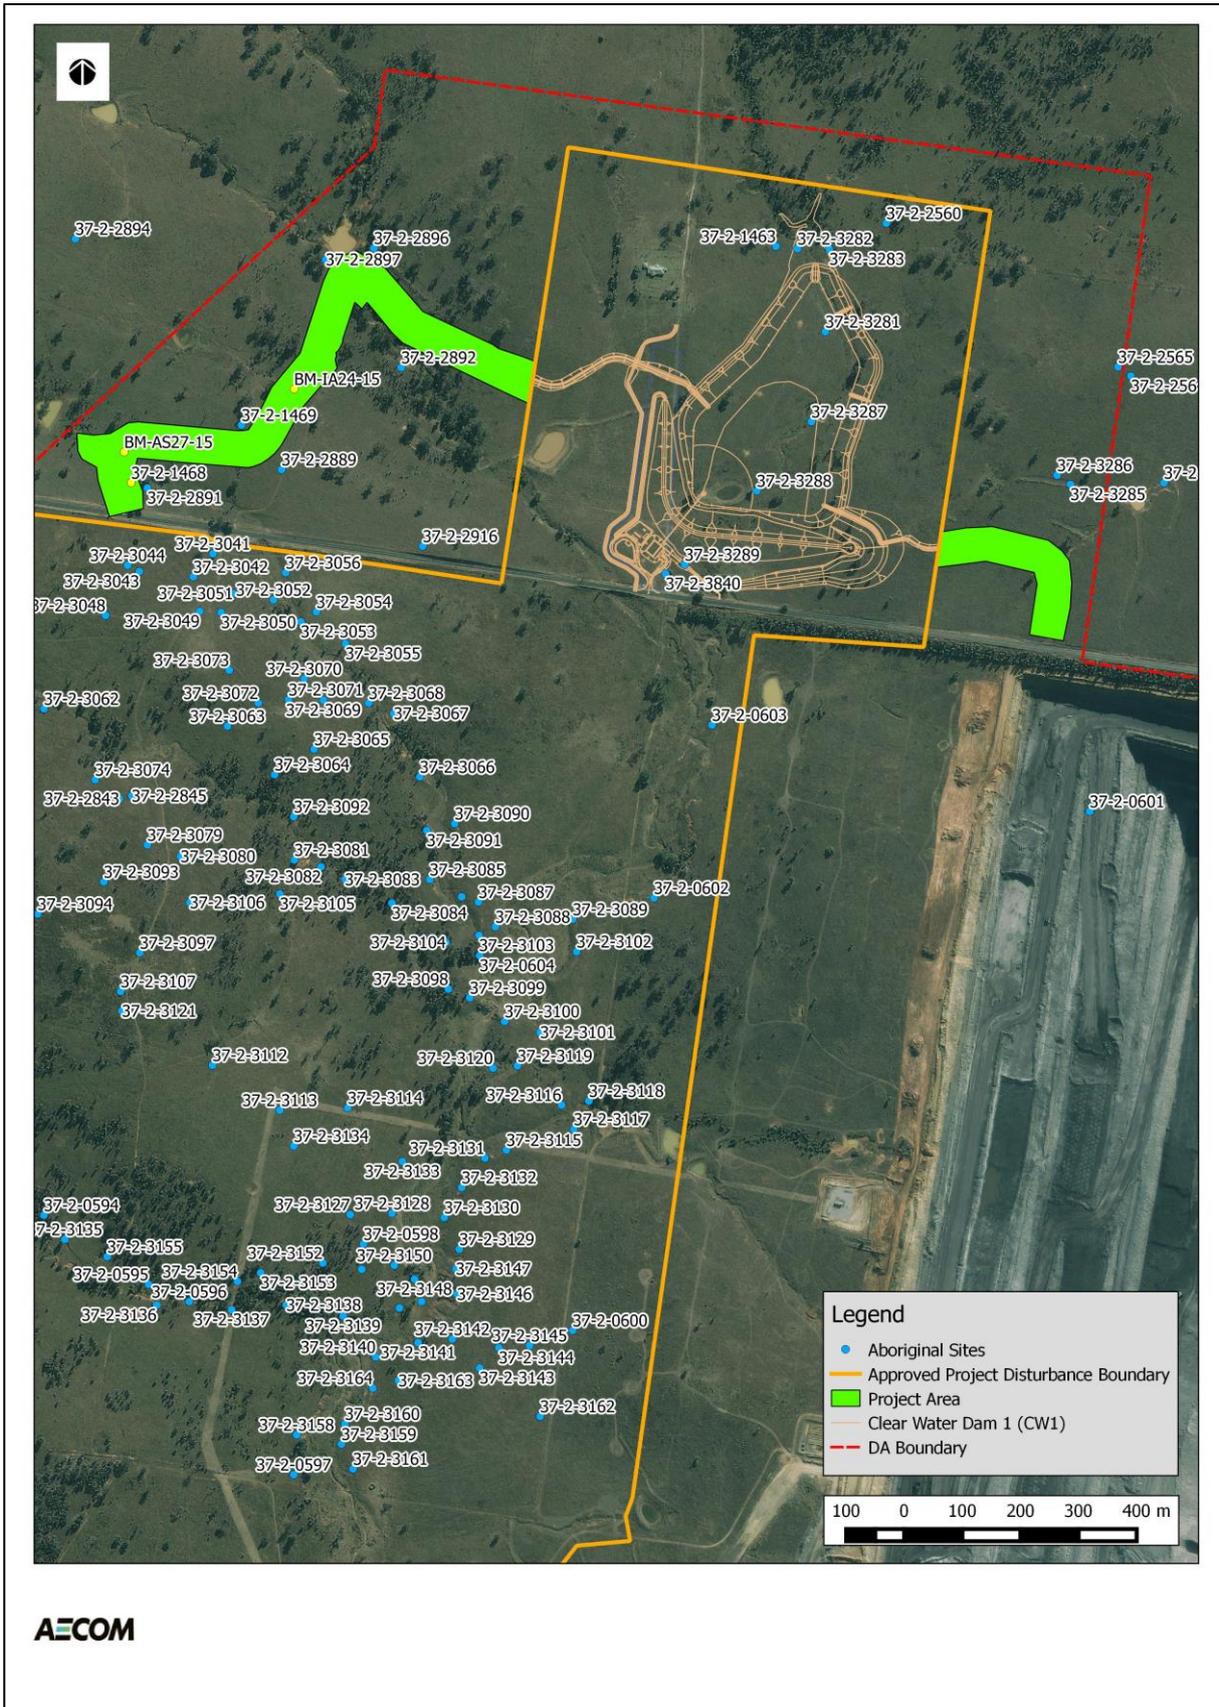
Figure 2: Levees outside approved operations and Aboriginal sites

Consideration of the location of previously recorded sites indicates that one site is located directly within the Project area – open artefact site A7-A8 (AHIMS#37-2-1468). In addition, the search indicated that four sites are located within 50 m of the project area including open artefact sites AHIMS#37-2-1469, 37-2-2891, 37-2-2896, and 37-2-2897. Table 2 provides a summary of site types within the search area with their locations shown on Figure 2.

- Impacts to AHIMS sites 37-2-1469, 37-2-2891, 37-2-2896, and 37-2-2897 should be avoided. As a precaution the sites should be temporarily fenced. Temporary fencing may consist of high visibility barrier mesh attached to star pickets. A suitable buffer of 5 to 10 m should be established as part of the temporary fencing to exclude the sites from potential impact.

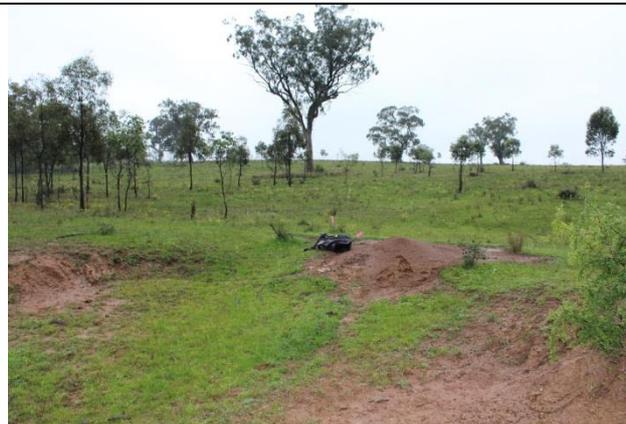
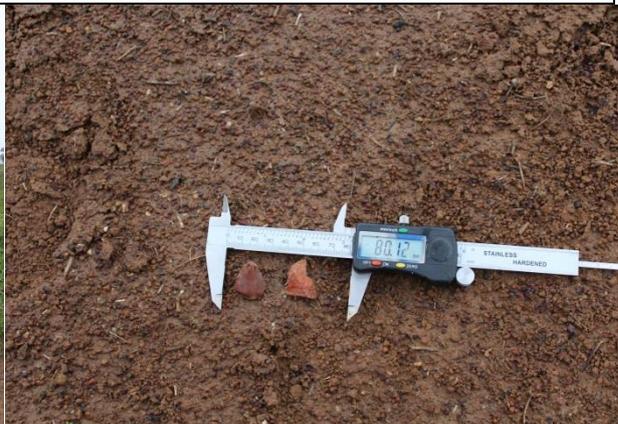
Site Name: BM-AS27-15

Site type: Artefact scatter

Landform: Lower slope

Site Area: 1m²

Artefacts: 1 x silcrete flake shatter, 1 x tuff complete flake

Disturbance Factors: Erosion, vegetation clearance

Significance: Low (scientific)

Plate 1: BM-AS27-15 (view north)

Plate 2: BM-AS27-15

- Impacts to previously recorded AHIMS site A7-A8 (#37-2-1468) and newly recorded Aboriginal sites BM-AS27-15 and BM-IA24-15 should be salvaged in accordance with the *Bengalla Mine Aboriginal Cultural Heritage Management Plan* (Bengalla Mine ACHMP) modified as required, once Modification to SSD-5170 has been approved.

- AHIMS site cards should be completed for Aboriginal sites BM-AS27-15 and BM-IA24-15 and submitted to the AHIMS register.
- In the event that Aboriginal objects, including possible human skeletal material (remains), are identified during project related activities all works must cease immediately in the area and the procedures identified in the Bengalla Mine ACHMP are to be followed. This will include contacting BMCs Environment Manager and engaging a qualified archaeologist to assess the site.

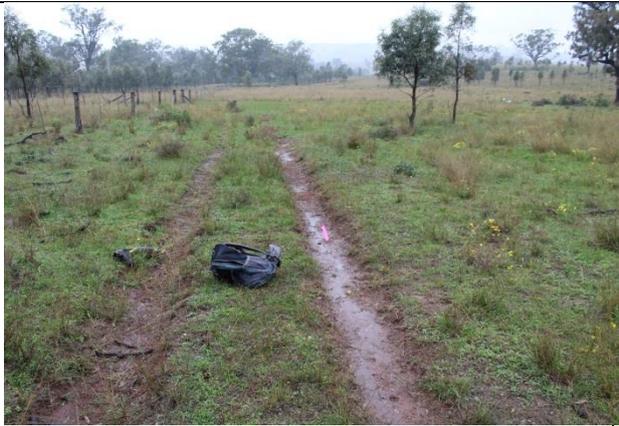
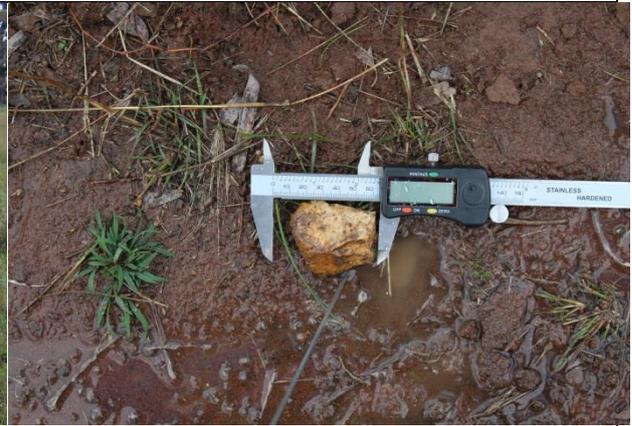
Site Name: BM-IA24-15

Site type: Isolated artefact

Landform: Lower slope

Site Area: 1m²

Artefacts: 1 x silcrete complete flake

Disturbance Factors: Vehicle track construction, erosion, vegetation clearance

Significance: Low (scientific)

Plate 3: BM-IA24-15 (view west)

Plate 4: BM-IA24-15
