G.4.2 Landholder Bore Survey Results

New Acland Coal Mine Stage 3 Project Environmental Impact Assessment

LANDHOLDER BORE SURVEY

Document title: Landholder Bore Survey – New Acland Revised Stage 3 Project

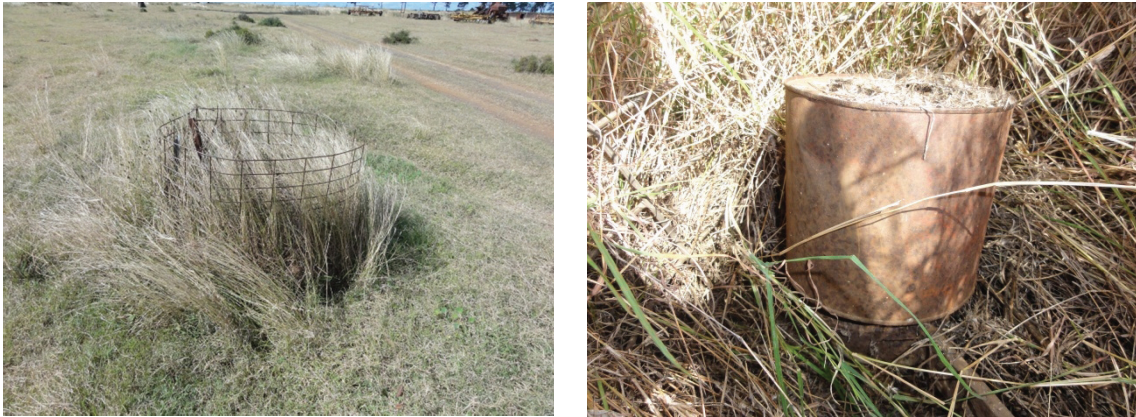
General Comments	
Bore was covered by tin can and I was unable to take this off the bore. LH did not list this as an existing bore on property. Limited time was available when assessing this bore, so only basic information was recorded.	
Photos

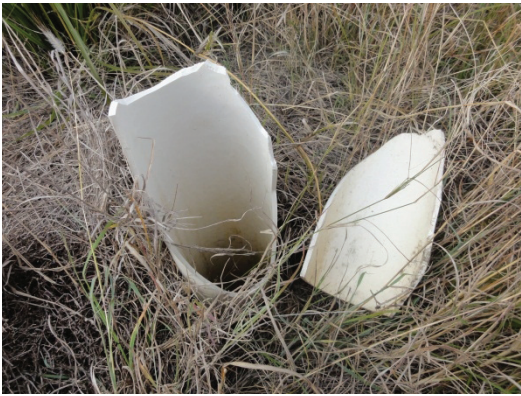
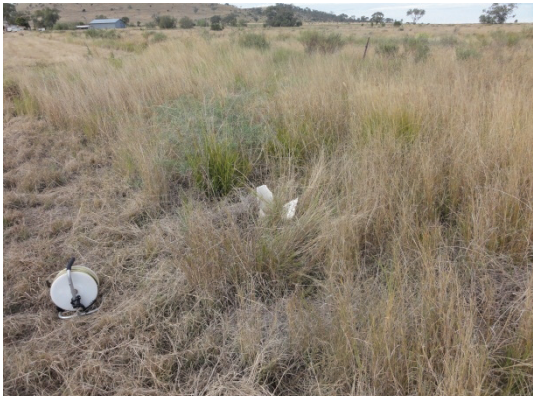
<i>(any seasonal variations?)</i>	
<i>Measured Maximum Flow Rate of Bore and Headworks at Site Visit (L/s)</i>	NA
<i>Describe riser, headwork and water distribution details:</i>	NA
<i>Equipment condition:</i>	NA
<i>Comments:</i>	
Water Details	
<i>Standing water level (m bgl): (measured or anecdotal)</i>	9.54mbToC measured (9.34mbgl)
<i>Stable pumping water level (m bgl): (measured, including mins after pump on)</i>	Unknown
<i>Water level measuring point</i>	Top of casing
<i>Interviewee / owner understanding of typical SWL / PWL (m bgl):</i>	LH believed SWL is 7mbgl
<i>Comments:</i>	
Water Sampling Details	
<i>Any historic water quality data available from owner?</i>	Mine collected samples (anecdotal)
<i>Any account of gas in the bore from interviewee?</i>	No
<i>Any potential for contamination at bore? (fuel storage, open bore casing, no stickup, aquifer intermixing from casing degradation)</i>	Bore casing cracked and not capped in an open field, potential for contamination.

<i>Water quality sample collected during this assessment?</i>	No
<i>Sample type: (primary, duplicate, field blank)</i>	NA
General Comments	
No bores on this property are currently used. Water is piped from family property nearby from a productive bore.	
Photos

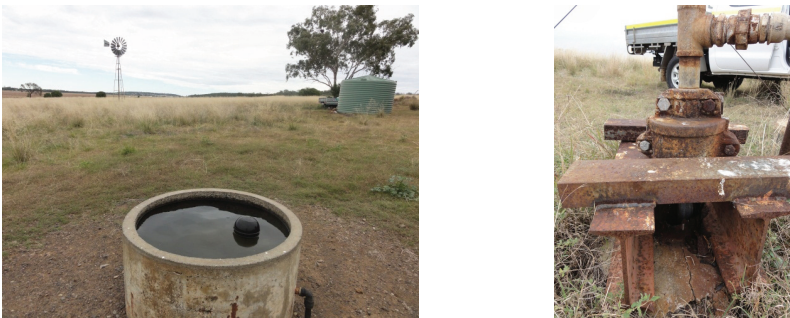
Water Details	
<i>Standing water level (m bgl): (measured or anecdotal)</i>	13.01mbgl (13.10mbToC). Did not measure total depth as there was some friction on dipper around the SWL. Could be a blockage or casing collapse.
<i>Stable pumping water level (m bgl): (measured, including mins after pump on)</i>	NA
<i>Water level measuring point</i>	Corroded entry point on casing
<i>Interviewee / owner understanding of typical SWL / PWL (m bgl):</i>	Interviewee assumes SWL is around 12m based on number of rods in well.
<i>Comments:</i>	
Water Sampling Details	
<i>Any historic water quality data available from owner?</i>	No
<i>Any account of gas in the bore from interviewee?</i>	No
<i>Any potential for contamination at bore? (fuel storage, open bore casing, no stickup, aquifer intermixing from casing degradation)</i>	Bore casing is highly corroded and has holes in the side of casing above ground. This could easily result in the introduction of insects and small animals to the bore

<i>Water quality sample collected during this assessment?</i>	No, wind only blew for 5 mins when at site then stopped completely.
<i>Sample type: (primary, duplicate, field blank)</i>	NA
General Comments	
Interview for all 3 bores scheduled for assessment had to be conducted when arrived at property in first 30 mins as interviewee had other work to do.	
Photos

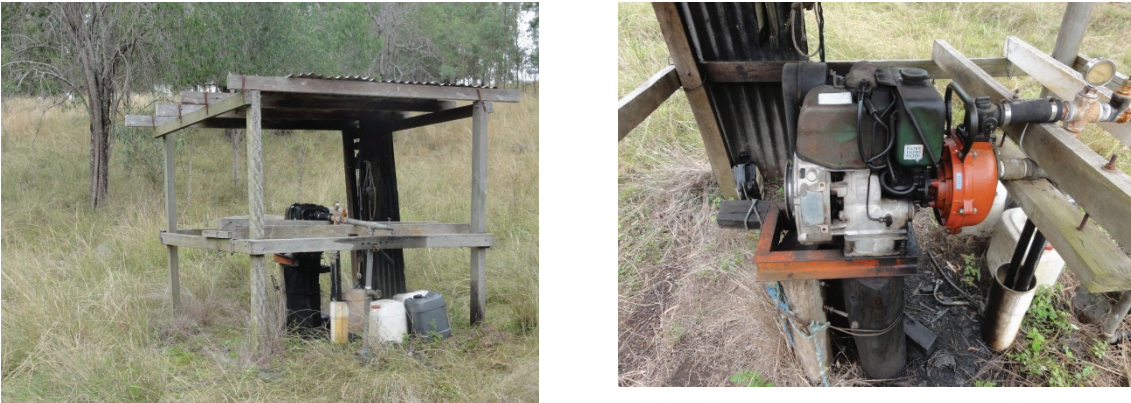
<i>Comments:</i>	
Water Details	
<i>Standing water level (m bgl): (measured or anecdotal)</i>	17.95mbgl (Measured 18.33mbToC)
<i>Stable pumping water level (m bgl): (measured, including mins after pump on)</i>	18.19mbgl (measured 18.57mbToC at 11:24am)
<i>Water level measuring point</i>	Top of casing
<i>Interviewee / owner understanding of typical SWL / PWL (m bgl):</i>	
<i>Comments:</i>	
Water Sampling Details	
<i>Any historic water quality data available from owner?</i>	No
<i>Any account of gas in the bore from interviewee?</i>	Sulphur rotten egg (H ₂ S smell at times from this bore)
<i>Any potential for contamination at bore? (fuel storage, open bore casing, no stickup, aquifer intermixing from casing degradation)</i>	Yes, diesel motor has leaked and the floor around the bore is covered in oil and diesel fuel. There are a number of fuel cans in the shelter next to the bore. The position of the pump means that it is nearly over the bore and fluids could fall in the bore. Bore is open.

<i>Water quality sample collected during this assessment?</i>	Yes, during the test water was taken from the sample tap and all outflows to the bore were switched off.
<i>Sample type: (primary, duplicate, field blank)</i>	Primary
General Comments	
The flow rate was taken from the sample tap, which is likely to be a restricted flow.	
Photos

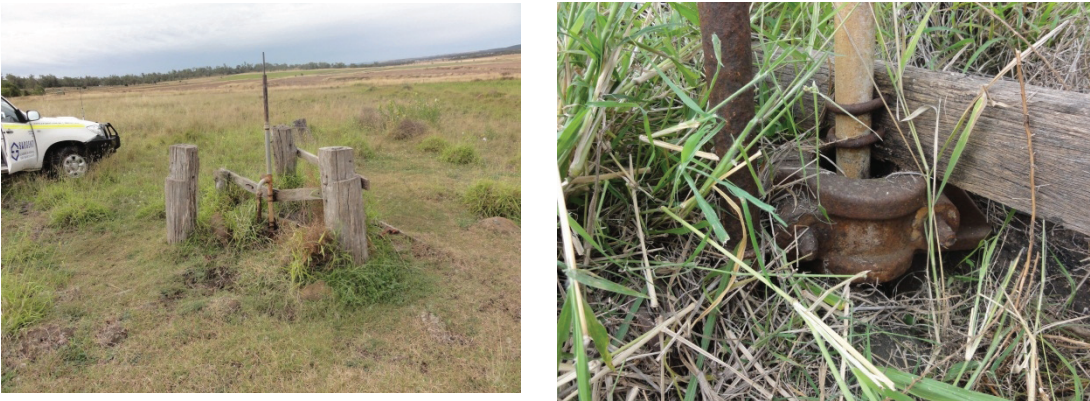
<i>(any seasonal variations?)</i>	
<i>Measured Maximum Flow Rate of Bore and Headworks at Site Visit (L/s)</i>	NA
<i>Describe riser, headwork and water distribution details:</i>	Bore casing is held in place by a surface clamp. The windmill pipes are held in the bore attached to a wooden beam. The outflow leads to a galvanised steel pipe that appears to run just under the surface vegetation. Outflow from this pipe is unknown.
<i>Equipment condition:</i>	Windmill equipment is still in bore. Interviewee believes a storm blew windmill over and the windmill pump and rods are still in the bore.
<i>Comments:</i>	
Water Details	
<i>Standing water level (m bgl): (measured or anecdotal)</i>	Attempted to dip but obstructions in bore prevented measurements.
<i>Stable pumping water level (m bgl): (measured, including mins after pump on)</i>	NA
<i>Water level measuring point</i>	Top of casing
<i>Interviewee / owner understanding of typical SWL / PWL (m bgl):</i>	NA

<i>Comments:</i>	
Water Sampling Details	
Any historic water quality data available from owner?	No
Any account of gas in the bore from interviewee?	No
Any potential for contamination at bore? (fuel storage, open bore casing, no stickup, aquifer intermixing from casing degradation)	Bore is open and unprotected. Vegetation grown up around bore.
Water quality sample collected during this assessment?	No
Sample type: (primary, duplicate, field blank)	NA
General Comments	
LH did have other bores on the property but was unable to contact when finished with this bore.	
Attempted to contact LH about accessing other bores but he was at appointment in Toowoomba and could not assist. He explained where other bore was but was unable to answer any questions.	
Photos

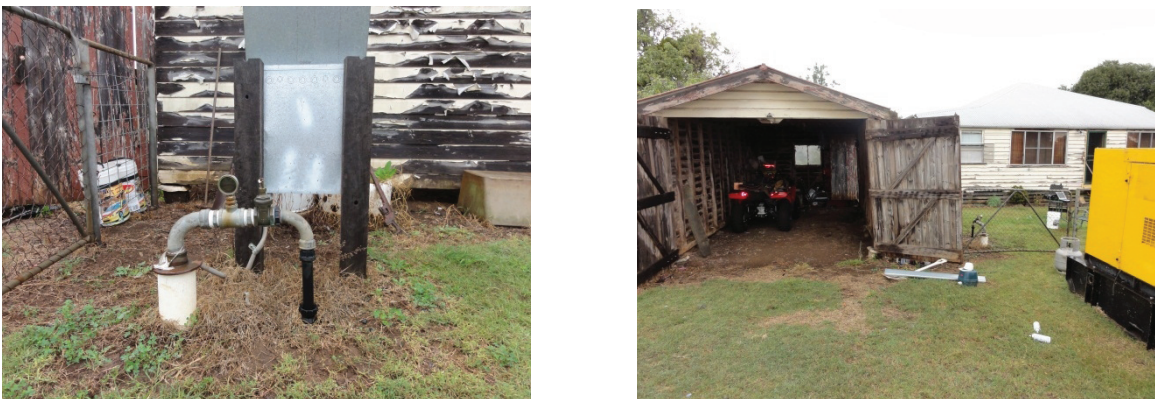
<i>Interviewee / owner understanding of typical SWL / PWL (m bgl):</i>	Not known
<i>Comments:</i>	Could not dip because of bore cap and insufficient space in the bore headworks.
Water Sampling Details	
Any historic water quality data available from owner?	No, although local school took some for a school project (unavailable however).
Any account of gas in the bore from interviewee?	No
Any potential for contamination at bore? (fuel storage, open bore casing, no stickup, aquifer intermixing from casing degradation)	Bore is well sealed but there are a number of scrap vehicles nearby and a storage shed adjacent the bore (with a dirt floor) which contains a quad bike and other farm equipment. A large generator sits within 5m of the bore (not known if this is permanent). Several 44 gallon drums adjacent shed (unknown use). In summary, some potential for sources of contaminants.
Water quality sample collected during this assessment?	Yes, from headwork's outflow.

Sample type: (primary, duplicate, field blank)	Primary
General Comments	
Difficulty taking flow rate and water sample. (No place to sample at the outflow tank and not easy to access). Had to turn the pump on and off to connect and disconnect headworks, due to proximity of the bore to the cottage. LH did not want the bore to flow near the cottage for any length of time, so water was pumped to the storage tank and the headworks were disconnected when samples or flow rates were required. Therefore limited field water quality readings were able to be taken during this assessment.	
Photos

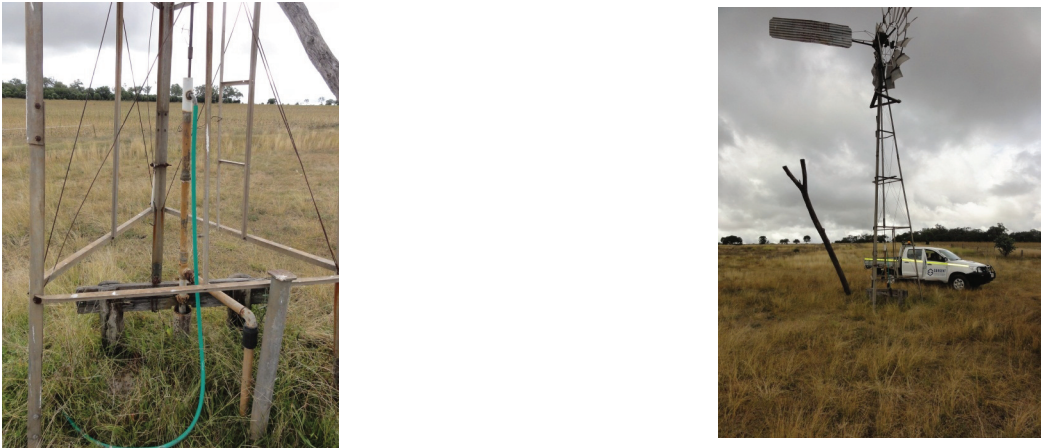
<i>Equipment condition:</i>	Equipment is old but in reasonable condition. LH indicated buckets on pump need changing.
<i>Comments:</i>	
Water Details	
<i>Standing water level (m bgl): (measured or anecdotal)</i>	Measured 9.9m bgl (10.36m below TOC)
<i>Stable pumping water level (m bgl): (measured, including mins after pump on)</i>	Not measured due to lack of wind
<i>Water level measuring point</i>	TOC (Top of casing)
<i>Interviewee / owner understanding of typical SWL / PWL (m bgl):</i>	Owner unsure; from drillers log SWL was 8m bgl on 8/12/1982
<i>Comments:</i>	
Water Sampling Details	
Any historic water quality data available from owner?	Some taken for a school project, 5-10 years ago (unavailable however).
Any account of gas in the bore from interviewee?	No
Any potential for contamination at bore? (fuel storage, open bore casing, no stickup, aquifer intermixing from casing degradation)	Bore is open and vegetation is high around bore. When dipped could feel resistance and debris falling into water, which could be indication of casing corrosion. No obvious source of contamination observed around the bore.

Water quality sample collected during this assessment?	No wind to provide flow for taking sample.
Sample type: (primary, duplicate, field blank)	n.a.
General Comments	
Drillers log and license info obtained	
Photos

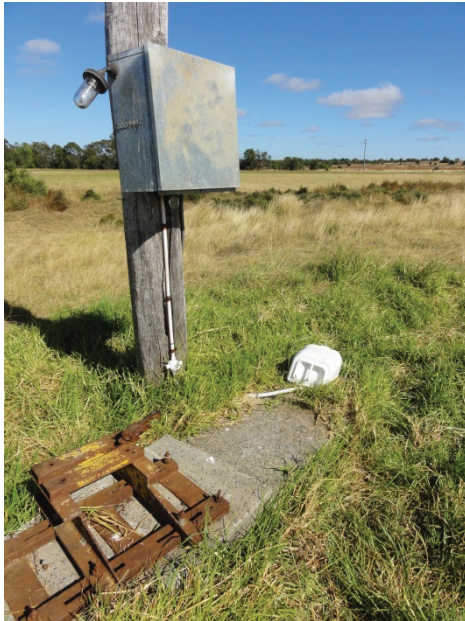
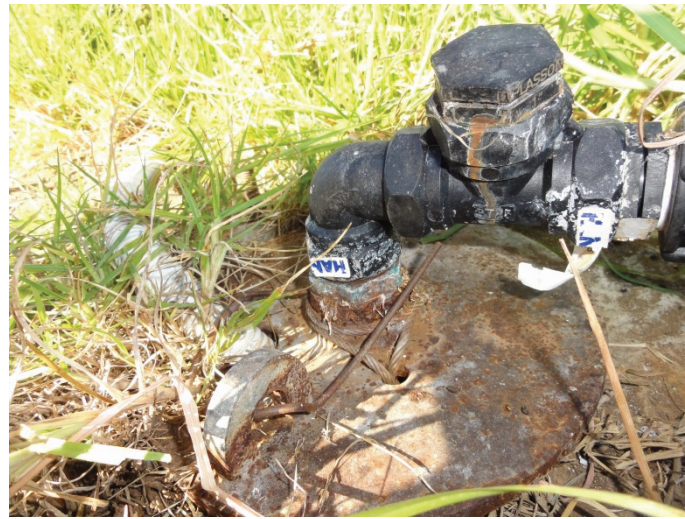
<i>Total depth (m):</i>	73.2m (from water license) However, bore log records 262 ft (80m) as total depth of the bore.
<i>Bore Condition Comments:</i>	Bore is fairly old and has a fair degree of corrosion. Bore is fairly well sealed with only small opening for cables.
Bore Equipment Details	
<i>Pump Installed?</i>	Yes
<i>Pump type, make and model, power source:</i>	Electric submersible pump, Franklin 1.1 kW (based on plate in control box), 3-phase, electricity from public (mains) supply.
<i>Date installed:</i>	2010 (anecdotal from LH)
<i>Date of most recent use</i>	07/05/2013. Tested to make sure working for assessment. Typical use is 13 x 15 minute intervals, approximately 4 times a week (year-round).
<i>Any repairs?</i>	Not since 2010
<i>Pump intake depth (m bgl):</i>	At bore depth (73.2m) according to LH.
<i>Interviewee's est. annual take (ML):</i>	0.22 ML
<i>Basis for estimate:</i>	13 x 15mins for an average of four nights per week at an average flow rate of 0.09 L/sec. This depends on number of cattle in paddock and domestic use - figures above are LH estimate of average use.

<i>Equipment condition:</i>	Appears in fair condition. Some surficial corrosion on bore cap. Concrete pad is in good condition.
<i>Comments:</i>	
Water Details	
<i>Standing water level (m bgl): (measured or anecdotal)</i>	Airline is approx. 10ft above the pump (anecdotal) at 70.45m bgl. (Reading of 11 PSI indicates around 7m of water above the airline, hence either the anecdotal position of the airline, or the bore depth is incorrect).
<i>Stable pumping water level (m bgl): (measured, including mins after pump on)</i>	At 10:10am (after 50 mins of pumping) the airline reading was 1 PSI (which is around typical atmospheric pressure), and indicates the water level had essentially drawn to or below the airline.
<i>Water level measuring point</i>	Airline
<i>Interviewee / owner understanding of typical SWL / PWL (m bgl):</i>	10-12 ft (3-3.5m) of water above pump (note this conflicts with the evidence from the airline reading). Pump believed to be at total depth. So SWL is believed to be at 70.45m bgl (anecdotal from LH)

<i>Comments:</i>	
Water Sampling Details	
<i>Any historic water quality data available from owner?</i>	Water quality test conducted approx 15 years ago. Results not available on day of interview.
<i>Any account of gas in the bore from interviewee?</i>	No
<i>Any potential for contamination at bore? (fuel storage, open bore casing, no stickup, aquifer intermixing from casing degradation)</i>	Bore is fairly well sealed. Unable to see condition under the bore cap. Bore is unfenced and in a field used for stock (bore reasonably well sealed), but no other obvious sources of potential contamination.
<i>Water quality sample collected during this assessment?</i>	Yes
<i>Sample type: (primary, duplicate, field blank)</i>	Primary
General Comments	
<p>Bore feeds concrete tank which has 7,000 gallon capacity. Currently only uses up to 5,000 gallon of this capacity due to deteriorating condition of the tank.</p> <p>Owner requested that it be recorded that the bore was originally equipped with a mono pump with a diesel motor. The flow rate was 350 gallons an hour (2003), but is now significantly reduced. (It is unclear however whether this is due to a change in the pump setting in the new pump, or a change groundwater levels, which has reduced available drawdown).</p>

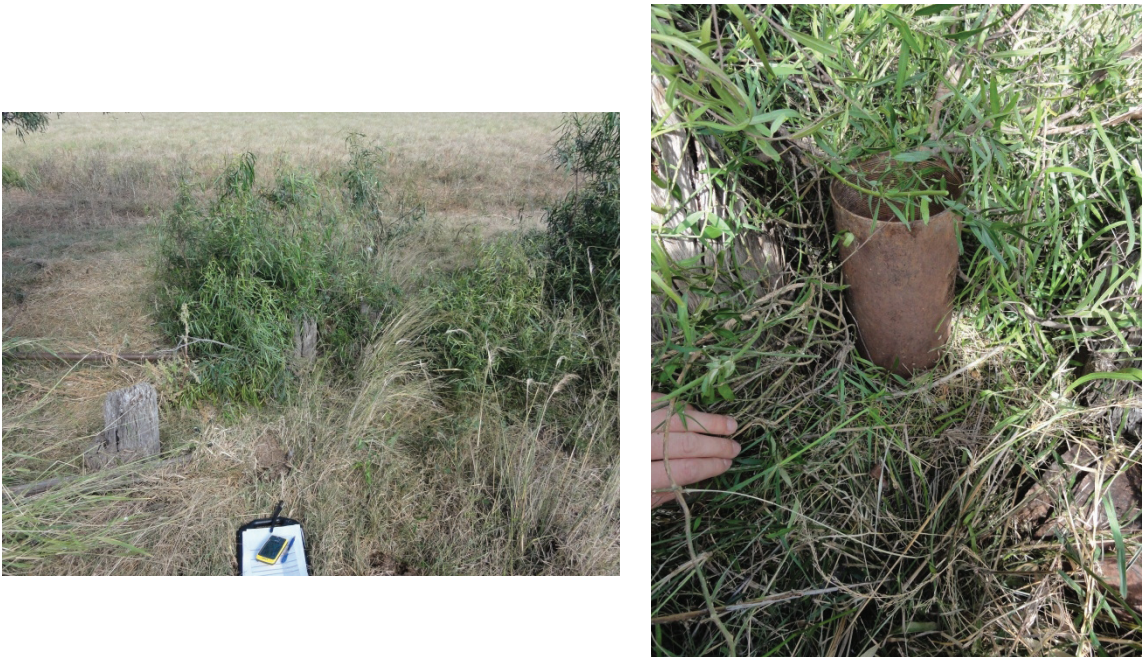
<i>distribution details:</i>	
<i>Equipment condition:</i>	n.a.
<i>Comments:</i>	
Water Details	
<i>Standing water level (m bgl): (measured or anecdotal)</i>	Did not dip as the LH indicated there has recently been something in the bore blocking it
<i>Stable pumping water level (m bgl): (measured, including mins after pump on)</i>	n.a.
<i>Water level measuring point</i>	n.a.
<i>Interviewee / owner understanding of typical SWL / PWL (m bgl):</i>	n.a.
<i>Comments:</i>	
Water Sampling Details	
Any historic water quality data available from owner?	No
Any account of gas in the bore from interviewee?	Unknown
Any potential for contamination at bore? (fuel storage, open bore casing, no stickup, aquifer intermixing from casing degradation)	Bore is open and overgrown by vegetation.
Water quality sample collected during this assessment?	No
Sample type: (primary, duplicate, field blank)	n.a.
General Comments	
Bore was hidden. Landholder highlighted that there was a blockage in the casing. There was insufficient time to ask the LH questions regarding historical aspects of the bore etc.

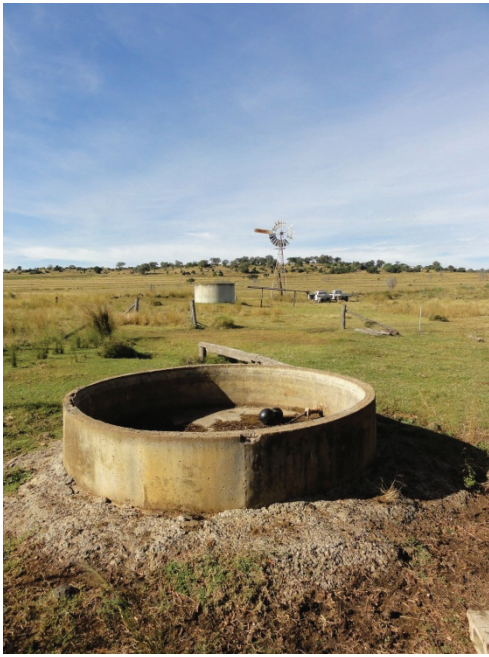
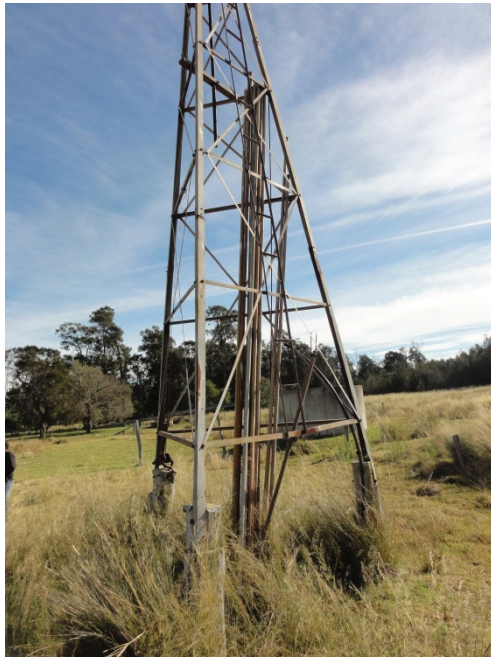
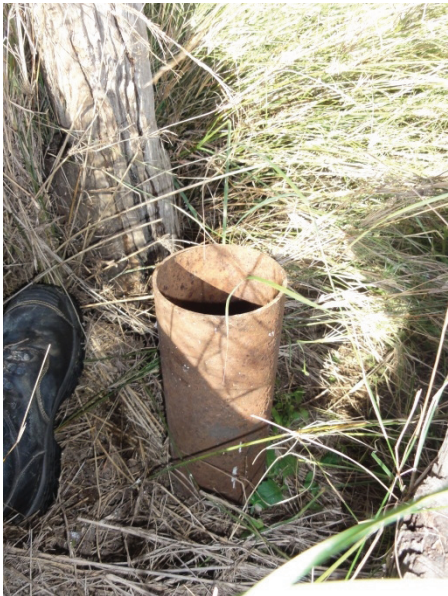
Bore Equipment Details	
<i>Pump Installed?</i>	Not currently in use. Pump last in: 07/04/08. (Windmill pump)
<i>Pump type, make and model, power source:</i>	Unknown make and model.
<i>Date installed:</i>	Pump on pipes (currently above ground) was installed in 1998.
<i>Date of most recent use</i>	07/04/08
<i>Any repairs?</i>	General wear and tear. Replaced leathers in pump.
<i>Pump intake depth (m bgl):</i>	Approx. 78m bgl (based on 13 rods of 6m length currently on surface at the site)
<i>Interviewee's est. annual take (ML):</i>	unknown
<i>Basis for estimate:</i>	n.a.
<i>Is bore use metered? Give details:</i>	No
<i>Detail specific uses of the bore water:</i>	Stock. Use volumes depends on season. Historically 150 head of cattle (oats

<i>Water quality sample collected during this assessment?</i>	No
<i>Sample type: (primary, duplicate, field blank)</i>	n.a.
General Comments	
Owner supplied VHS tape of down hole camera inspection conducted in 2008. (Didn't take this tape as it is his only copy). Copied details and took photos of the tape cover: "Bore 07/04/2008. Water level 58m, depth 104m, Mangineeze coming in at about 92-93m (build up in hole)" (Presumably 'mangineeze' means 'manganese').	
Photos

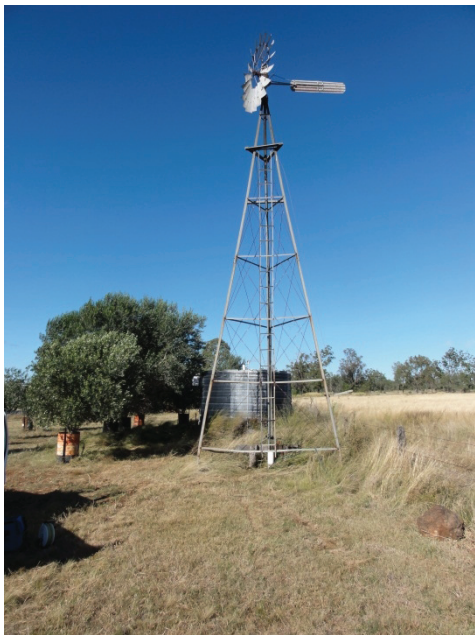
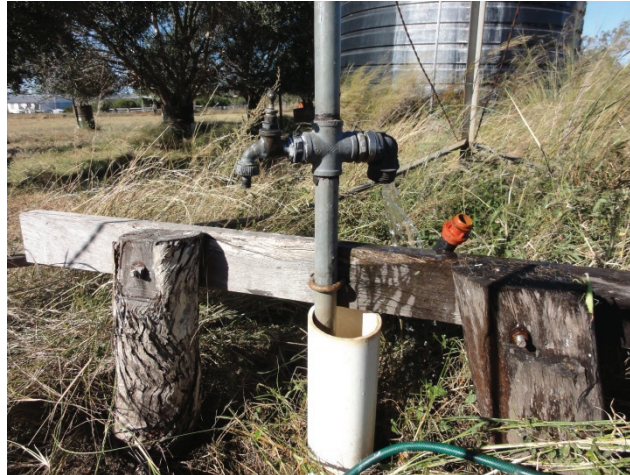
<i>Date installed:</i>	1995, same as bore (anecdotal)
<i>Date of most recent use</i>	Switched off yesterday midday.
<i>Any repairs?</i>	Anecdotal: Only normal running repairs on the pump buckets (approx. 2008)
<i>Pump intake depth (m bgl):</i>	19.4mbgl (based on estimate of 65 feet from LH)
<i>Interviewee's est. annual take (ML):</i>	0.8 ML used from tank. Likely takes more than this however, as windmill is not switched off, e.g. around 3 ML/yr if assumed to be running at average the flow rate experienced during the inspection (0.1 L/sec)
<i>Basis for estimate:</i>	2,000 L per day for stock, plus toilet use estimate of 100 L per day.
<i>Is bore use metered? Give details:</i>	No
<i>Detail specific uses of the bore water:</i>	Stock: 39 cows at present, can range from 25 to 50 throughout year. Domestic toilet flushing.
<i>Detail all other water sources for property:</i>	Rainwater for all other domestic. 4 dams on property

Water quality sample collected during this assessment?	Yes
Sample type: (primary, duplicate, field blank)	Primary
General Comments	
One other bore on the property (covered in in 1991). 'Punched' in 1989 but screen became blocked and unusable, so abandoned.	
Photos

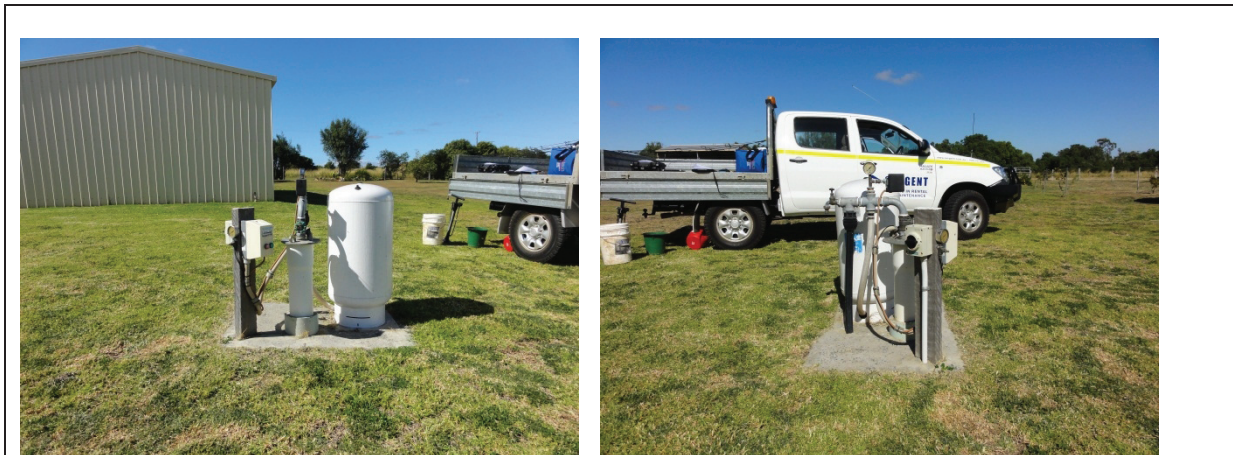
<i>Equipment condition:</i>	Very good condition. No damage
<i>Comments:</i>	
Water Details	
<i>Standing water level (m bgl): (measured or anecdotal)</i>	Airline pressure 95 psi (depth of airline unknown, but possibly around pump)
<i>Stable pumping water level (m bgl): (measured, including mins after pump on)</i>	At 1:25pm airline pressure was 65 psi
<i>Water level measuring point</i>	NA
<i>Interviewee / owner understanding of typical SWL / PWL (m bgl):</i>	Not known
<i>Comments:</i>	
Water Sampling Details	
Any historic water quality data available from owner?	Yes (collected 01/07/2008 and copies provided)
Any account of gas in the bore from interviewee?	Once in a dry period (2009/2010) when water was pumped to the tank the land holder commented on a rotten egg smell (H ₂ S) from water entering tank. Owner unsure of exact time.
Any potential for contamination at bore? (fuel storage, open bore casing, no stickup, aquifer intermixing from casing degradation)	Minimum. Bore sealed effectively and maintained.

Water quality sample collected during this assessment?	Yes. Sample was only taken from tap on bore headwork's.
Sample type: (primary, duplicate, field blank)	Primary
General Comments	
<p>Sample taken after 30 mins of pumping because LH had warned that bore would cut out when tank was full. Sample was collected when tank was almost full. LH didn't want to disconnect pipe from bore, as wasn't sure if could be reconnected properly and concern was raised about capturing water, due to rate of flow.</p> <p>Bore commenced pumping at 12:40.</p> <p>LH leaves the bore off and turns on when wants to top up the tank. Bore has an auto shut off when tank is full, so his estimation of usage he mentioned was a very rough estimate.</p>	
Photos

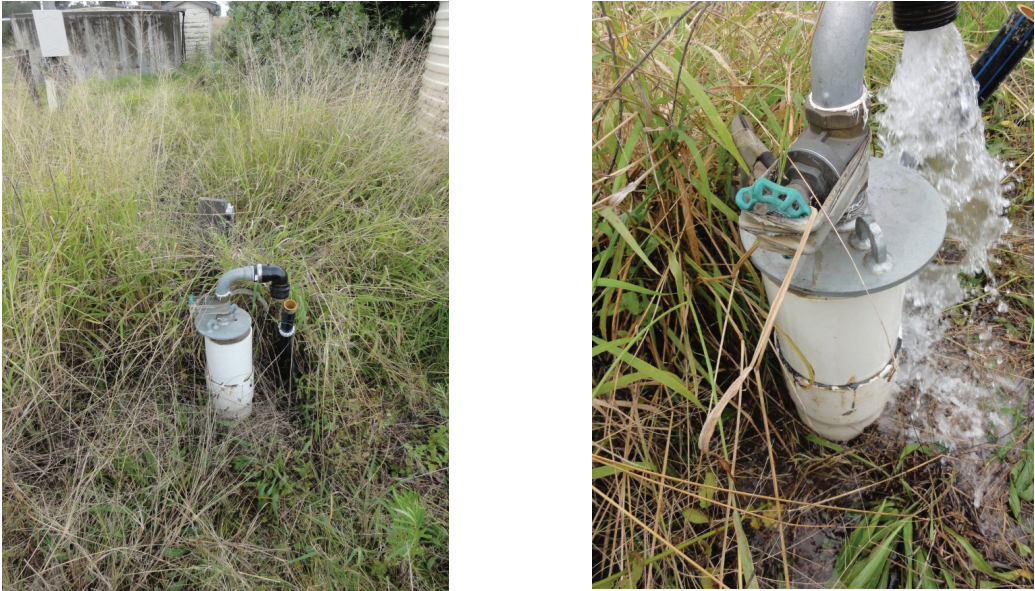
<i>Measured Maximum Flow Rate of Bore and Headworks at Site Visit (L/s)</i>	2.5 L/s
<i>Describe riser, headwork and water distribution details:</i>	Bore cap has an outflow with a valve attached. This connects to a black poly pipe (approx 50mm diameter) and flows to a concrete storage tank. This is then transported to the two plastic storage tanks (24,424 L capacity each) and distributed to troughs.
<i>Equipment condition:</i>	New. Very good condition.
<i>Comments:</i>	
Water Details	
<i>Standing water level (m bgl): (measured or anecdotal)</i>	Airline measured before pumping at 21.5 PSI (approx. 15m head of water above end of airline)
<i>Stable pumping water level (m bgl): (measured, including mins after pump on)</i>	Airline measured at 12:24 (i.e. at end of pumping) at 21 PSI (indicating less than one metre of drawdown during pumping).
<i>Water level measuring point</i>	Airline (not sure of depth of airline)

<i>Interviewee / owner understanding of typical SWL / PWL (m bgl):</i>	-
<i>Comments:</i>	-
Water Sampling Details	
<i>Any historic water quality data available from owner?</i>	Yes test when bore was installed to indicate whether water potable or not. (However no copies were available).
<i>Any account of gas in the bore from interviewee?</i>	No
<i>Any potential for contamination at bore? (fuel storage, open bore casing, no stickup, aquifer intermixing from casing degradation)</i>	Bore is well sealed. Not set on a very large concrete pad. No obvious sources of potential contaminants.
<i>Water quality sample collected during this assessment?</i>	Yes
<i>Sample type: (primary, duplicate, field blank)</i>	Primary: P_loughlin_01
General Comments	
Wife of L.H. was present at site visit to show the location of the bore and instruct on pump operation (but was not able to answer questions in any detail). Spoke to L.H. on the phone at a later date and added additional information.

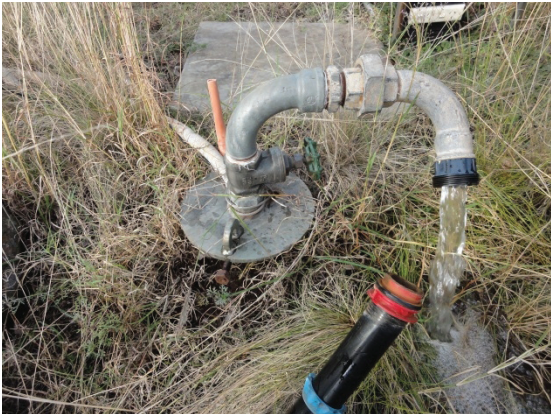
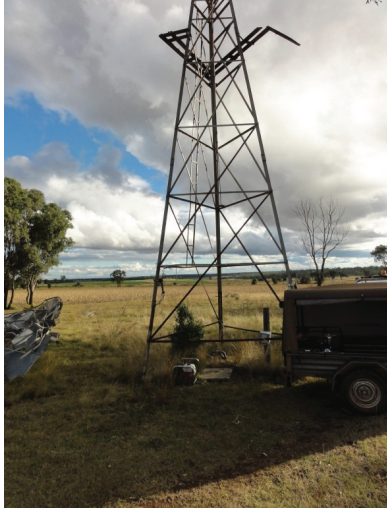
<i>Stable pumping water level (m bgl): (measured, including mins after pump on)</i>	14 PSI at 4:15 (after 50 minutes of pumping), indicating a pumping drawdown of around 7m.
<i>Water level measuring point</i>	Airline
<i>Interviewee / owner understanding of typical SWL / PWL (m bgl):</i>	
<i>Comments:</i>	Airline was leaking but managed to stabilise around readings.
Water Sampling Details	
Any historic water quality data available from owner?	No
Any account of gas in the bore from interviewee?	No
Any potential for contamination at bore? (fuel storage, open bore casing, no stickup, aquifer intermixing from casing degradation)	Bore is well sealed and the space for cables is very small leaving little room for contaminants to enter directly down the bore. Hay barn approx. 50m away may contain some sources of contaminants but unlikely. Old windmill structure protects bore from cattle immediately around well head.

Water quality sample collected during this assessment?	Yes
Sample type: (primary, duplicate, field blank)	Primary
General Comments	
L.H. interview conducted post site visit. After talking to L.H. added information to collected field data. L.H. searched for missing data but has not been provided, so presumably missing.	
Photos

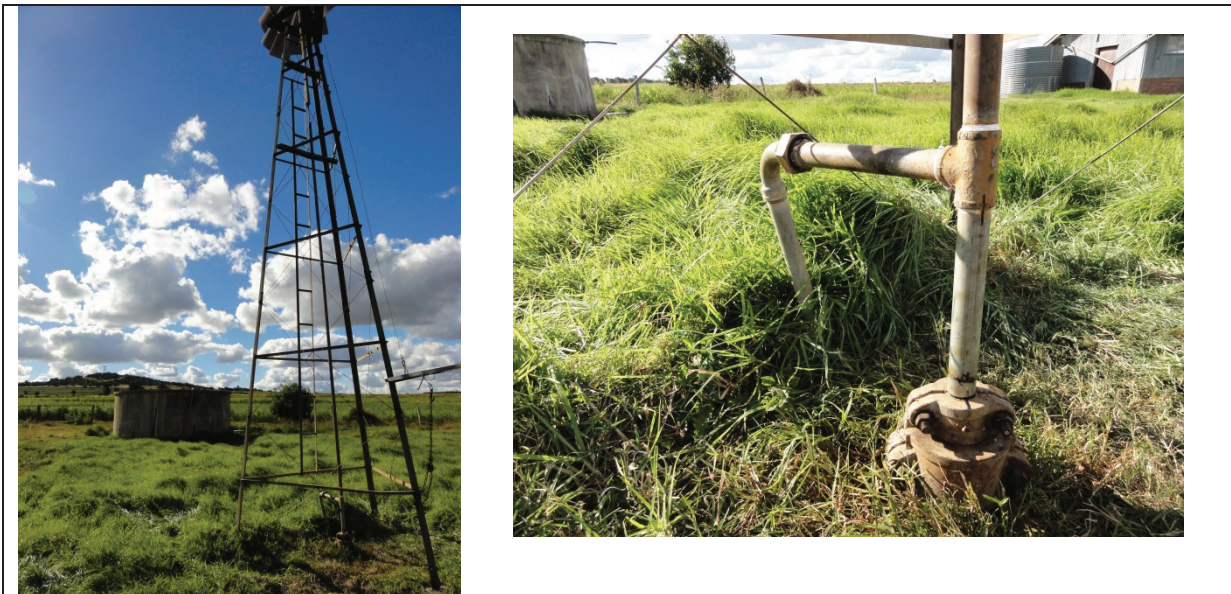
<i>Equipment condition:</i>	The equipment is well maintained. (Was receiving repairs on the day of the site assessment).
<i>Comments:</i>	
Water Details	
<i>Standing water level (m bgl): (measured or anecdotal)</i>	From the windmill maintenance contractor, Russel Gierke (refer comments below): 1996 = 39.3m bgl, 2005 = 48.1m bgl, 2013 = 55.16m bgl.
<i>Stable pumping water level (m bgl): (measured, including mins after pump on)</i>	Sealed headworks, unable to dip.
<i>Water level measuring point</i>	n.a.
<i>Interviewee / owner understanding of typical SWL / PWL (m bgl):</i>	Refer above.
<i>Comments:</i>	
Water Sampling Details	
<i>Any historic water quality data available from owner?</i>	No
<i>Any account of gas in the bore from interviewee?</i>	No
<i>Any potential for contamination at bore? (fuel storage, open bore casing, no stickup, aquifer intermixing from casing degradation)</i>	Fairly well sealed with only minor openings in the headworks. Bore casing is fairly low to the ground. Storage sheds in the vicinity of the bore may contain potential contaminant sources, but unlikely. Bore does not have a concrete pad.

<i>Water quality sample collected during this assessment?</i>	Yes, from outflow before discharge to the tank.
<i>Sample type: (primary, duplicate, field blank)</i>	Primary
General Comments	
<p>Russel Gierke of Downs Windmill and Pump Service was servicing a couple of windmill bores on the property at the time of the site assessment, and was able to supply total depth and water level readings from previous visits. Work on the bore finished at 2:00pm. Sampling was delayed as long as possible after this maintenance (to allow settlement of anything disturbed during pump repairs). However, this could potentially have impacted on the sample (e.g. stirring up silt in bore etc). It was extremely difficult to get an accurate flow rate. A visual estimate of 5L per minute was made, however the wind was weak at the time of this observation, and flows will vary significantly with wind speed.</p>	
Photos

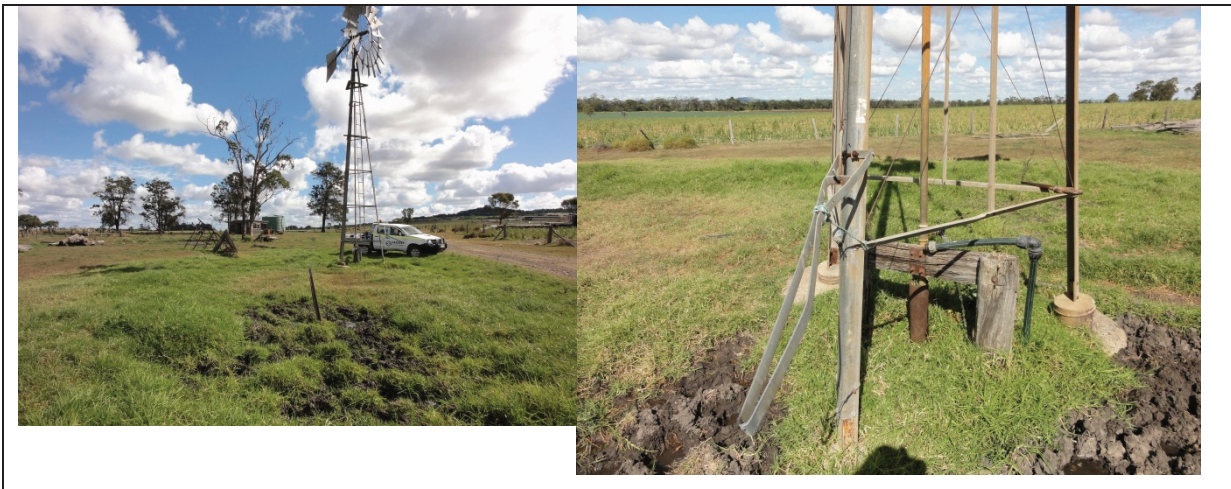
<i>Equipment condition:</i>	Fair condition, although quite old. Steel casing is fairly corroded.
<i>Comments:</i>	
Water Details	
<i>Standing water level (m bgl): (measured or anecdotal)</i>	From the windmill maintenance contractor, Russel Gierke (refer comments below): 2005= 37.8m bgl, 2007= 37.2m bgl, 2011=37.2m bgl.
<i>Stable pumping water level (m bgl): (measured, including mins after pump on)</i>	Did not dip due to risk of getting dipper stuck.
<i>Water level measuring point</i>	
<i>Interviewee / owner understanding of typical SWL / PWL (m bgl):</i>	Owner guess of 45.7 - 48.7 m bgl for SWL (but does not match with maintenance contractor estimates).
<i>Comments:</i>	
Water Sampling Details	
<i>Any historic water quality data available from owner?</i>	No
<i>Any account of gas in the bore from interviewee?</i>	No
<i>Any potential for contamination at bore? (fuel storage, open bore casing, no stickup, aquifer intermixing from casing degradation)</i>	Bore casing is open and has couch grass growing in the bore. Surface casing is corroded and the ground around the bore is very boggy due to overflow outlet, which has potential to cause contamination. (If the anecdotal evidence regarding the age of the bore is correct, a high level of down-hole bore corrosion is likely)

<i>Water quality sample collected during this assessment?</i>	Yes. Outflow pipe at the rising main elbow was disconnected to take sample directly from bore.
<i>Sample type: (primary, duplicate, field blank)</i>	Primary
General Comments	
Bore pumping continuously on arrival. Russel Gierke, of Downs Windmill and Pump Service, was servicing a couple of windmill bores on the property at the time of the site assessment, and was able to supply total depth and water level readings from previous visits.	
Photos

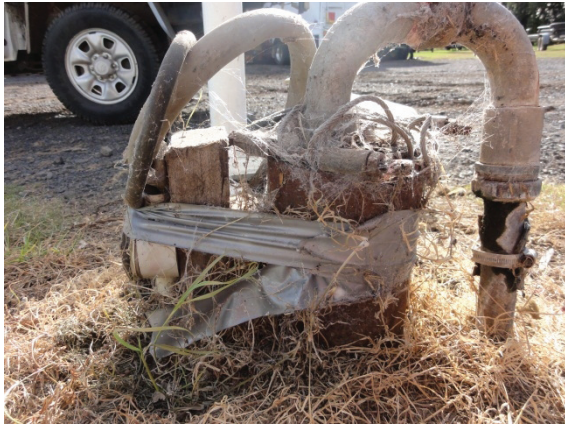
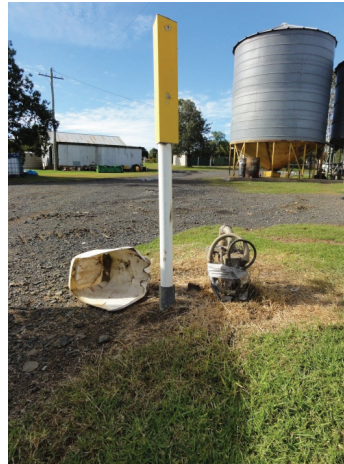
<i>Equipment condition:</i>	Headworks are old but appear to be in a good condition.
<i>Comments:</i>	
Water Details	
<i>Standing water level (m bgl): (measured or anecdotal)</i>	Approx. 90m (from time of pump installation – refer below). No airline and insufficient space in the bore annulus, so could not dip during the field survey.
<i>Stable pumping water level (m bgl): (measured, including mins after pump on)</i>	Unknown
<i>Water level measuring point</i>	n.a.
<i>Interviewee / owner understanding of typical SWL / PWL (m bgl):</i>	On 19/3/2012 when the pump was fitted the WL in the bore was 300ft (91m).
<i>Comments:</i>	
Water Sampling Details	
<i>Any historic water quality data available from owner?</i>	Alders did a water quality test two months ago due to dispute about weed spray not working. A copy of results was not available.
<i>Any account of gas in the bore from interviewee?</i>	No
<i>Any potential for contamination at bore? (fuel storage, open bore casing, no stickup, aquifer intermixing from casing degradation)</i>	Bore is well sealed but is surrounded by animal sheds, which could be a source of nutrients to the aquifer (however nitrate in the sample results was low). The bore is covered with a plastic cap.

<i>Water quality sample collected during this assessment?</i>	Yes. Sample had to be taken from the outflow to the storage tank, around 70m from bore, as pipes at the bore could not be disconnected.
<i>Sample type: (primary, duplicate, field blank)</i>	Primary
General Comments	
Could not take a flow rate due to the position of the outflow, but the LH gave a confident estimation of the flow rate of the bore as 1500 L/hr (0.42 L/s).	
Photos

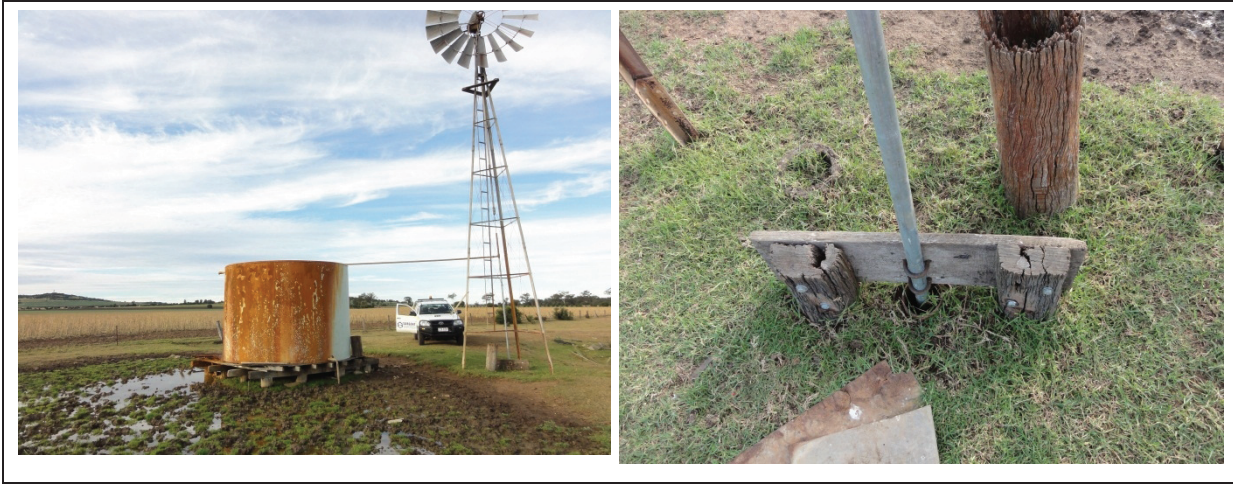
Water quality sample collected during this assessment?	Could not sample because a) limited wind throughout assessment and b) it was not possible to safely sample the outflow.
Sample type: (primary, duplicate, field blank)	n.a.
General Comments	
Bore could not be sampled because of lack of wind and location of outflow.	
Interview was conducted before the site visit, as the LH was not available to accompany to the site.	
Photos

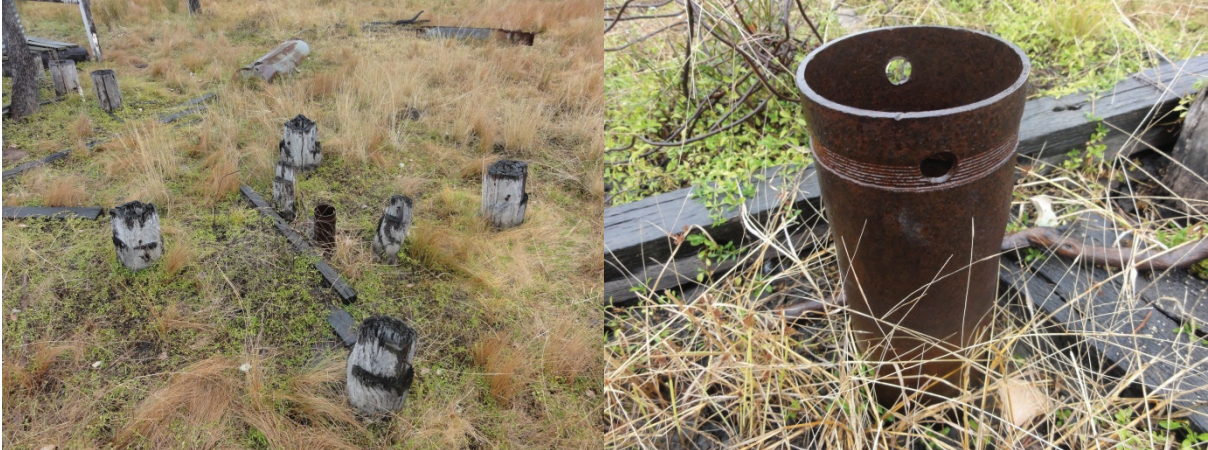
Measured Maximum Flow Rate of Bore and Headworks at Site Visit (L/s)	n.a.
Describe riser, headwork and water distribution details:	n.a.
Equipment condition:	n.a.
Comments:	
Water Details	
Standing water level (m bgl): (measured or anecdotal)	20.93m bgl (measured at time of inspection)
Stable pumping water level (m bgl): (measured, including mins after pump on)	n.a.
Water level measuring point	ToC
Interviewee / owner understanding of typical SWL / PWL (m bgl):	n.a.
Comments:	
Water Sampling Details	
Any historic water quality data available from owner?	Unknown
Any account of gas in the bore from interviewee?	n.a.
Any potential for contamination at bore? (fuel storage, open bore casing, no stickup, aquifer intermixing from casing degradation)	Bore is open and in an open field. Vegetation is low around bore, which is likely due to grazing. No obvious sign of potential contamination source.
Water quality sample collected during this assessment?	No sample taken (no pump in the bore)

Sample type: (primary, duplicate, field blank)	n.a.
General Comments	
Bore location was provided by APC manager. The bore was located and some basic measurements were able to be taken. The bore is not used and little information was available regarding this bore.	
Photos

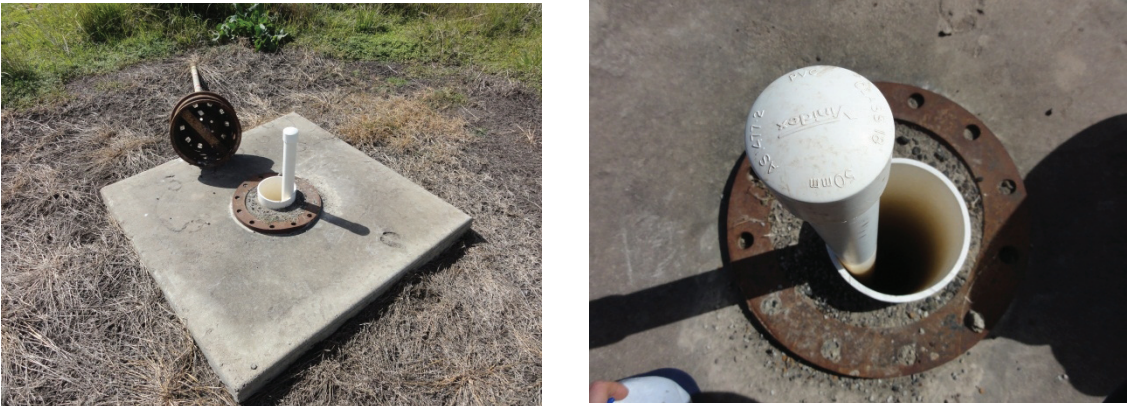
<i>pumping: (any seasonal variations?)</i>	
<i>Measured Maximum Flow Rate of Bore and Headworks at Site Visit (L/s)</i>	NA
<i>Describe riser, headwork and water distribution details:</i>	Concrete platform. There is a large diameter (~200mm) white PVC casing surrounding a smaller capped (50 mm) white PVC casing.
<i>Equipment condition:</i>	NA
<i>Comments:</i>	
Water Details	
<i>Standing water level (m bgl): (measured or anecdotal)</i>	15.62mbgl measured
<i>Stable pumping water level (m bgl): (measured, including mins after pump on)</i>	NA
<i>Water level measuring point</i>	Top of inner casing
<i>Interviewee / owner understanding of typical SWL / PWL (m bgl):</i>	NA
<i>Comments:</i>	
Water Sampling Details	
<i>Any historic water quality data available from owner?</i>	NA
<i>Any account of gas in the bore from interviewee?</i>	NA
<i>Any potential for contamination at bore? (fuel storage, open bore casing, no stickup, aquifer intermixing from casing degradation)</i>	Bore has a fitted cap.

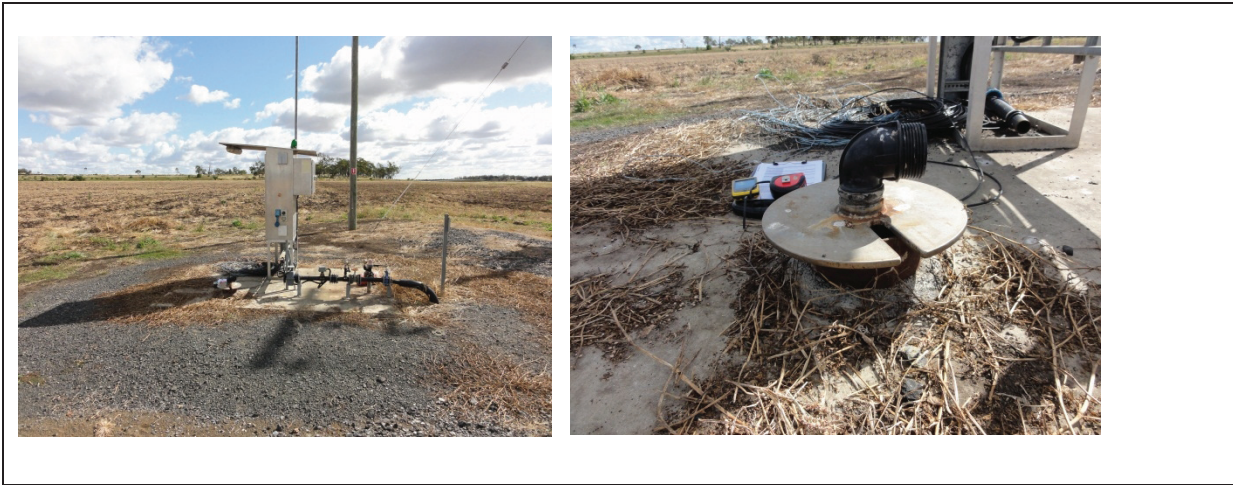
<i>Equipment condition:</i>	Surface casing appears in good condition with little sign of wear and tear. Not clear whether there is a pump currently in the bore, but rising main remains in bore. Rising main not connected to the surface infrastructure rendering the bore unusable in its current state. Power cable is not connected.
<i>Comments:</i>	
Water Details	
<i>Standing water level (m bgl): (measured or anecdotal)</i>	24.45 m bgl (measured)
<i>Stable pumping water level (m bgl): (measured, including mins after pump on)</i>	NA
<i>Water level measuring point</i>	Airline has a hole in it near the bore and therefore a reading could not be taken
<i>Interviewee / owner understanding of typical SWL / PWL (m bgl):</i>	NA
<i>Comments:</i>	
Water Sampling Details	
<i>Any historic water quality data available from owner?</i>	Unknown
<i>Any account of gas in the bore from interviewee?</i>	Unknown
<i>Any potential for contamination at bore? (fuel storage, open bore casing, no stickup, aquifer intermixing from casing degradation)</i>	In current state, the bore is not completely sealed, which is a potential source of contaminant (e.g. vegetation, insects etc.)

<i>Water quality sample collected during this assessment?</i>	No
<i>Sample type: (primary, duplicate, field blank)</i>	NA
General Comments	
Bore is currently not used. No power line attached to pump if in well.	
Photos

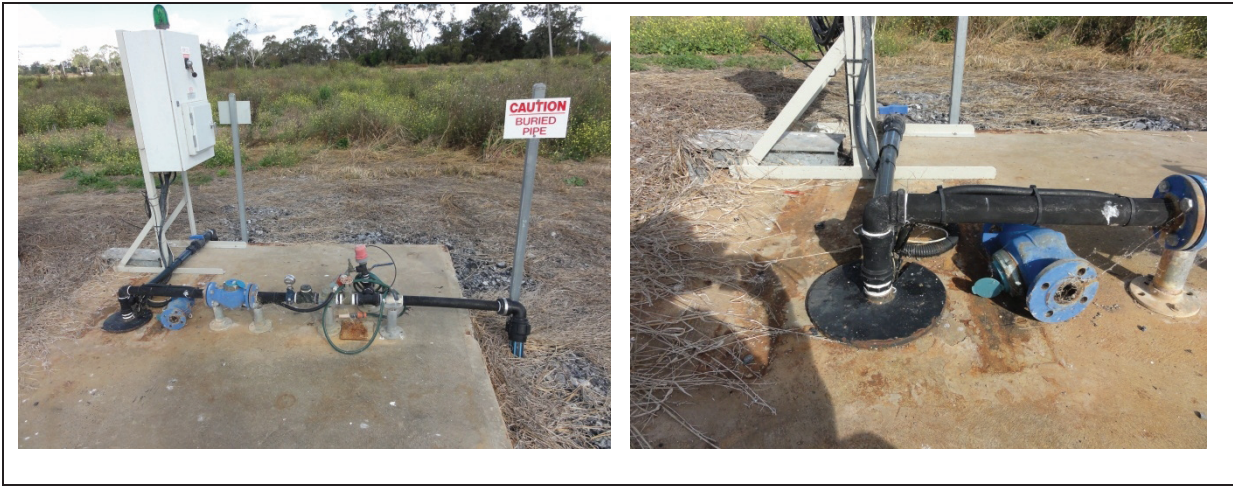
<i>Equipment condition:</i>	Headworks appear to be in good condition. Part of headworks is not sealed (open hole at top of poly pipe), and would need to be sealed appropriately before being used.
<i>Comments:</i>	
Water Details	
<i>Standing water level (m bgl): (measured or anecdotal)</i>	Unknown
<i>Stable pumping water level (m bgl): (measured, including mins after pump on)</i>	Unknown
<i>Water level measuring point</i>	NA
<i>Interviewee / owner understanding of typical SWL / PWL (m bgl):</i>	Unknown
<i>Comments:</i>	A reading of 15psi was taken from the airline.
Water Sampling Details	
<i>Any historic water quality data available from owner?</i>	Unknown
<i>Any account of gas in the bore from interviewee?</i>	Unknown
<i>Any potential for contamination at bore? (fuel storage, open bore casing, no stickup, aquifer intermixing from casing degradation)</i>	In its current state, the bore has an open hole between the blue valve and the T joint, which is a potential source of contamination (e.g. vegetation, insects etc.)

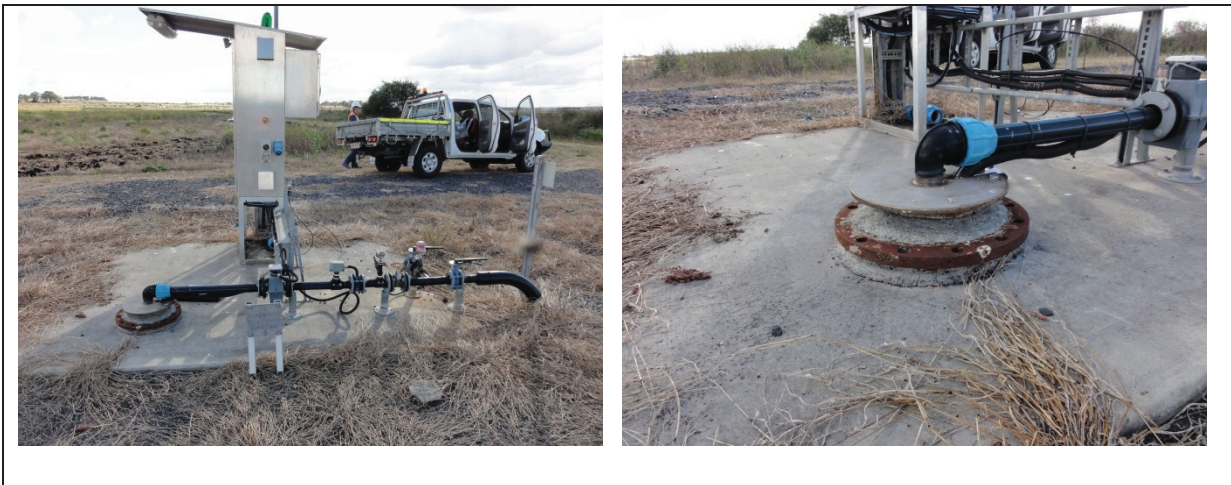
<i>Equipment condition:</i>	Appears in good condition.
<i>Comments:</i>	
Water Details	
<i>Standing water level (m bgl): (measured or anecdotal)</i>	Airline leaking
<i>Stable pumping water level (m bgl): (measured, including mins after pump on)</i>	Unknown
<i>Water level measuring point</i>	Unknown
<i>Interviewee / owner understanding of typical SWL / PWL (m bgl):</i>	Unknown
<i>Comments:</i>	Leak in airline makes taking reading difficult.
Water Sampling Details	
<i>Any historic water quality data available from owner?</i>	Unknown
<i>Any account of gas in the bore from interviewee?</i>	Unknown
<i>Any potential for contamination at bore? (fuel storage, open bore casing, no stickup, aquifer intermixing from casing degradation)</i>	Bore is sealed and there are very few potential sources of contamination.
<i>Water quality sample collected during this assessment?</i>	Yes on 15/05/2013 from sample tap
<i>Sample type: (primary, duplicate, field blank)</i>	Primary
