G.4.2 Landholder Bore Survey Results

New Acland Coal Mine Stage 3 Project Environmental Impact Assessment

LANDHOLDER BORE SURVEY

Document title: Landholder Bore Survey – New Acland Revised Stage 3 Project

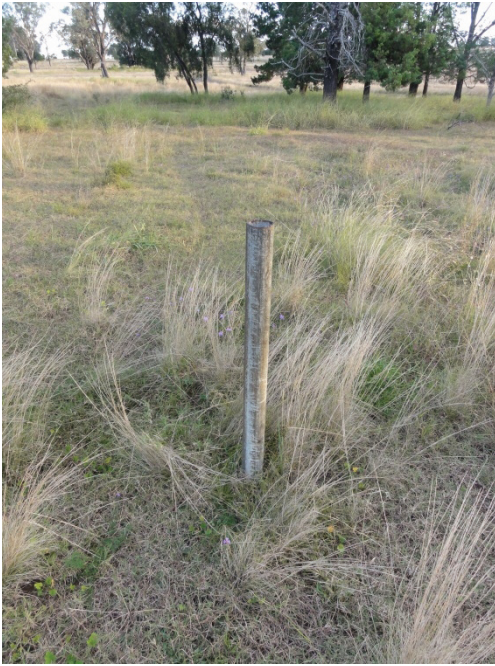
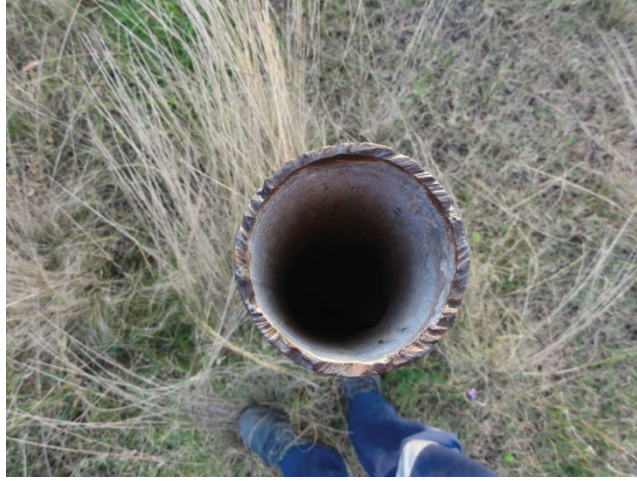
<i>Sample type: (primary, duplicate, field blank)</i>	NA
General Comments	
This bore was discovered as we were leaving site. There was not enough time to conduct an assessment, so only pictures and its position were taken. Referred to afterwards by APC Property Manager as the 'school bore'.	
Photos

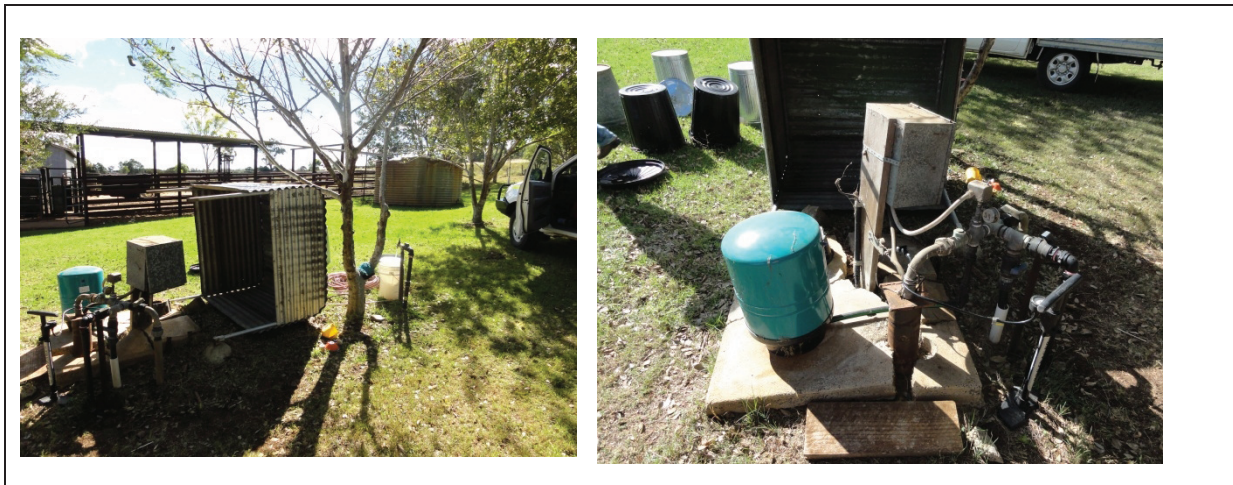
<i>Equipment condition:</i>	Equipment appears in good condition.
<i>Comments:</i>	
Water Details	
<i>Standing water level (m bgl): (measured or anecdotal)</i>	Could not dip due to lack of space at the bore headworks.
<i>Stable pumping water level (m bgl): (measured, including mins after pump on)</i>	Not known (but refer below for estimate of drawdown during pumping)
<i>Water level measuring point</i>	NA
<i>Interviewee / owner understanding of typical SWL / PWL (m bgl):</i>	Airline reading before turned pump on of approx. 35 psi (around 24.5m water above airline). Airline reading at 12:37pm was 19 psi (around 13.5m), indicating around 11m of drawdown had occurred during pumping. (Location of end of airline below surface is not known).
<i>Comments:</i>	
Water Sampling Details	
Any historic water quality data available from owner?	No
Any account of gas in the bore from interviewee?	No
Any potential for contamination at bore? (fuel storage, open bore casing, no stickup, aquifer intermixing from casing degradation)	Bore is fairly well sealed and covered by shelter. Near stables but limited obvious sources of contamination. Yard is clear / well kept.

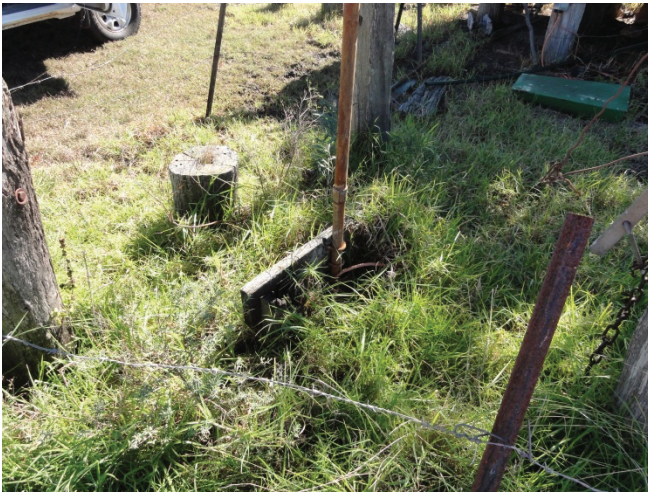
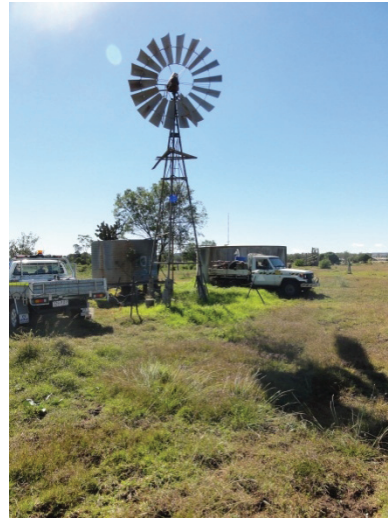
<i>Equipment condition:</i>	Appears in good condition. Windmill pipe (rising main) is old but appears to be in reasonable condition. Pump has not been pulled up since property transferred to APC, so pump condition is unknown.
<i>Comments:</i>	
Water Details	
<i>Standing water level (m bgl): (measured or anecdotal)</i>	Bore casing is open and appears possible to dip. However due to the submersible pump electrical cable winding around the windmill rising main, it is possible that the dip meter tape could get lodged. The interviewee was not aware of how the electrical cable is attached to the rising main. Due to the chance of the dipper becoming (permanently) snagged, an attempt was not made to measure the water level.
<i>Stable pumping water level (m bgl): (measured, including mins after pump on)</i>	Unknown, not measured (as described above)
<i>Water level measuring point</i>	n.a.
<i>Interviewee / owner understanding of typical SWL / PWL (m bgl):</i>	Unknown

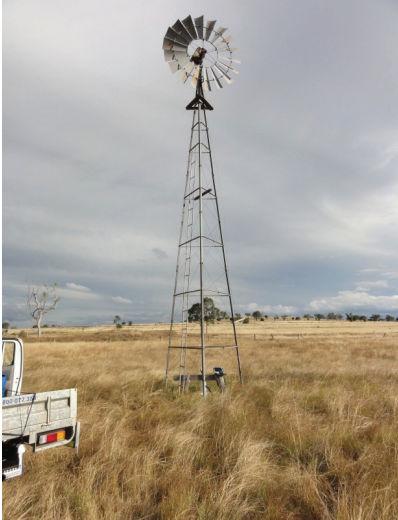
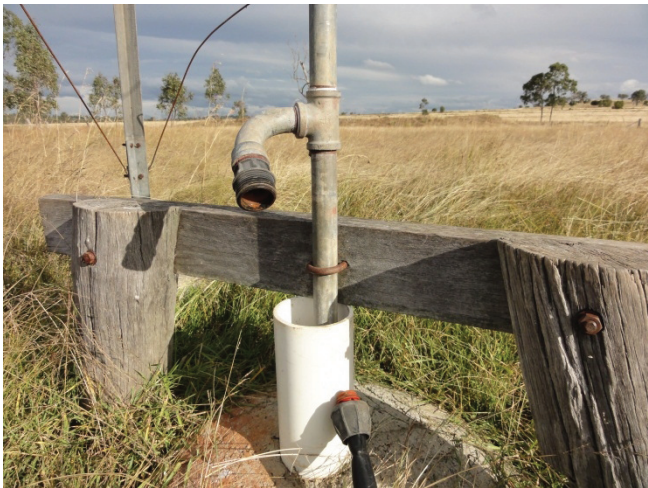
<i>Date installed:</i>	Unknown
<i>Date of most recent use</i>	Windmill is turning but not producing water.
<i>Any repairs?</i>	Unknown
<i>Pump intake depth (m bgl):</i>	Unknown
<i>Interviewee's est. annual take (ML):</i>	Zero
<i>Basis for estimate:</i>	Dam stays relatively full without this bore; has not been pumped since Ben Muirhead started with New Hope approximately 7 years ago.
<i>Is bore use metered? Give details:</i>	No
<i>Detail specific uses of the bore water:</i>	Used to supply dam
<i>Detail all other water sources for property:</i>	Dams.
<i>Typical pumping rate of bore (L/s):</i>	Unknown
<i>Does this rate vary annually or can the pump rate be varied?:</i>	Currently not working – when operational will vary with wind conditions.

<i>Typical duration and frequency of pumping: (any seasonal variations?)</i>	Currently not working – when operational will vary with wind conditions.
<i>Measured Maximum Flow Rate of Bore and Headworks at Site Visit (L/s)</i>	Pump not working
<i>Describe riser, headwork and water distribution details:</i>	PVC bore casing is set in a concrete pad. The rising main is held in place with two wooden stakes and a cross beam. The outflow from the riser connects to a black poly pipe, which transports the water to a dam approx. 150m away.
<i>Equipment condition:</i>	Windmill in good condition
<i>Comments:</i>	Bore is not used. Ben believes the pump has fallen off the end of the rising main.
Water Details	
<i>Standing water level (m bgl): (measured or anecdotal)</i>	9.88m bgl (measured 10.36m below TOC).
<i>Stable pumping water level (m bgl): (measured, including mins after pump on)</i>	n.a.
<i>Water level measuring point</i>	Top of bore casing (TOC)
