**J.12 Acland Colliery Conservation
Management Plan**

ACLAND COLLIERY CONSERVATION MANAGEMENT PLAN

*New Acland Coal Mine Stage
3 Project*

JANUARY 2014

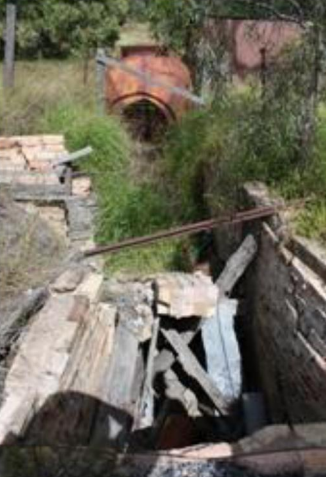
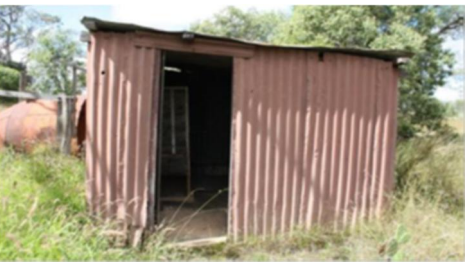
| Element # | Element Name | Brief Description | Photographs |
|---|---|--|--|
| 25 | Air Shaft / Egress Acland No. 2 | <p>Associated with the subsurface mine workings accessible via Acland No. 2 Portal, the Egress / Air Shaft No. 2 is located to the east of the site. The Air Shaft / Egress point was filled in prior to the opening of the museum in 1986 and currently features: remnant brickwork outlining the former footprint of the air shaft and egress; casing from ventilation fan; and adjacent shed for former winch operator. The Air Shaft played an important role in the function of Acland No. 2, providing vital ventilation to the underground workings as well as an egress point which was facilitated by a hundred foot timber ladder.</p> | <p>Air Shaft No. 2, showing the remnant brickwork and casing from former ventilation fan. Below: Shed.</p> |

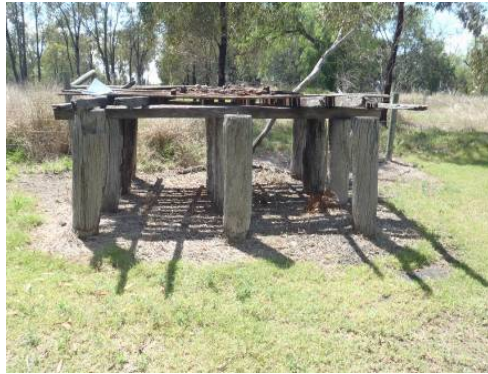
Photo 1 – Tank Stand

The tank stand remains are located adjacent to Francis Street and outside the present property boundary. The remnants are illustrated in the following photos.

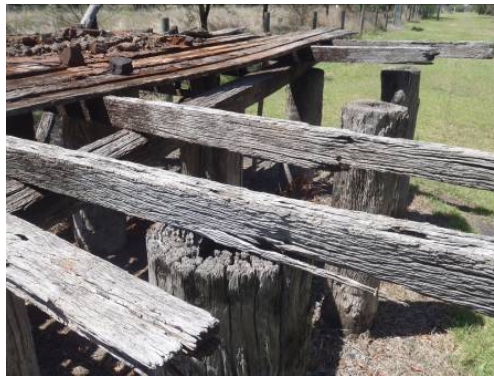
Photo 2 – Decayed Members

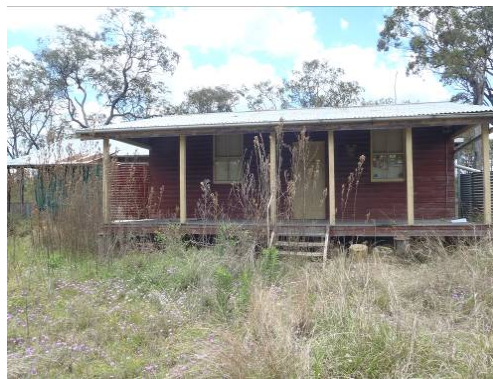
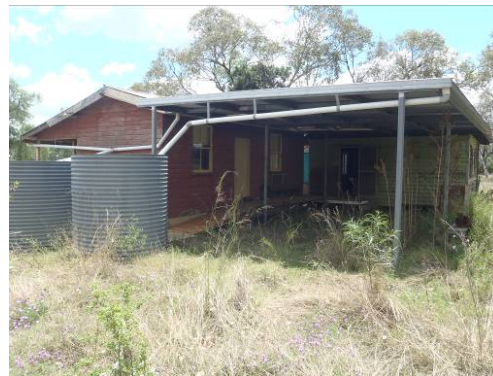
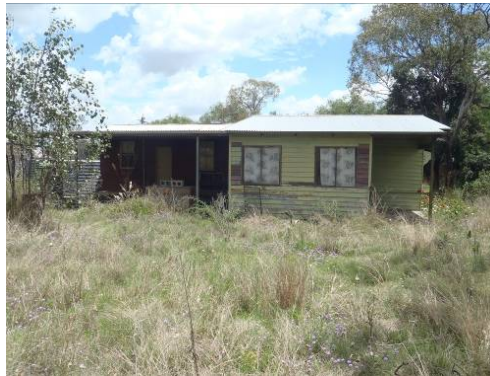
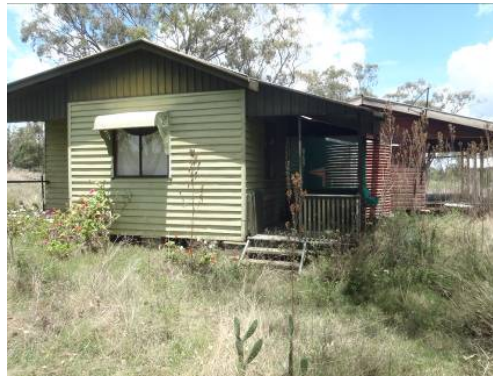
The manager's office consists of an original 2 room building with a later building added alongside. The construction is basic and consists of corrugated iron roof, timber clad external and internal, timber floor boards and timber joists on timber piers. The overall condition of the manager's office is excellent; the construction is solid with no major structural issues.

The overall structural condition of the building is excellent. There are no visual signs of distress and all members are sound.

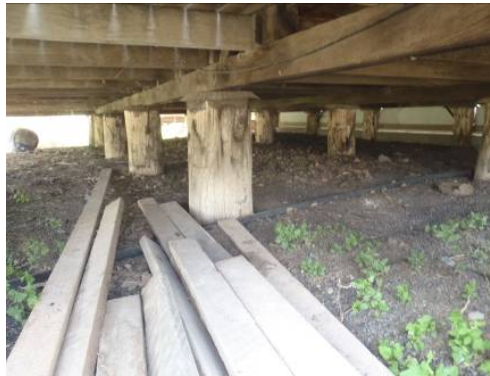
There does not appear to be any tie down of the rafters to the roof beams. There are fixings between the roof beams and posts, as well as positive fixings between floor framing and piers.

Photo 10 – Subfloor Framing and Fixings

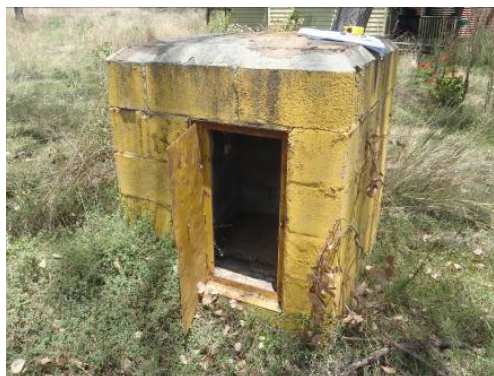
Photo 12 – Elevation of Detonator Store

The detonator store is a small structure located adjacent to the manager’s office. The structure consists of core-filled block construction with a concrete lid. The blocks are porous in construction indicating inadequate compaction. The store is 1m x 1m x 1.3m high and is painted yellow. There is a steel frame at the top of the lid which supports the concrete lid. The overall condition of the detonator store is excellent with no signs of distress. There has been cracking to one of the walls.

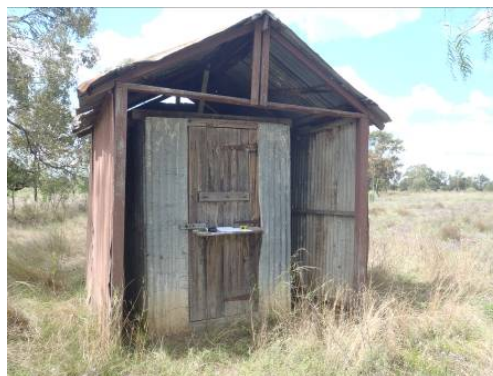
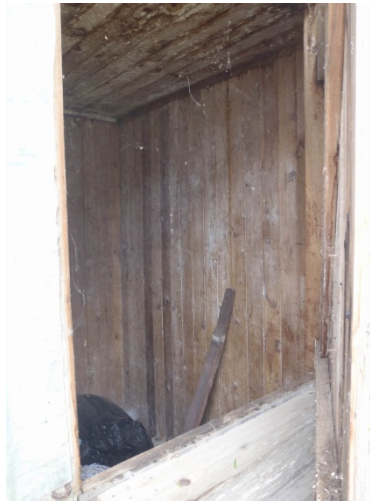
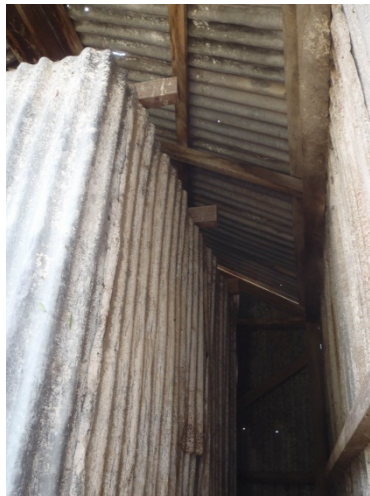
The overall structural condition of the explosive shed is sound. Several members have decay at their ends. The inner shed is leaning approximately 100mm but appears sound. The possible reason for the lean is settlement of the footings. There are signs of termite activity in the roof framing of the inner shed and decay at the base of the posts which are embedded in the ground.

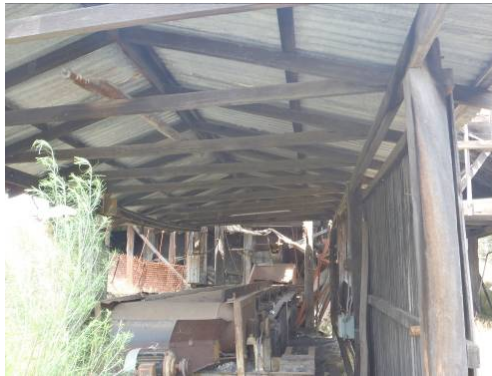
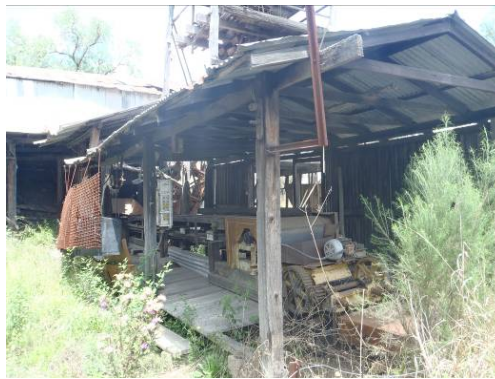
The structural condition of the picking belt shed is fair. There is considerable sag in one roof beam on the eastern side. There are positive bolt fixings of beams to posts but not for purlins or rafters. Roofing iron sheets are loose.

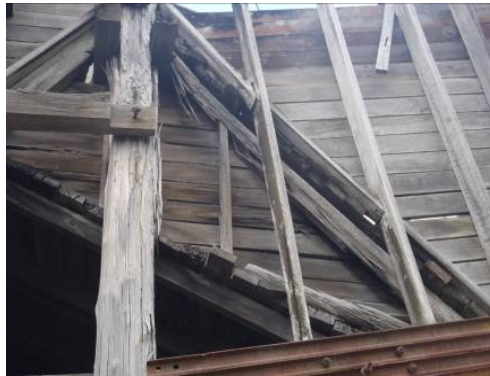
Photos 33 – Hopper Framing

The hopper is a timber coal storage bin supported on large timber joists, two of which are cracked as are two supporting bearers and a pole. Exposed timbers are more weathered and decayed than internal protected timbers but the majority of the structural members are in fair to good condition. Generally the framing of the hopper itself is good. With replacement of the damaged or decayed support members the hopper could be returned to a satisfactory structural condition.

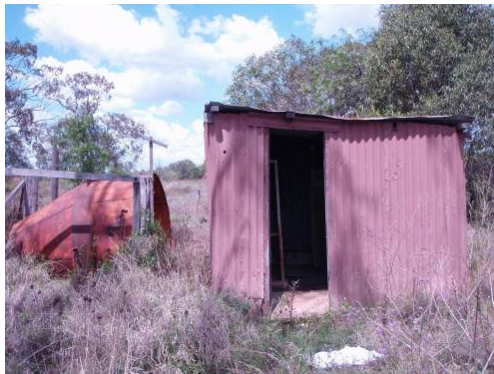
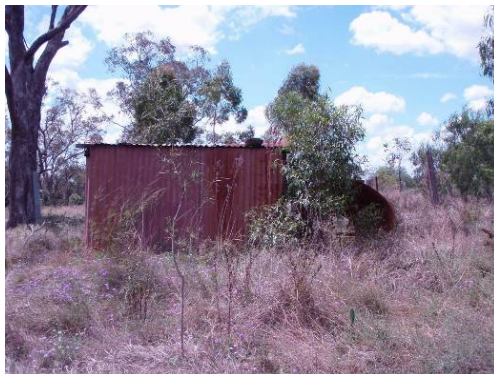
The air shaft comprises brick lined and timber shored shafts that have been partially filled in, a steel fan cowl, and a timber and iron shed. The timber of the shed show signs of severe termite decay. The air shafts have collapsed brick walls and shoring.

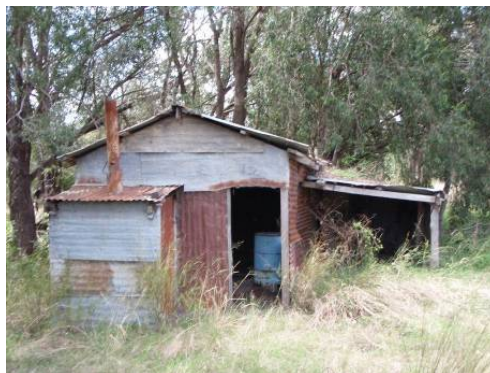
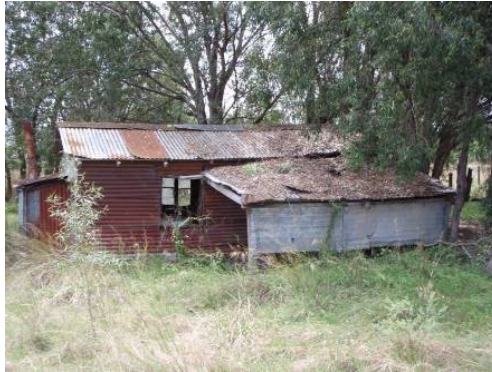
Internal timbers show signs of severe termite attack. Several studs are broken.

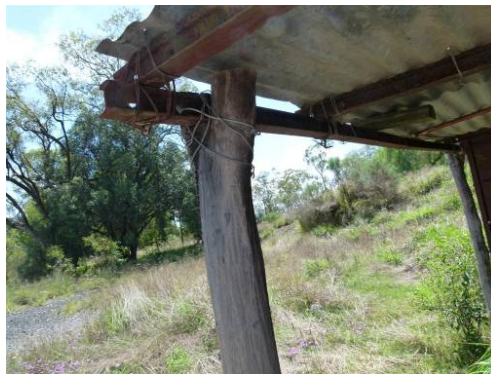
Photo 66 – Awning Rail Track Beam to Post Fixing

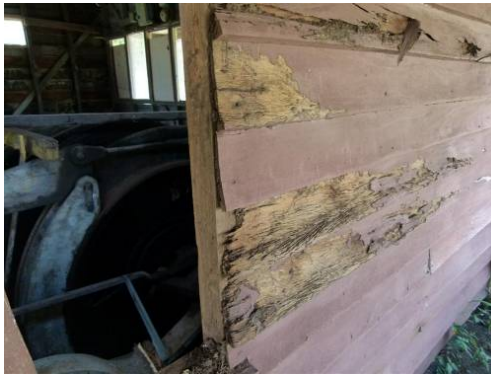
Photo 67 – Severe Termite Attack to Weather Boards

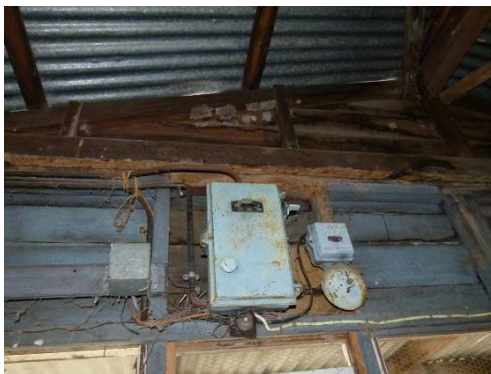
Photo 68 – Termite Attack to Underside of Roof Members

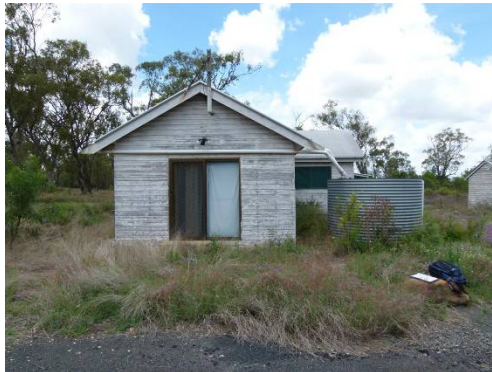
Photo 70 – North Elevation

The overall condition of the former bathroom block is fair to good. The construction is solid with no major structural issues. There appears to be a slight weathering of timber cladding but no apparent termite attack.

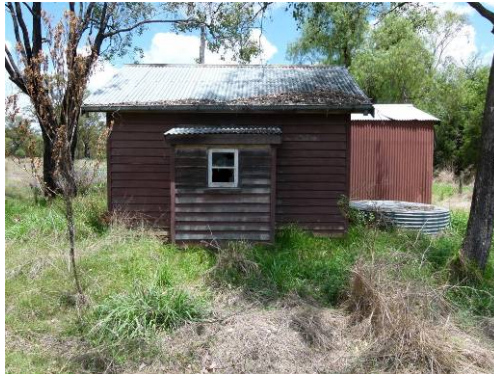
Photo 75 – North Elevation

The Leccy shed is in fair structural condition. The construction is solid with some termite attack to minor structural components.

| Building | Description of works | Priority |
|---|--|---|
| Leccy Shed | Replace termite affected members | 3 |

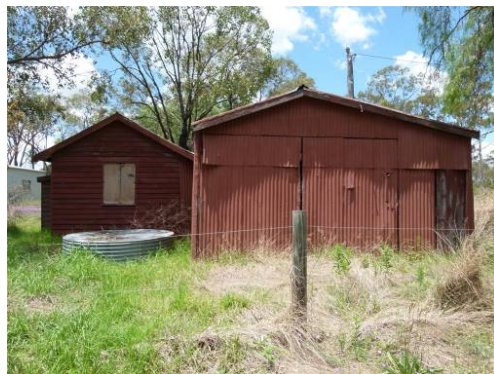
Photo 76 – West Elevation

The Workshop is in poor structural condition. The steel framing members are in a fair condition however the timber members are completely termite ridden and / or missing. Some roof sheeting is hanging precariously due to the missing timber battens or has collapsed. This structure may partially collapse within the next 5 years if repairs are not undertaken.

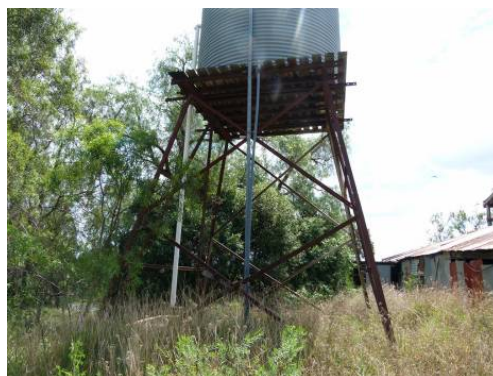
Photo 82 – East Elevation

Overall the Water Tank is in poor to fair condition. Bracing components are rusted through and require repair. Repairs are required within 5 years or structural failure may occur due to bracing section loss on northern side of structure.

- Pit Head and Gantry – replacement of decayed members, substantial temporary works will be required to make this structure safe.
- Tank stand adjacent to the Managers Office – replacement of decayed members
- Water Tank – replacement of corroded bracing
- Air Shaft No. 2 - completion of filling in air shafts to ground level

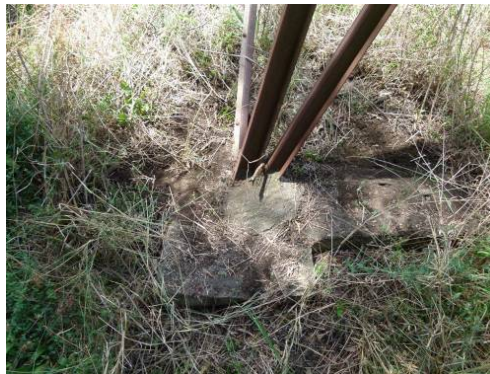
Photo 83 – Concrete Foundation of Water Tank 500 X 500mm

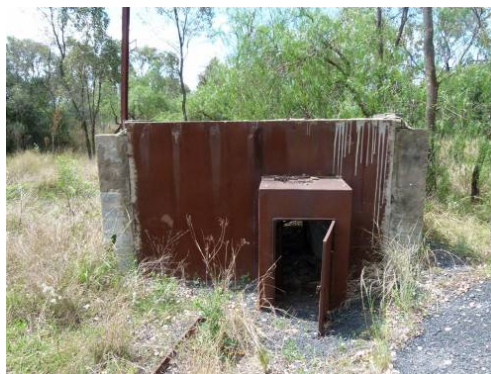
Photo 115 – South Elevation

The structure has been deemed unsafe to enter.

Concrete block wall construction with concrete roof. Shafts filled in with rubble. Walls cracked and leaning in unstable condition.

Additional temporary propping is recommended to the side walls to prevent collapse of the shaft.

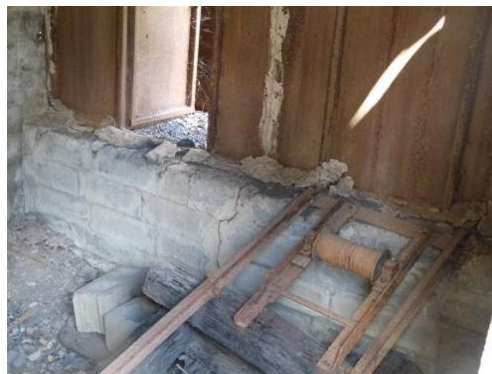
Photo 122 – Railway Tracks inside Structure
