# BENGALLA MINE ANNUAL REVIEW 2023

**BENGALLA MINING COMPANY PTY LIMITED**  
LOCKED BAG 5  
MUSWELLBROOK NSW 2333

March 2024

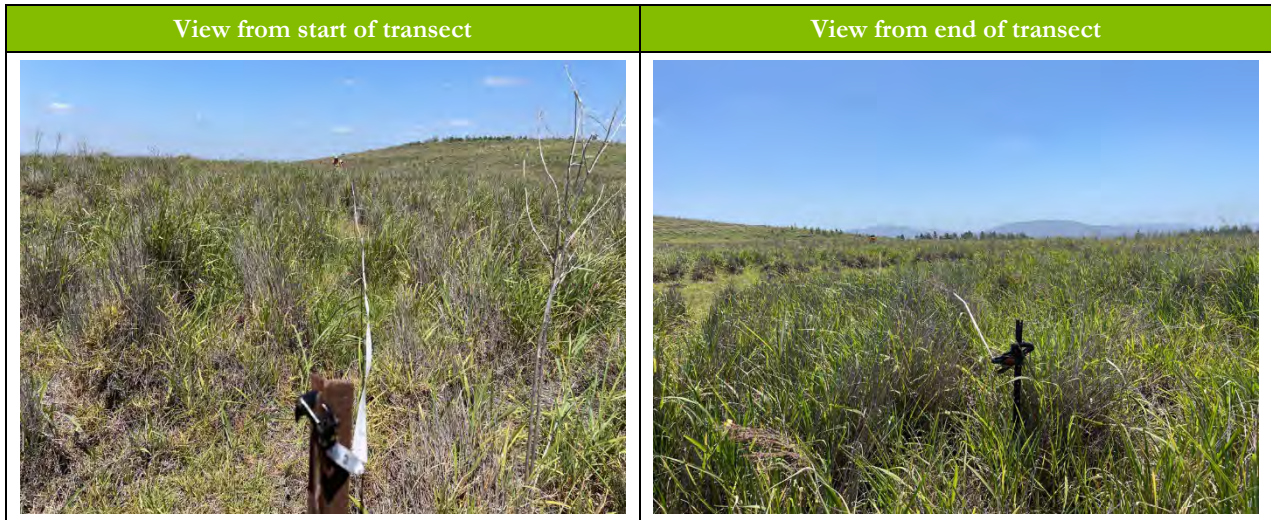
### Monitoring Site: P3

Pasture composition recorded in P3 in 2023 showed considerable change from last year. A total of nine species were recorded which comprised only two desirable pasture species (two grasses), three non-invasive exotic forbs and two priority weeds. Pasture composition in PR4 in 2023 recorded a total of nine species including three desirable pasture species (as per the RMP) and six exotic species.

No increasing trends in feral pest populations and species diversity	Rabbit digging and pellets were observed in P3.	No

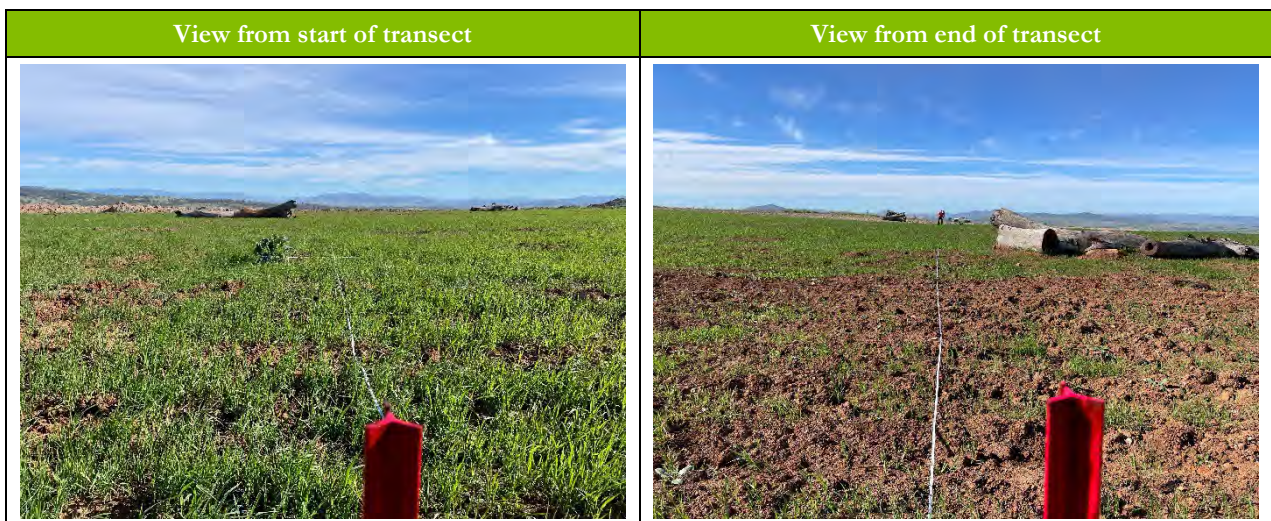
### Monitoring Site: PR4

As in 2022, *Urochloa panicoides* (Liverseed grass) was not recorded at P3 however a small amount was recorded in PR4 (0.1% cover) and has been observed at other locations throughout the project site. Liverseed grass has the potential to cause nitrate poisoning to sheep and cattle though it is not likely to be hazardous under normal conditions. Liverseed grass can be toxic if large amounts of nitrate are accumulated in the plant, especially to animals under stress. The species is an annual grass with strong seed dormancy which typically germinates and establishes in a single flush following rain (Walker et al, non-dated); it is therefore likely that a viable seed load of the species occurs in the soil.

A new unclassified pasture plot was established in Zone 8 during 2023. The herbage biomass target in 2023 is approximately ~1,170 kg DM/ha. The result for biomass achieved in Zone 8 (**Graph 7 & Graph 8**) are consistent with the area being direct seeded in December 2023, one month prior to sample collection, and is currently within the establishment phase. Since this is the first year of data collection no comparisons are available currently.

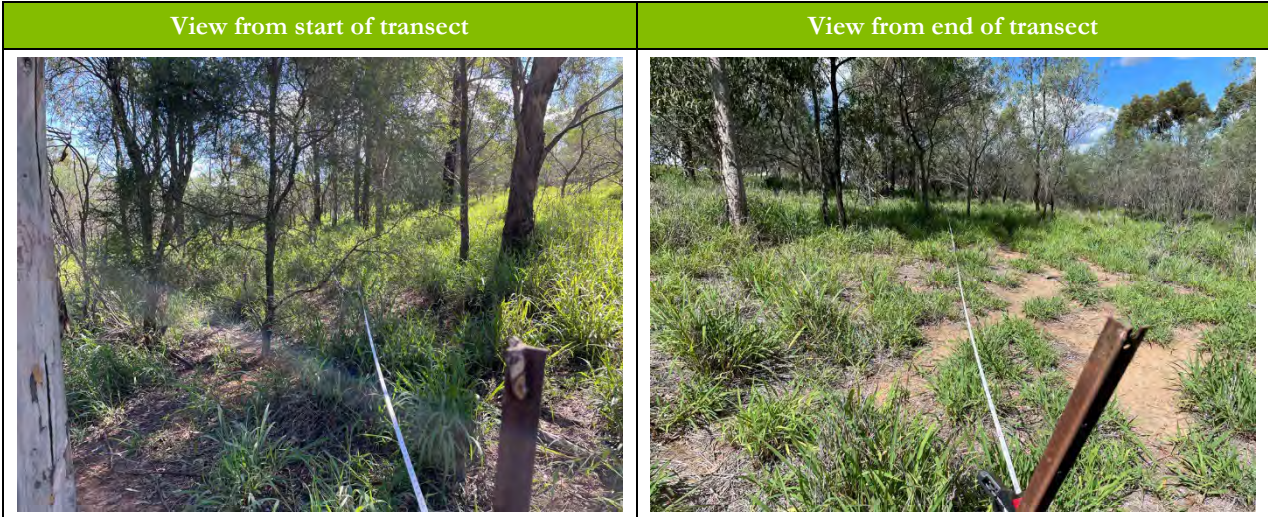
### Monitoring Site: HDWV01

Consistent with 2022, active natural tree regeneration (i.e. recruitment of second-generation tree seedlings) was observed at six of the eleven historic sites. Furthermore, most recruitment consisted of *Acacia salicina* (Cooba) seedlings with only two other *Acacia* species being recorded namely *Acacia ligulata* and *Acacia linifolia* saplings occurring at HDWV06 and HDWV11 respectively. Only one site (HDWV01) recorded young saplings of canopy eucalypt species.

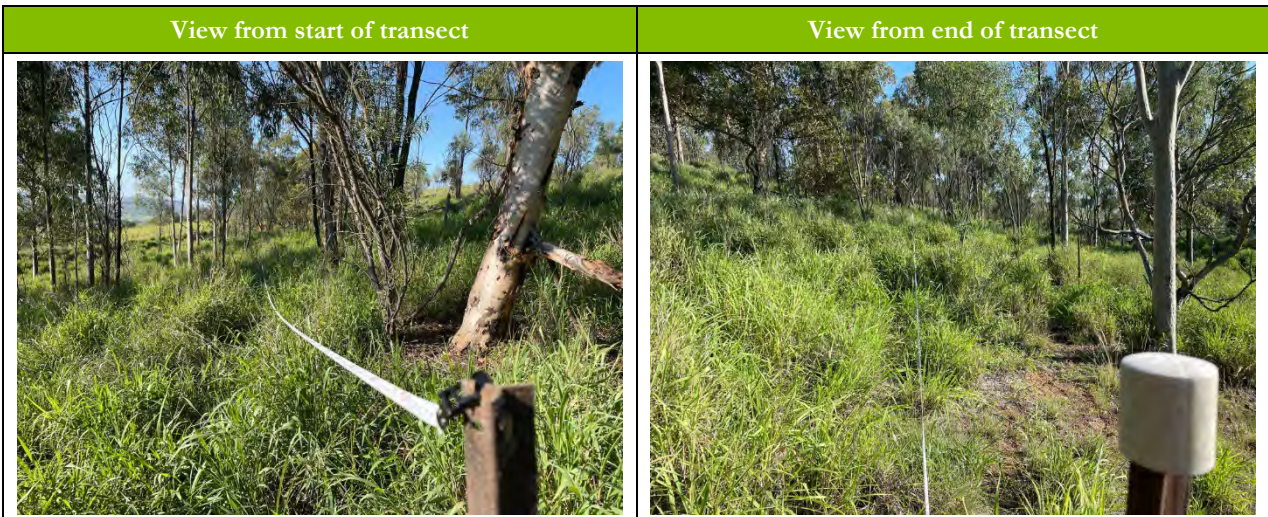
**Monitoring Site: HDWV02**

Total stem densities recorded in 2023 ranged from 100 stems/ha at HDWV06 to 620 stems/ha at HDWV02, with an average of ~402 stems/ha which is marginally above the defined target benchmark of 400 stem/ha.

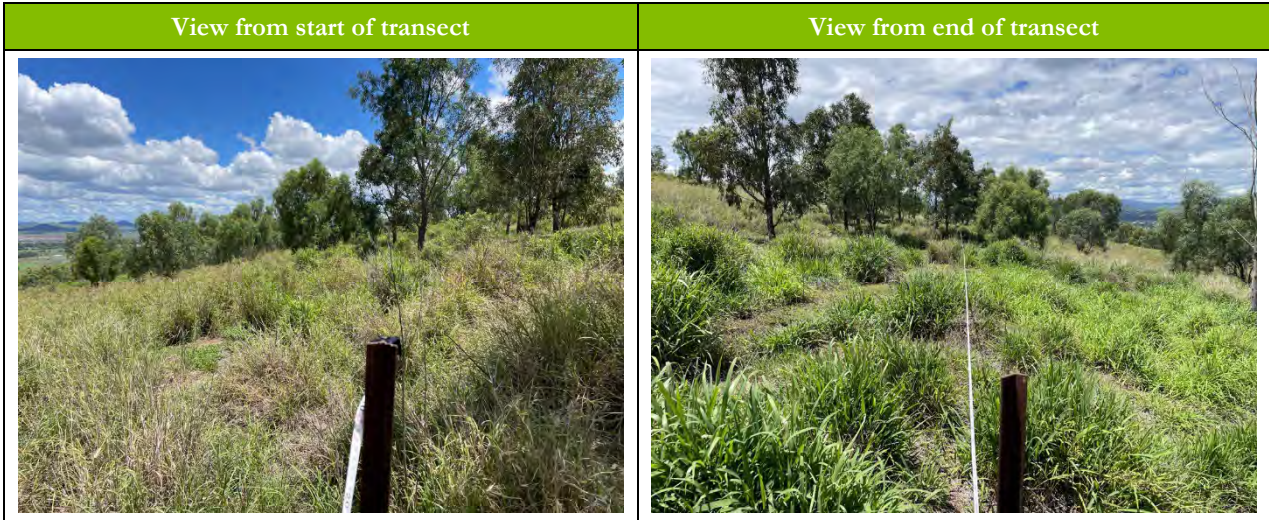
**Monitoring Site: HDWV04**

Acacia species continue to dominate the stem count at all but two monitoring sites (HDWV01 and HDWV02) total stem counts continue to be largely comprised of *Acacia salicina* (Cooba) and not preferred long-lived canopy eucalypt species. As mentioned in the 2022 report, this is not a satisfactory outcome as the species is shorter-lived (~50 years) and will unlikely provide adequate vegetation structure and complexity in the long-term. Supplementary infill tree plantings should be undertaken in other locations, particularly HDWV 04, 06, 07 and 10 to establish eucalypt species commensurate with CHGBIW and CHSGIGBF.

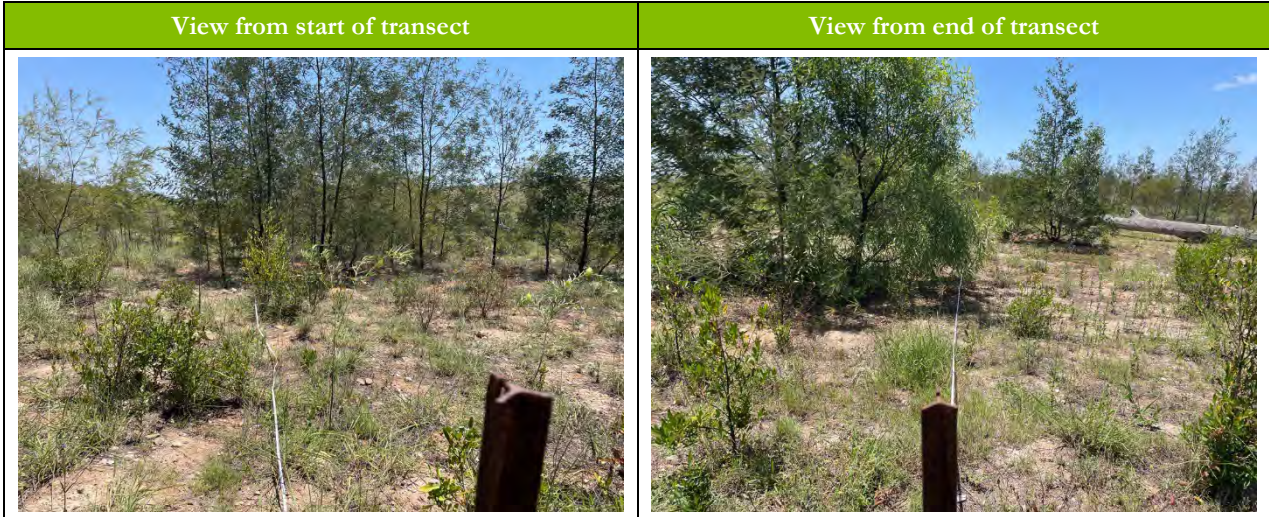
**Monitoring Site: HDWV18**

Of note, HDWV18 made a remarkable recovery from the 2022 drop largely due to a flush in Hopbush germination.

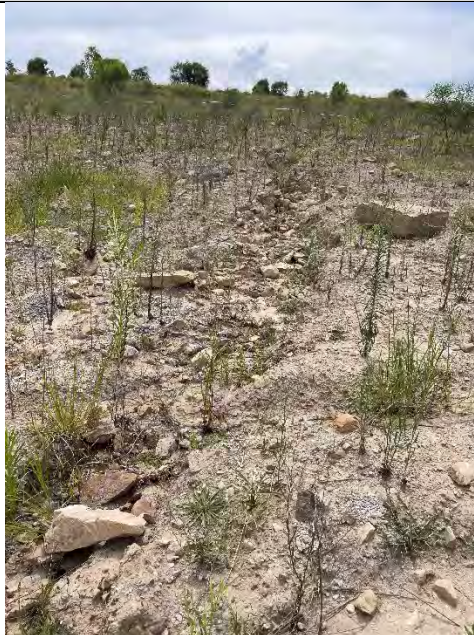
**Photo 2 – Example of stabilising Moderate rill erosion in in Zone 2**

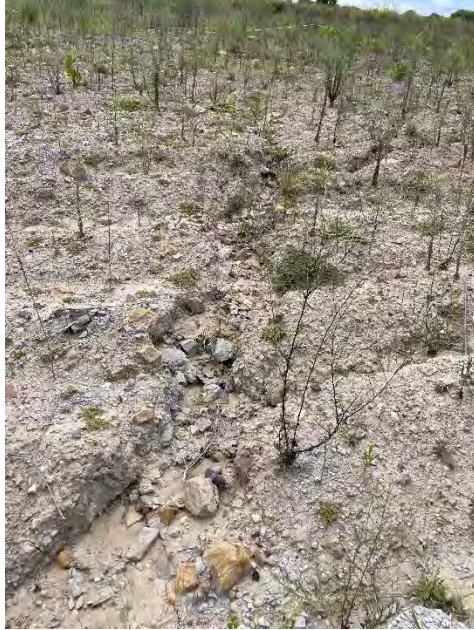
**Photo 3 – Moderate rill erosion in Zone 2**

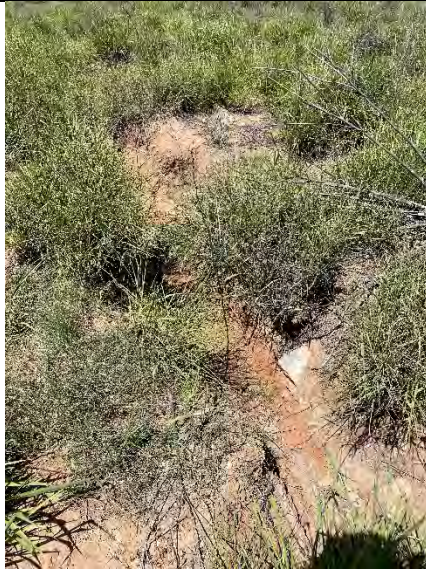
**Photo 4 – Example of Gully erosion**

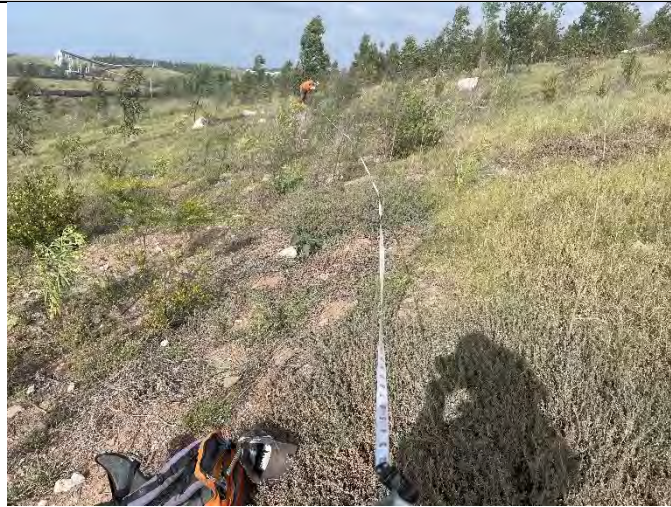
Erosion - slumping	Localised slumping was recorded in Zone 1 near HDWV36 at the location of tunnel erosion where the area around older tunnels had collapsed and slumped.	Photo 1	2
Weeds – Galenia	Galenia has been suppressed as evidenced by control efforts leaving large patches of dead plant material over obvious previous infestations. However, although survey results show a reduced cover in monitoring plots, it remains prevalent and widely distributed across the entire site including severe infestations and localised patches scattered throughout.	Photo 5 and 7	2

**Photo 5 – Example of weed infestation along transect line, not presenting in the surrounding area in Zone 2**

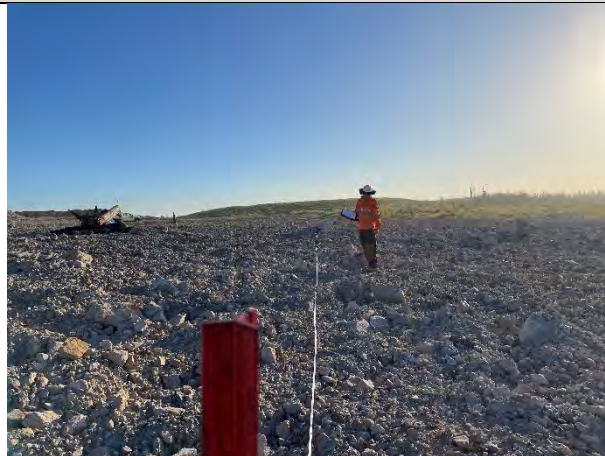
**Photo 6 – Example of log piles**

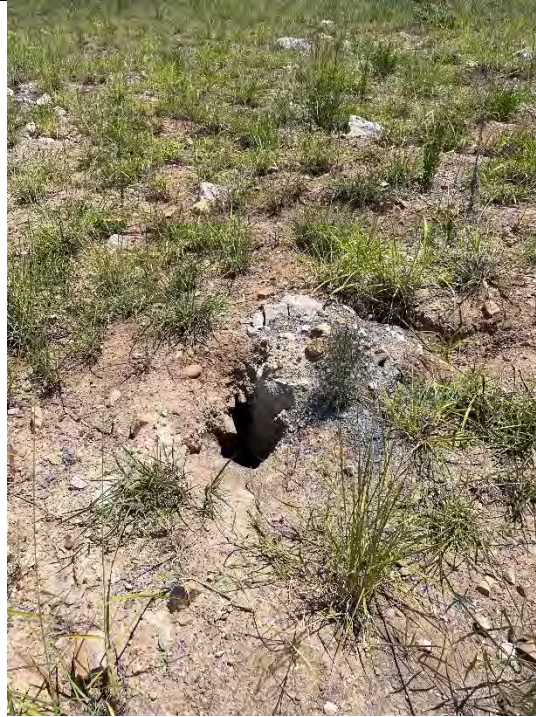
Habitat augmentation	Fourteen artificial habitat features (log piles) were created in 2023 in the newly created Zone 8. These have been mapped in Figure 3. In their current configuration they are more likely to harbour vertebrate pests such as rabbits and foxes and regular monitoring should be undertaken to determine if targeted pest control is required.	Photo 6	4
Animal pests	Although no vertebrate pest animals were sighted, rabbit and feral pig sign such as diggings and scats were recorded at low abundance in the rehabilitation areas during the 2023 surveys. Pigs are difficult to control as they travel great distances daily unless there is a constant resource and opportunistic observations should be mapped to check if numbers may be increasing. Evidence of rabbits occurred in and around the pasture areas though no warrens were discovered. Nocturnal transect spotlight surveys are recommended to establish a baseline count to better understand rabbit abundance going forward..	Photo 7	3

**Photo 7 – Example of animal diggings (possible wombat) in Zone 2**

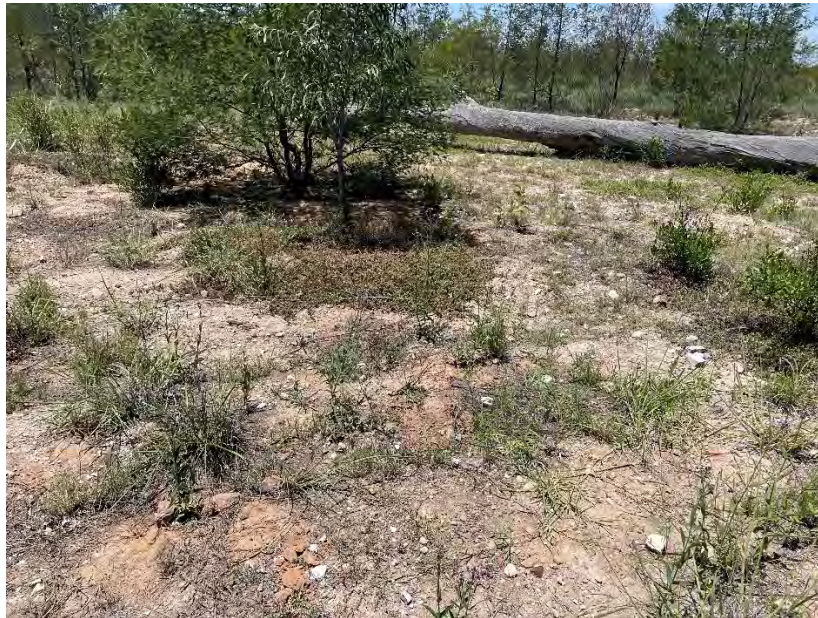
**Photo 8 – Example of bare area in Zone 4B**

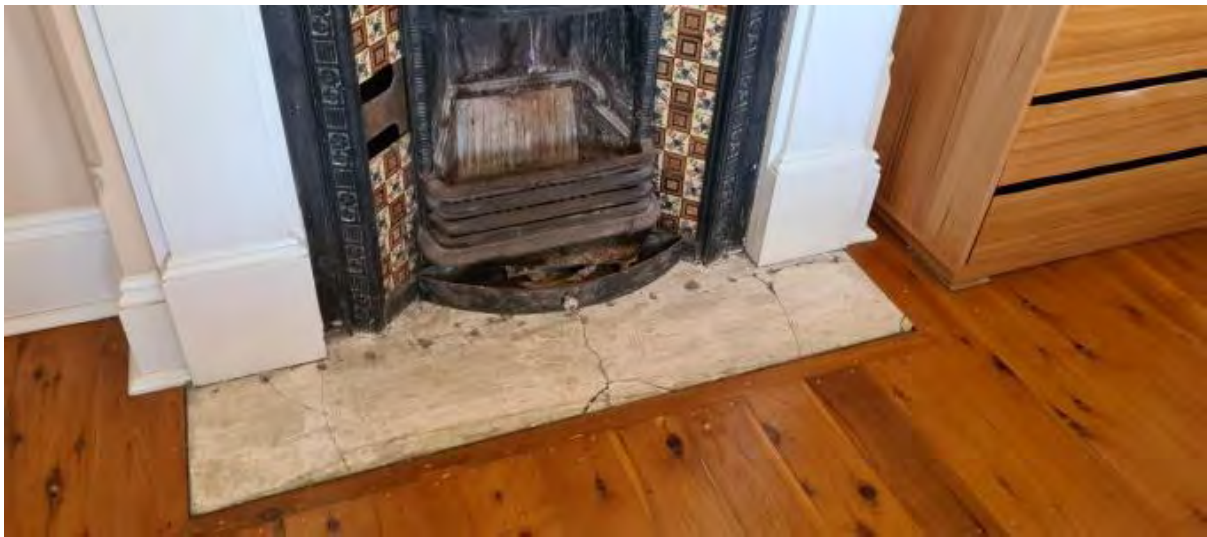
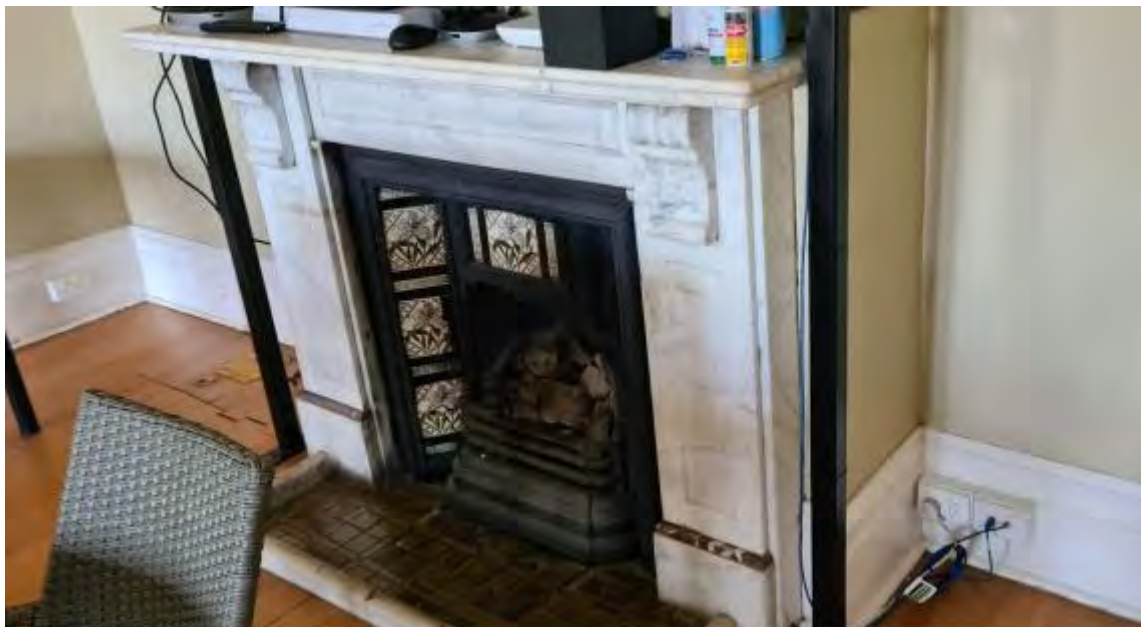
Internal views of fire places

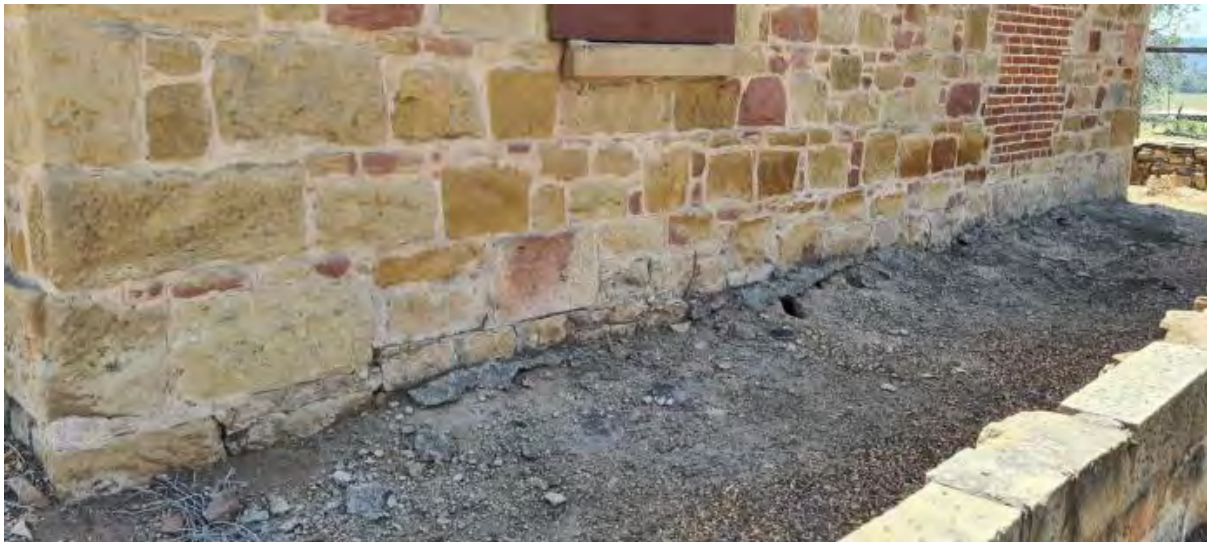
External view of exposed verandah area

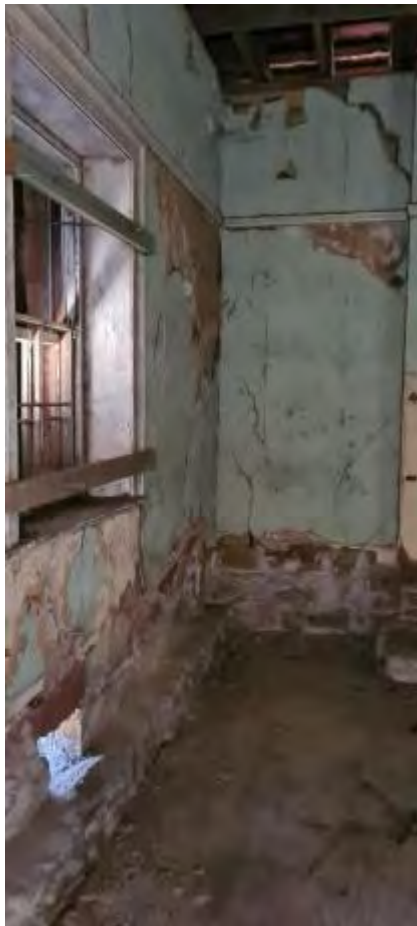
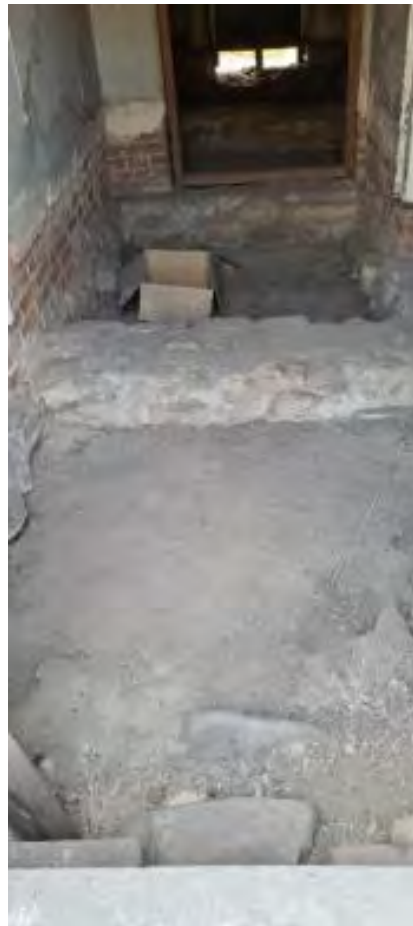
Internal views of Overdene Cottage
