BENGALLA MINE ANNUAL REVIEW 2019

BENGALLA

MARCH 2020

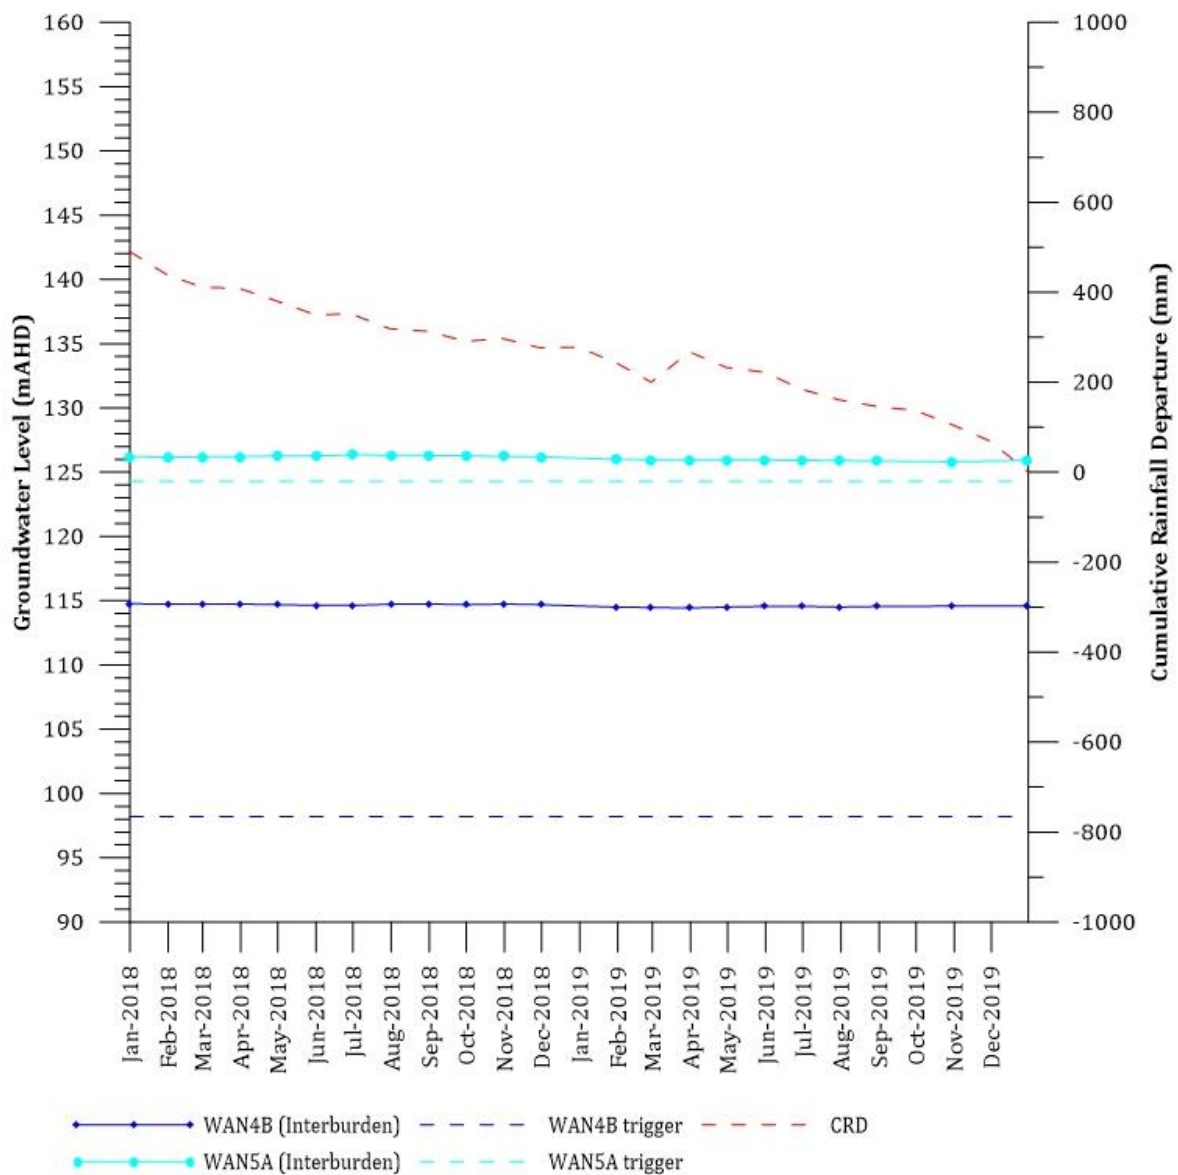
Figure 6.5 Hydrographs of deep Permian monitoring bores

Figure 6.5 and Figure 6.6 show the groundwater levels for the Permian monitoring bores (WAN4B, WAN5A, and WAN1B). Key observations can be summarised as follows:

- Groundwater levels in WAN4B and WAN5A have remained relatively stable in 2019, despite below average rainfall.

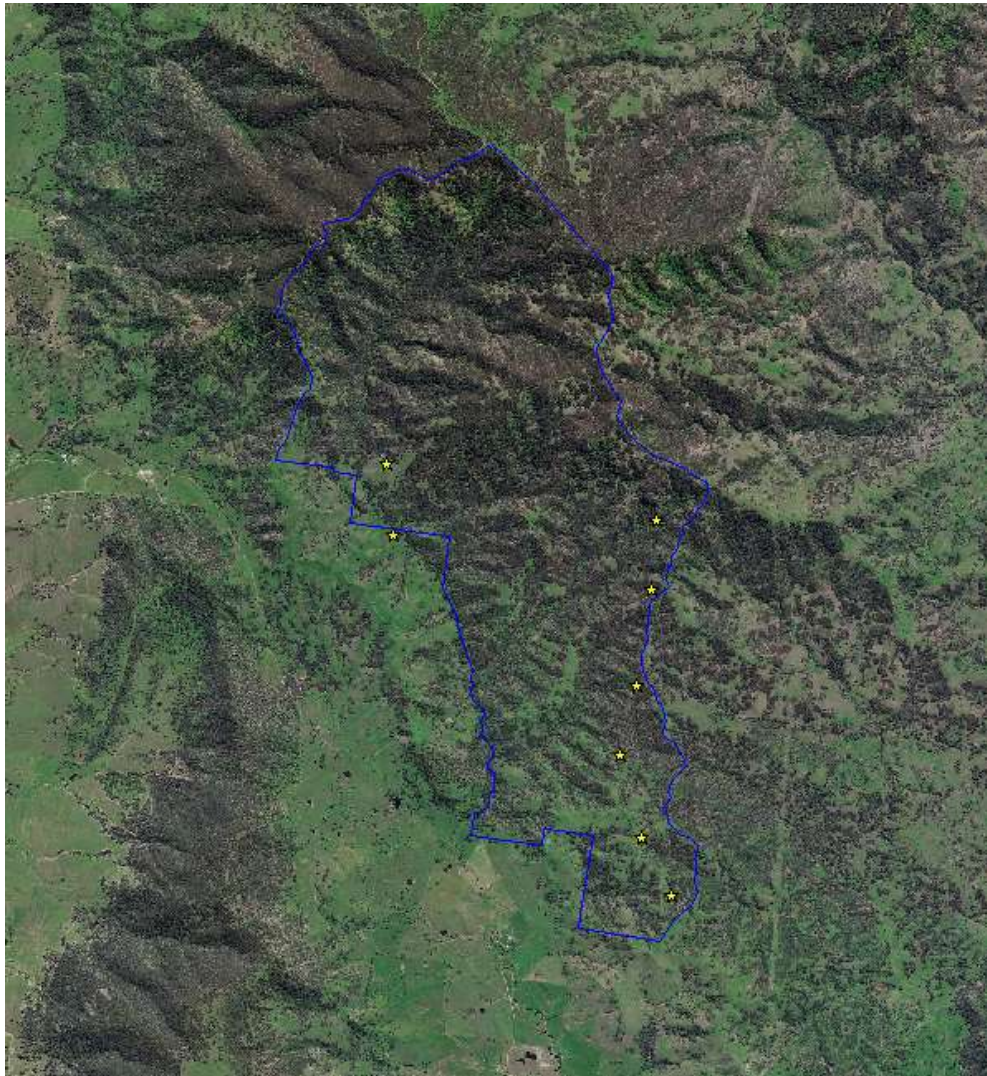
Figure 1: Black Mountain Weed Management Locations 2019

Application was primarily via vehicle mounted spray rigs however backpacks were also used in some areas.

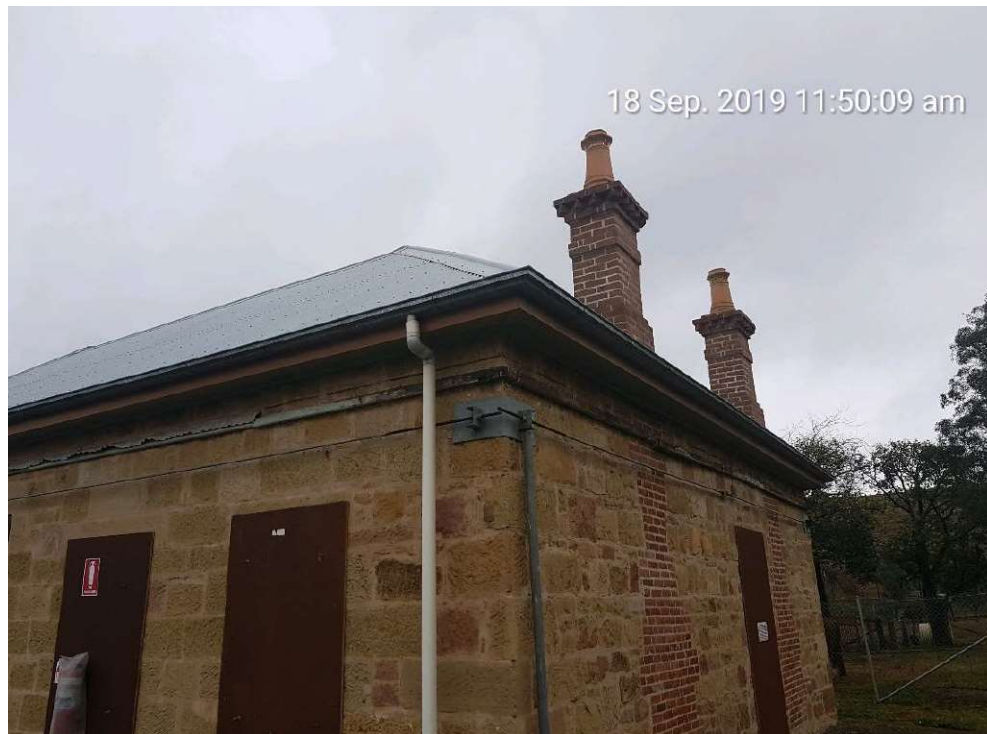
Figure 12: Overdene Homestead September 2019

The replacement of the roof sheeting and diversion of stormwater away from the building appeared to be successful and the previous restoration of the sandstone and brickwork appeared to be stable.

The remaining outstanding items for the external part of the building included the replacement of missing pipe props from the tie rod ends to assist in continually stabilising the structure.

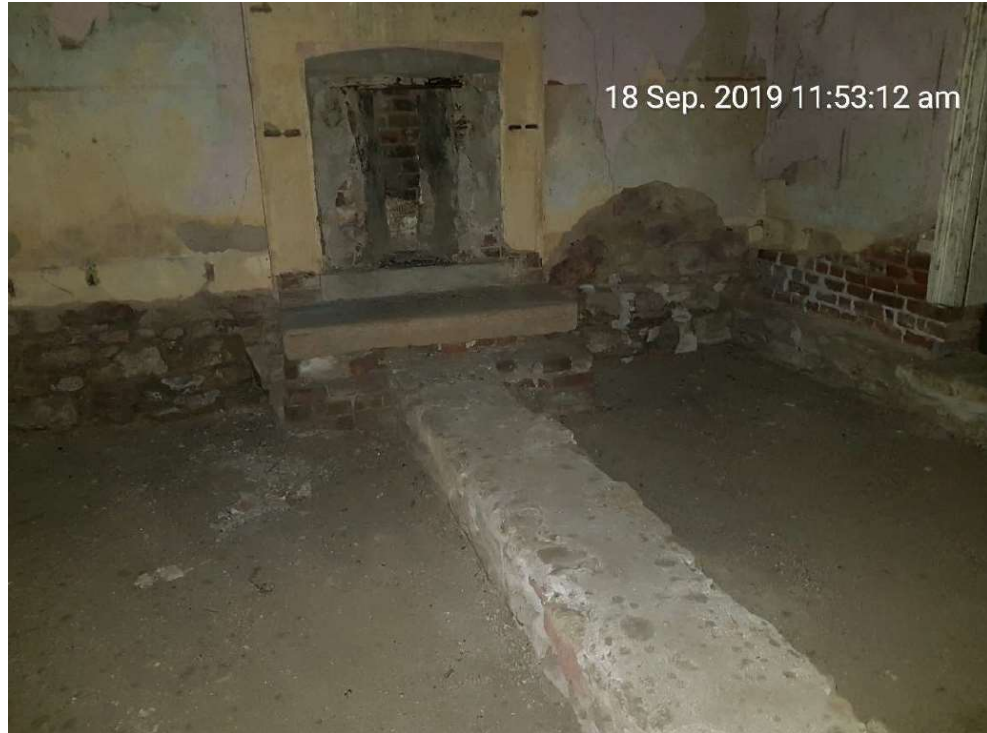
Figure 13: Inside Overdene Homestead September 2019

Internally, the condition of the cottage appeared to be stable. Installation of a new floor system, restoration of windows, doors and internal walls was still outstanding.
