BENGALLA MINE ANNUAL REVIEW 2022

BENGALLA MINING COMPANY PTY LIMITED
LOCKED BAG 5
MUSWELLBROOK NSW 2333

April 2023

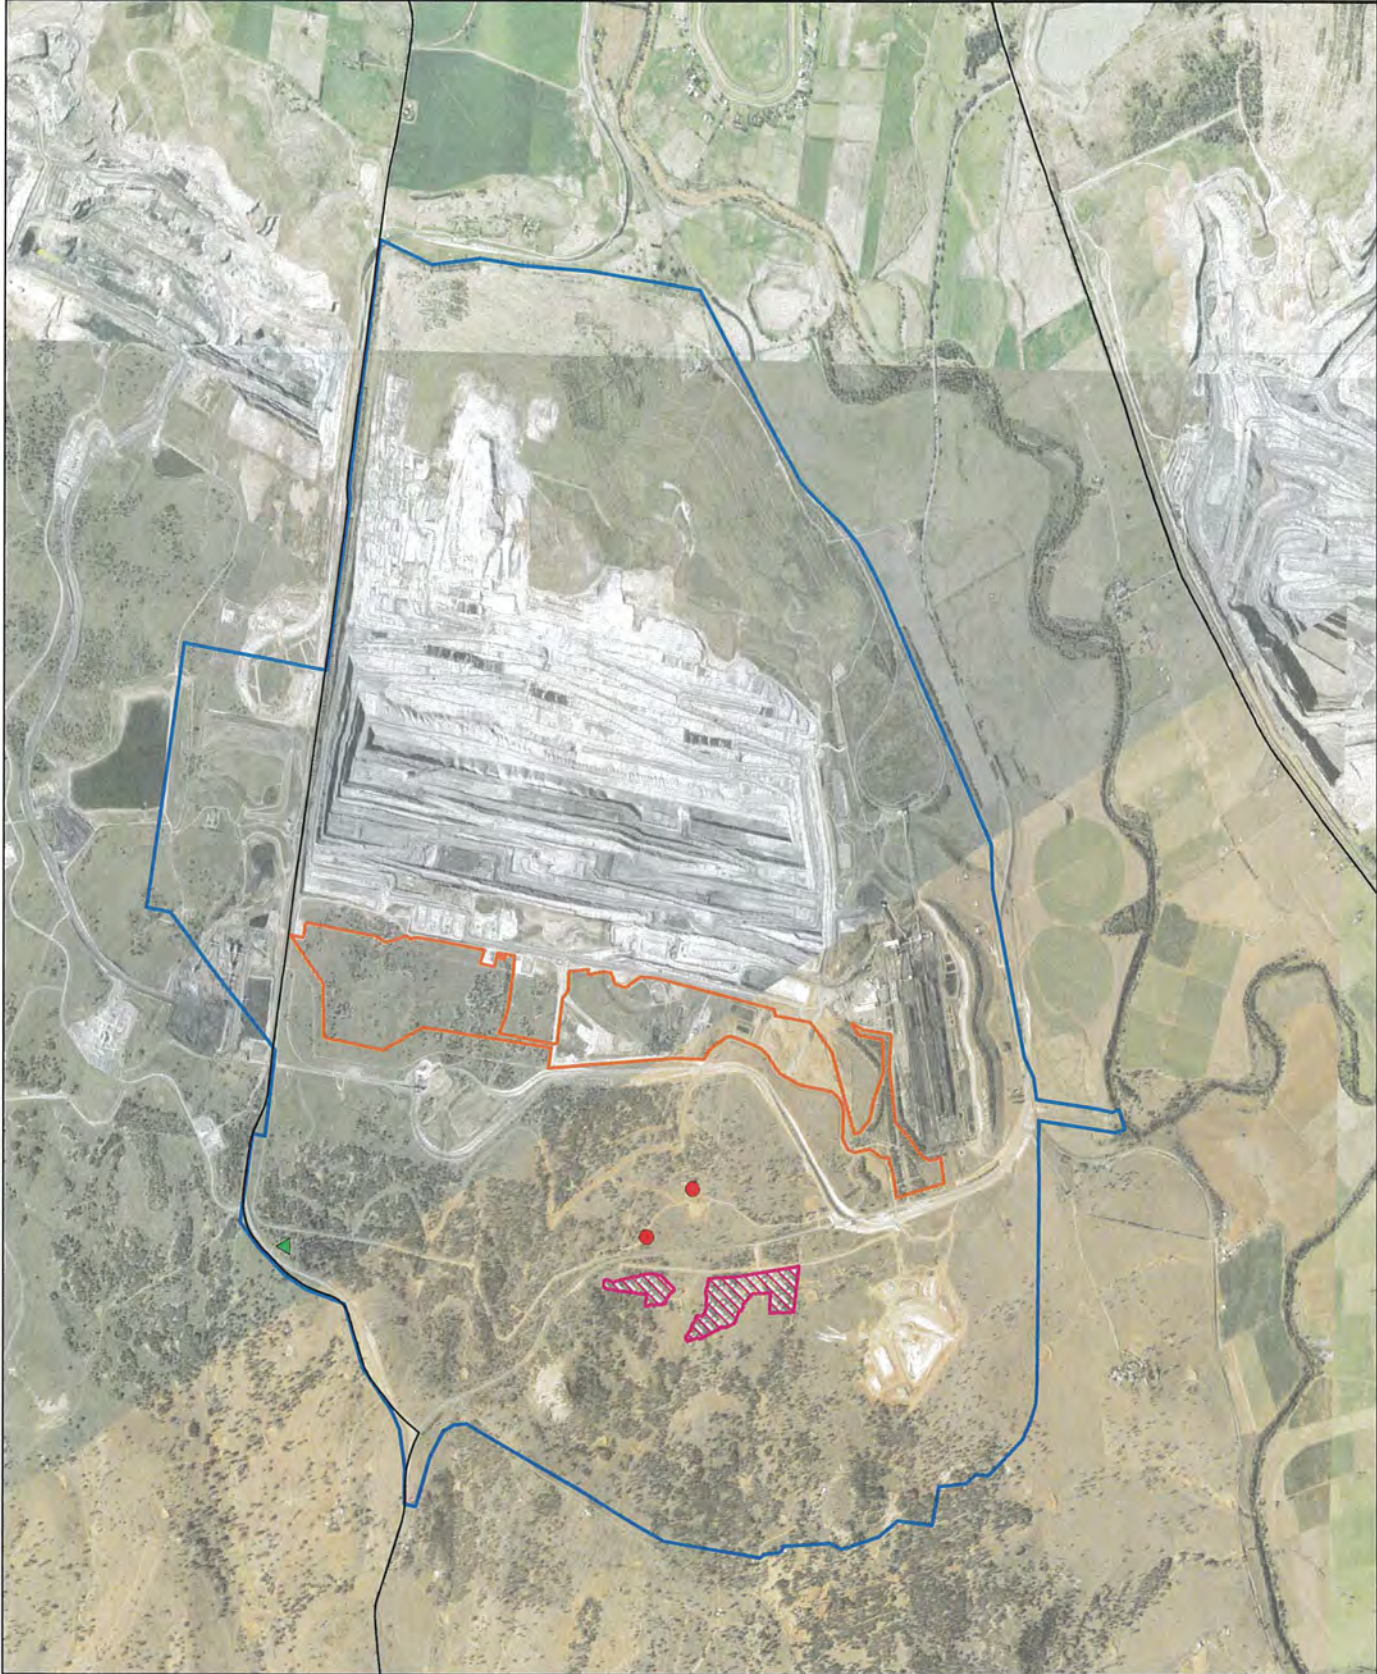
Figure 3.1
Ground disturbance permit areas subject
to clearing activities in 2022

- Legend**
- Cymbidium Translocation Site
 - Relocation Points
 - Road
 - Fauna Relocation Site
 - Project Development Boundary
 - GDP2201

Sites suitable for the relocation of displaced native fauna were assessed prior to the commencement of the ecology pre-clearance survey. Relocation sites were assessed for habitat attributes which represent similar or commensurate habitat attributes as those within the clearing areas. All relocation sites are located outside of the clearing area and consist of the same vegetation community. Fauna relocation sites are illustrated on Figure 3.1.

Pre-clearing surveys completed by or on behalf of BMC in 2022 are summarised in Table 3.1 and illustrated in Figure 3.1. It should be noted that throughout 2022, the GDP area was assessed on more than one occasion due to only part of the GDP area being disturbed, or an extended time frame between the initial pre-clearance inspection and commencement of works.

The GDP area cleared in part in 2022 is summarised in Table 3.3 and illustrated on Figure 3.1. The removal of understory vegetation surrounding habitat trees was undertaken a minimum of 24 hours prior to habitat tree removal. Stage 2 clearing of habitat trees was undertaken over eight discrete periods in 2022, with a total of 207 habitat trees felled.

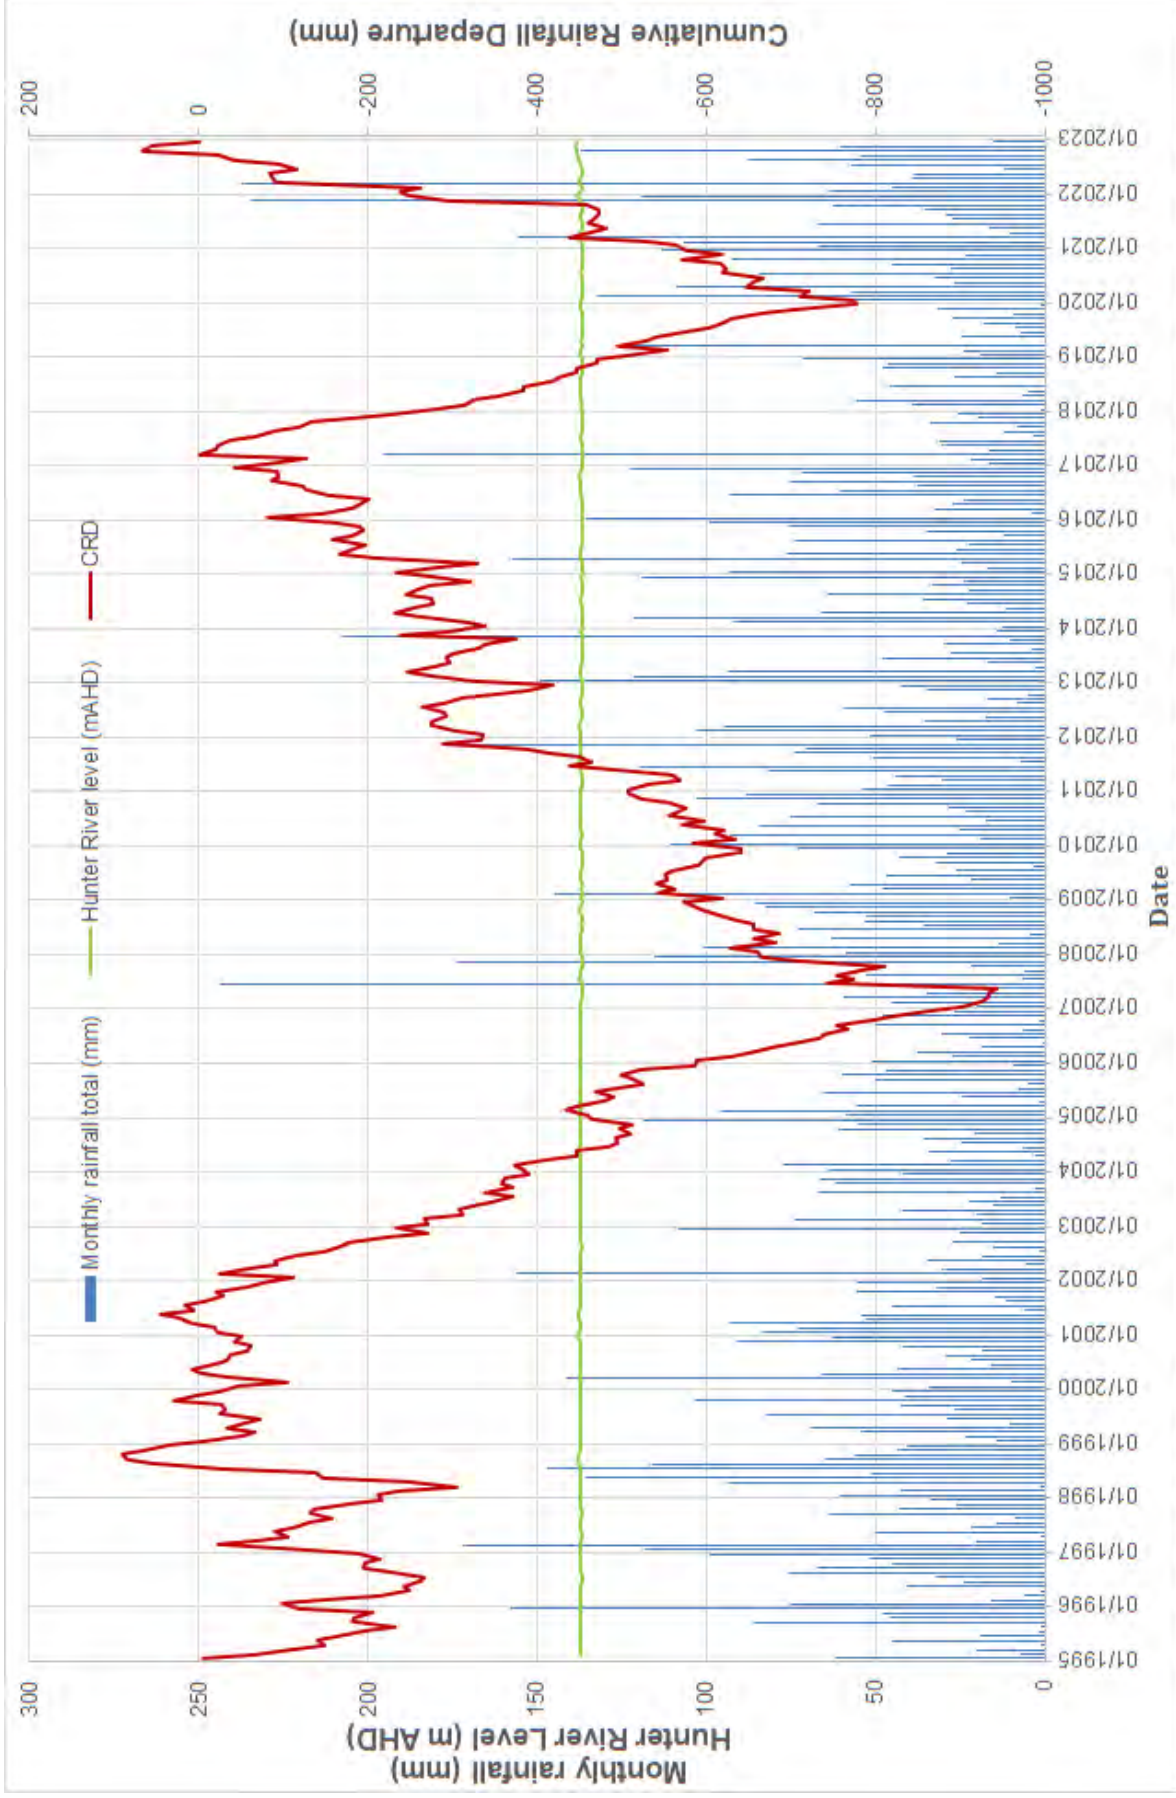
Figure 2.1 Cumulative rainfall departure (1995 to 2022) for Bengalla weather monitoring station

Historical rainfall was contextualised using the Cumulative Rainfall Departure (CRD) method (Figure 2.1). This method is a summation of the monthly departure of rainfall from the long-term average monthly rainfall. A rising trend in the CRD plot indicates periods of above average rainfall, whilst a falling slope indicates periods when rainfall is below average. The Hunter River water level was also plotted with rainfall (Figure 2.1) using data from the Muswellbrook Bridge monitoring station (210002), which is located approximately 5 km up-stream of Bengalla.

The CRD (Figure 2.1) has displayed an increasing trend throughout 2021 and 2022, following drought conditions from early 2017 to late 2019. The Hunter River water level data indicates that, whilst periods of higher rainfall correlate with elevated river levels, the Hunter River generally displays relatively stable water levels due to being regulated by the Glenbawn Dam.

Generally, the Hunter River level is above the water table in the Hunter River alluvium, and near Bengalla the river is losing water to the alluvium. The level of the Hunter River is relatively constant under normal conditions due to the regulation of water discharge from Glenbawn Dam (refer Figure 2.1).

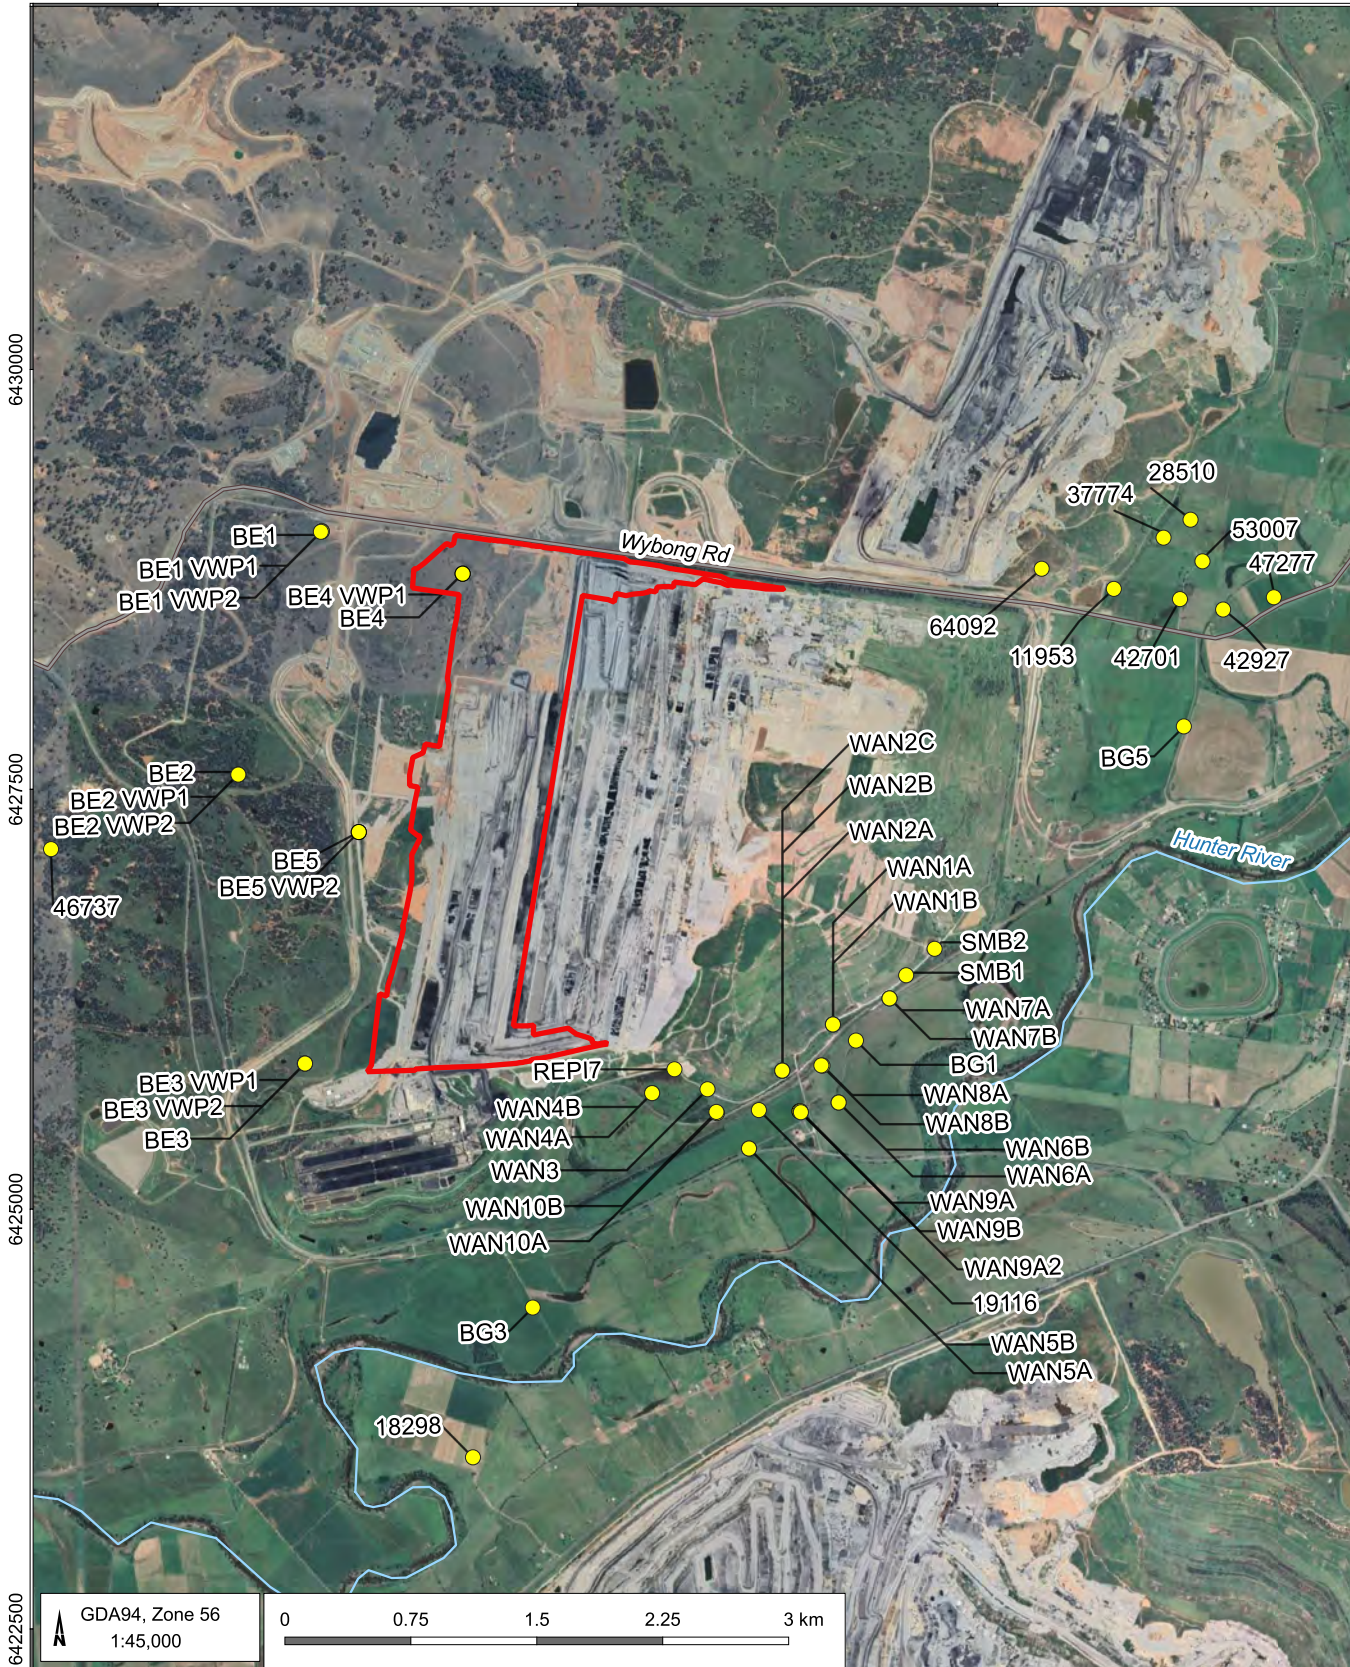
BMC has established a groundwater monitoring network around Bengalla with data from 1992 onwards. Table 4.1 summarises the monitoring bore network and the Vibrating Wire Piezometer (VWP) locations. Figure 4.1 shows the bore and VWP locations. The following text provides a chronological summation of monitoring bore network upgrades.

WAN4A/B is located closer to the pit than WAN5A/B and WAN6A/B (Figure 4.1). WAN5A/B and WAN6A/B have coal seam/interburden and alluvium water levels at similar elevations to each other (Figure 6.10 and Figure 6.11), whereas those from WAN4A/B are separated by >10 m (Figure 6.9). This suggests that either the water levels in the interburden and Edderton Seam at WAN5A/B and WAN6A/B show minimal response to mining (refer Figure 6.10 and Figure 6.11), or that the rate of recharge from the alluvium to the interburden is greater than the rate of seepage to the pit at this location. In December 2021, WAN5A and WAN6A/B groundwater levels increased significantly in response to rainfall recharge. WAN5B was unblocked in October 2022 and sampling resumed after being damaged by cattle in September 2020.

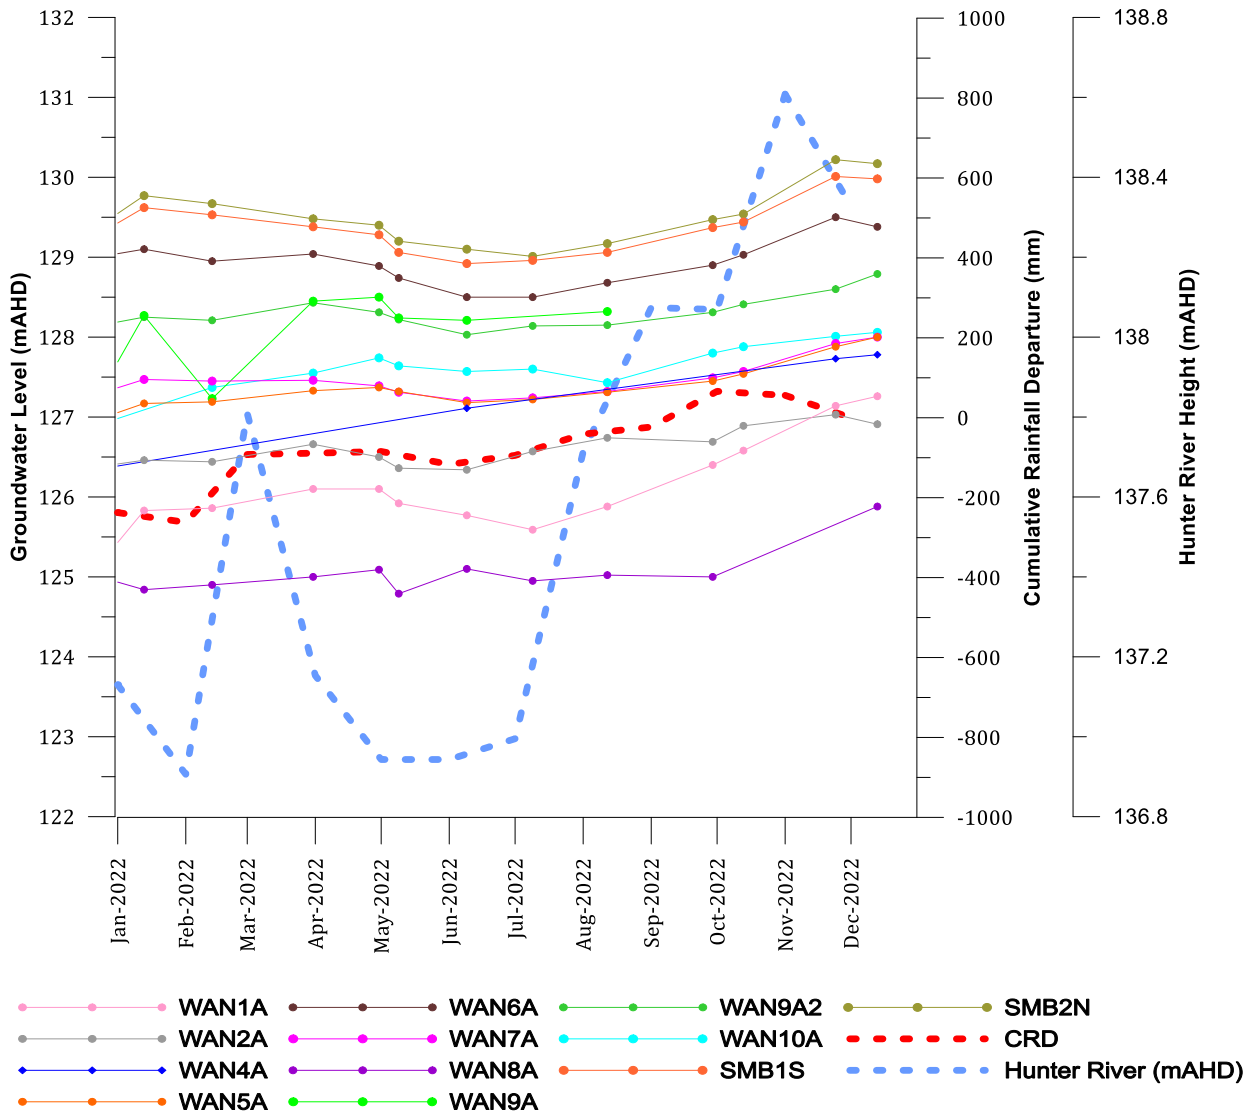
Figure 6.1 Hydrographs of alluvial bores - Wantana extension area

Figure 6.1 shows the alluvial groundwater level trends in the Wantana Extension area overlain with the CRD trend and Hunter River level. The water level trends for the Wantana Extension bores increased during 2022, coincident with above average rainfall and an increasing CRD.

The increasing trends in groundwater levels in Figure 6.1 show a strong correlation between the CRD and Hunter River level (at Station 210002, Muswellbrook Bridge).

The exception to this correlation is WAN8A, which displays a variable groundwater level response when compared to Hunter River level, the CRD, or the other Wantana Extension bores. This may be due to this bore being located on the fringe of the alluvium, with the screened interval not being completely representative of the Hunter River alluvium.

Groundwater monitoring bores WAN4A, WAN4B, WAN8A, WAN10A and WAN10B could not be accessed on multiple occasions in 2022 due to ponded surface water from recent rainfall events. Remaining data collection from the Wantana Extension bores indicated increases in groundwater levels during 2022, coincident with significant rainfall events and an increasing CRD.

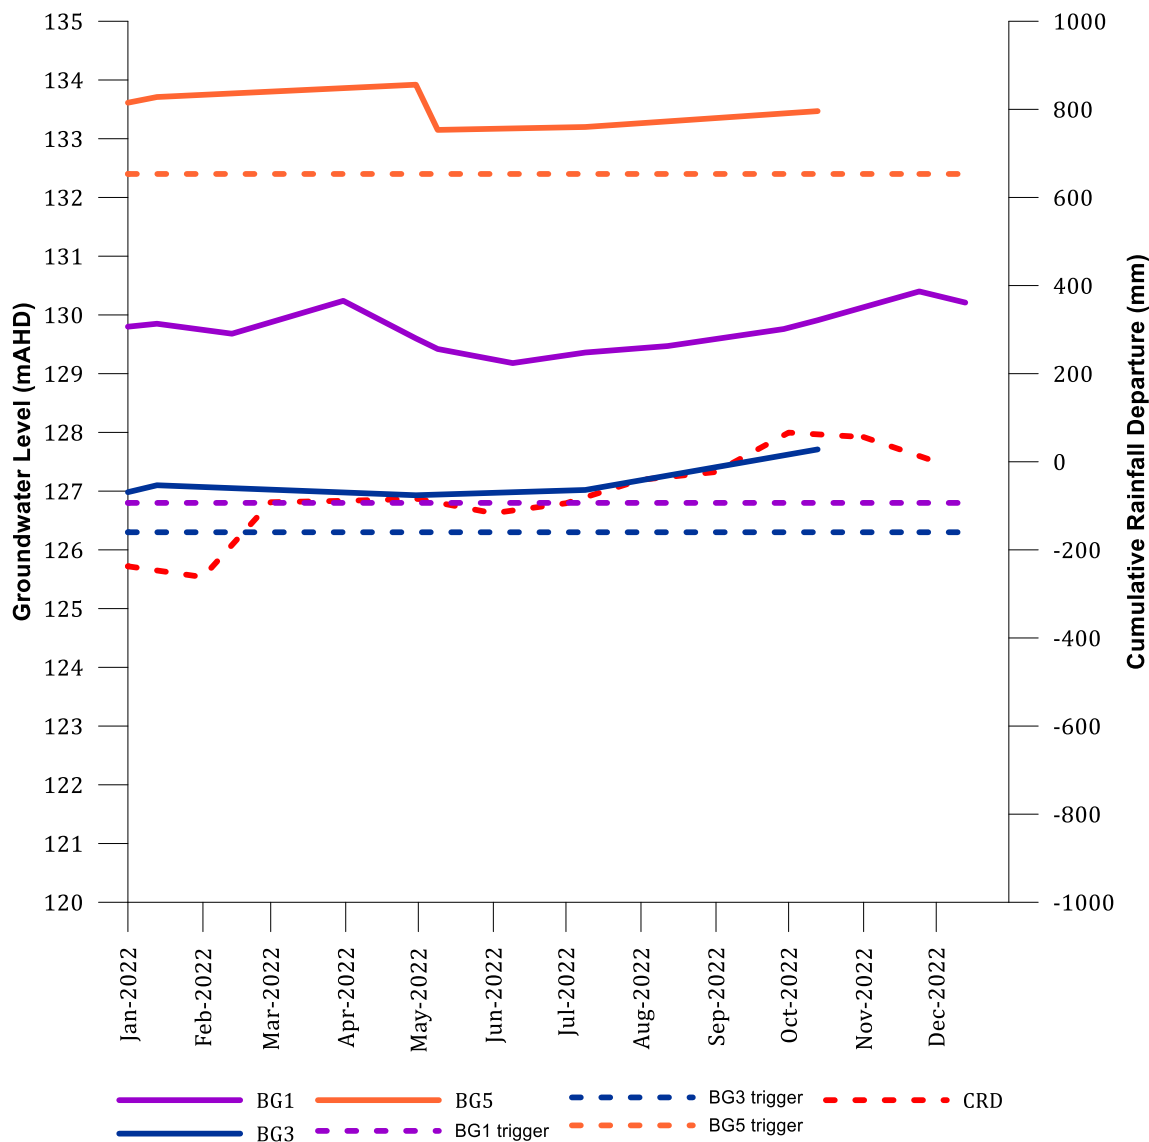
Figure 6.2 Hydrographs of Regional alluvial bores

Figure 6.2 shows groundwater levels measured in the Regional Hunter River alluvial monitoring bores. Groundwater levels in BG1 and BG5 remained above established triggers during 2022. Groundwater levels in BG5 have remained above the trigger value since April 2018.

Groundwater levels in BG3 were higher than those recorded in 2021 largely due to significant rainfall recharge, and have remained above the prescribed trigger level for the entirety of 2022.

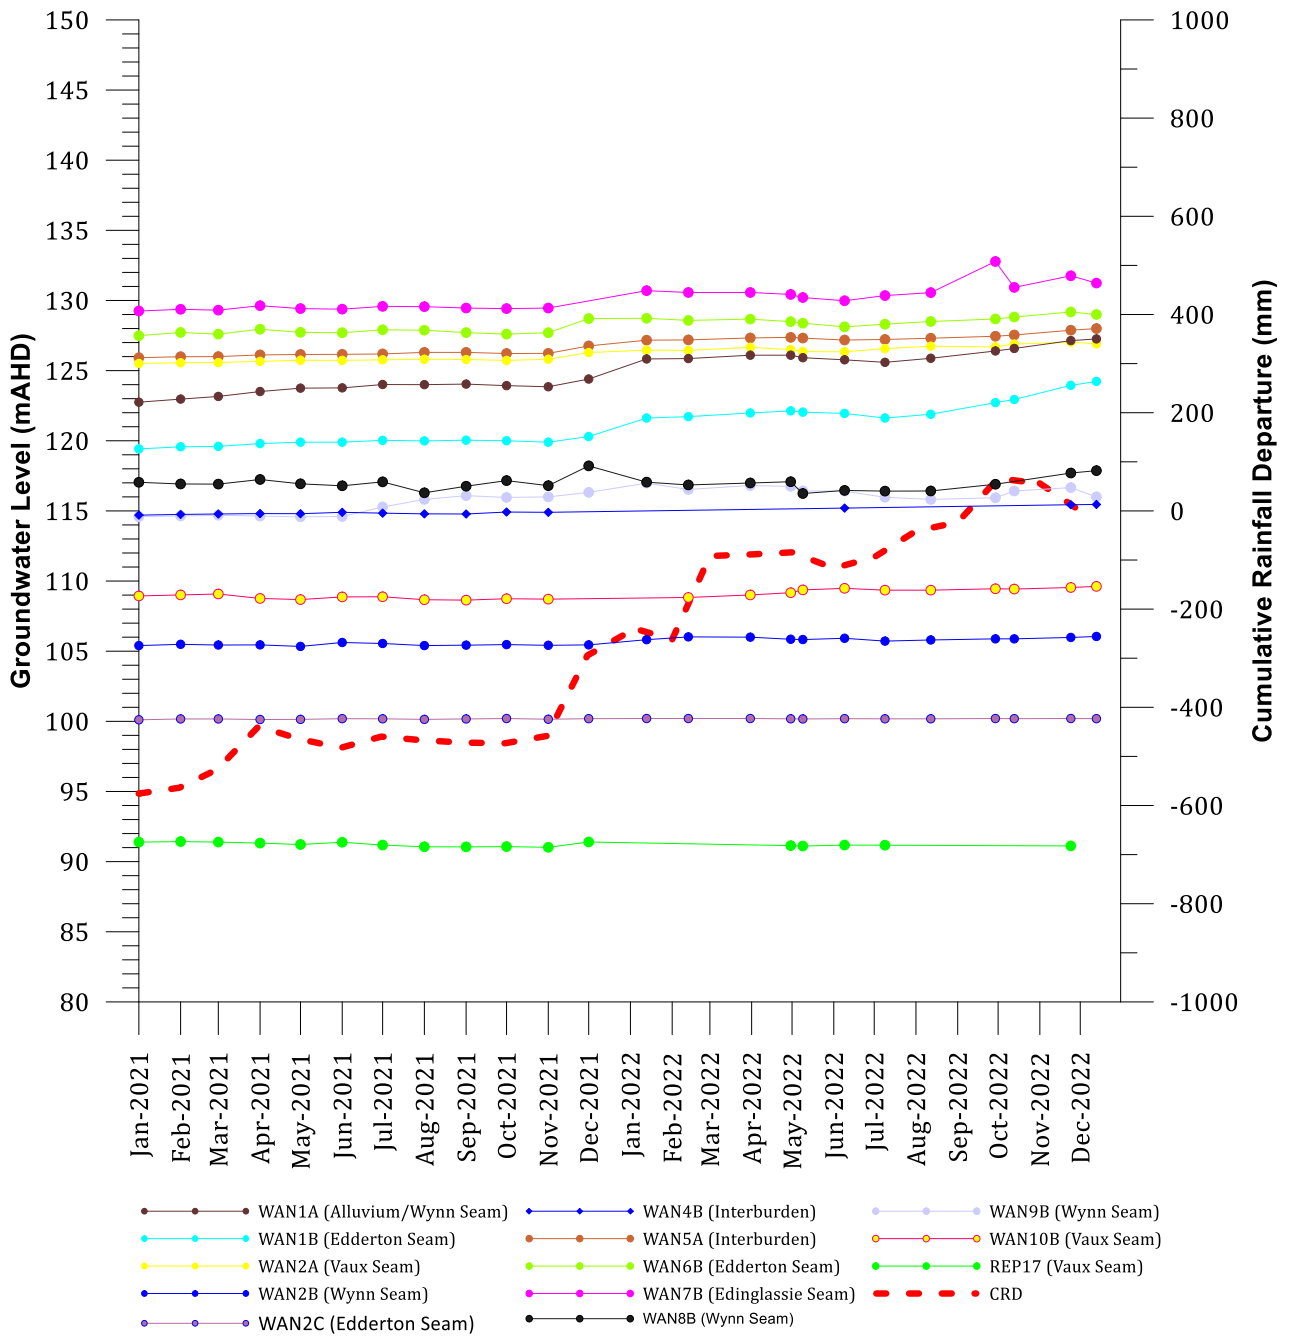
Figure 6.4 Hydrographs of coal seam/interburden bores – Wantana extension area

Groundwater levels in all Permian monitoring bores remained above established trigger values throughout 2022. Figure 6.4 shows long-term shallow Permian groundwater levels monitored in the Wantana Extension area to the south of Bengalla. Key observations are outlined below:

- Groundwater levels in bore WAN1A (screened in the Wynn Coal seam) increased gradually throughout 2022 after being relatively static since 2007. After being recorded as almost dry in April 2020, the observed water level at WAN1A is now 5.86 m above the base of the casing.

- WAN3 was found to be dry throughout 2022. The last recorded groundwater measurement was taken in December 2021, which was one of only three measurements recorded at this bore in six years.

- Monitoring bore WAN2C was blocked prior to October 2019. Measurements for 2022 show consistent groundwater levels of approximately 100 mAHD.
- Monitoring bore WAN2B displayed a gradual but steady recovery in water level from mid-2013. As with WAN1B, the recovery noted in WAN2B may represent a gradual recovery in pressure as mining operations move further away from this bore.

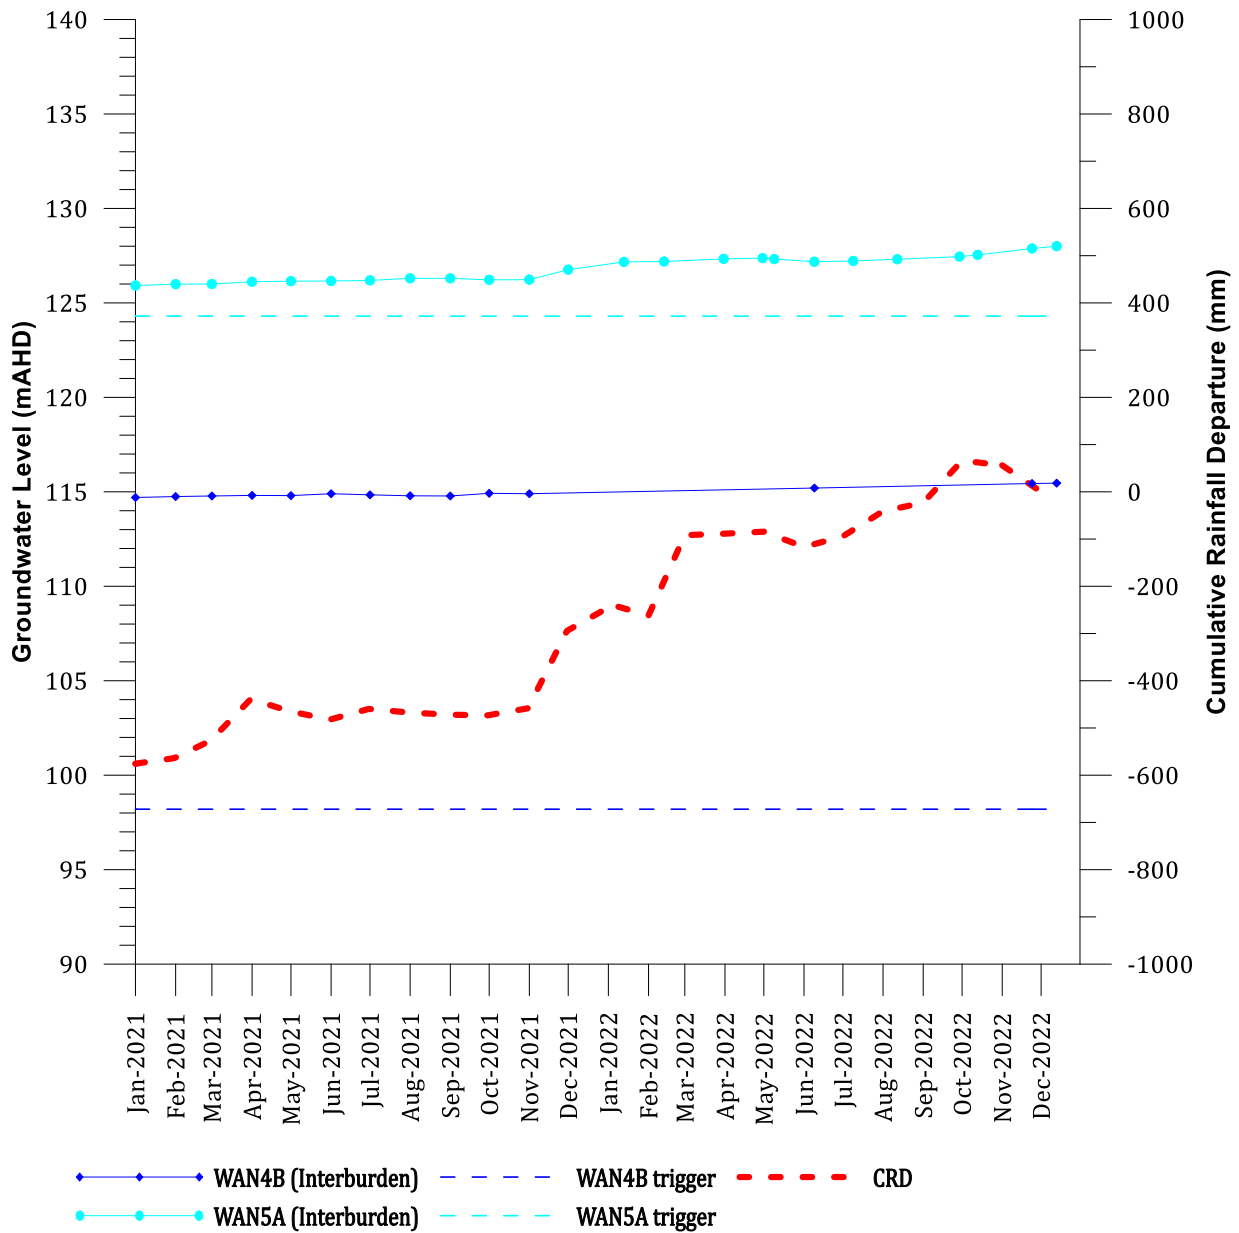
Figure 6.5 Hydrographs of deep Permian monitoring bores

Figure 6.5 and Figure 6.6 show the groundwater levels for the Permian monitoring bores (WAN4B, WAN5A, and WAN1B). Key observations can be summarised as follows:

- Groundwater levels in WAN4B and WAN5A have increased in 2022, commensurate with above average rainfall and an increasing CRD;
- Figure 6.6 shows a coal seam (Edderton Seam) monitoring bore (WAN1B) plotted against the CRD. Groundwater levels have risen by almost 2 m in 2022; a similar increase to that recorded in 2021. Groundwater level recovery in WAN1B is likely due to the westward progression of mining operations (i.e. away from WAN1B) and above average rainfall over the course of the year; and
- WAN4B, WAN5A, and WAN1B remained above established triggers throughout 2022.

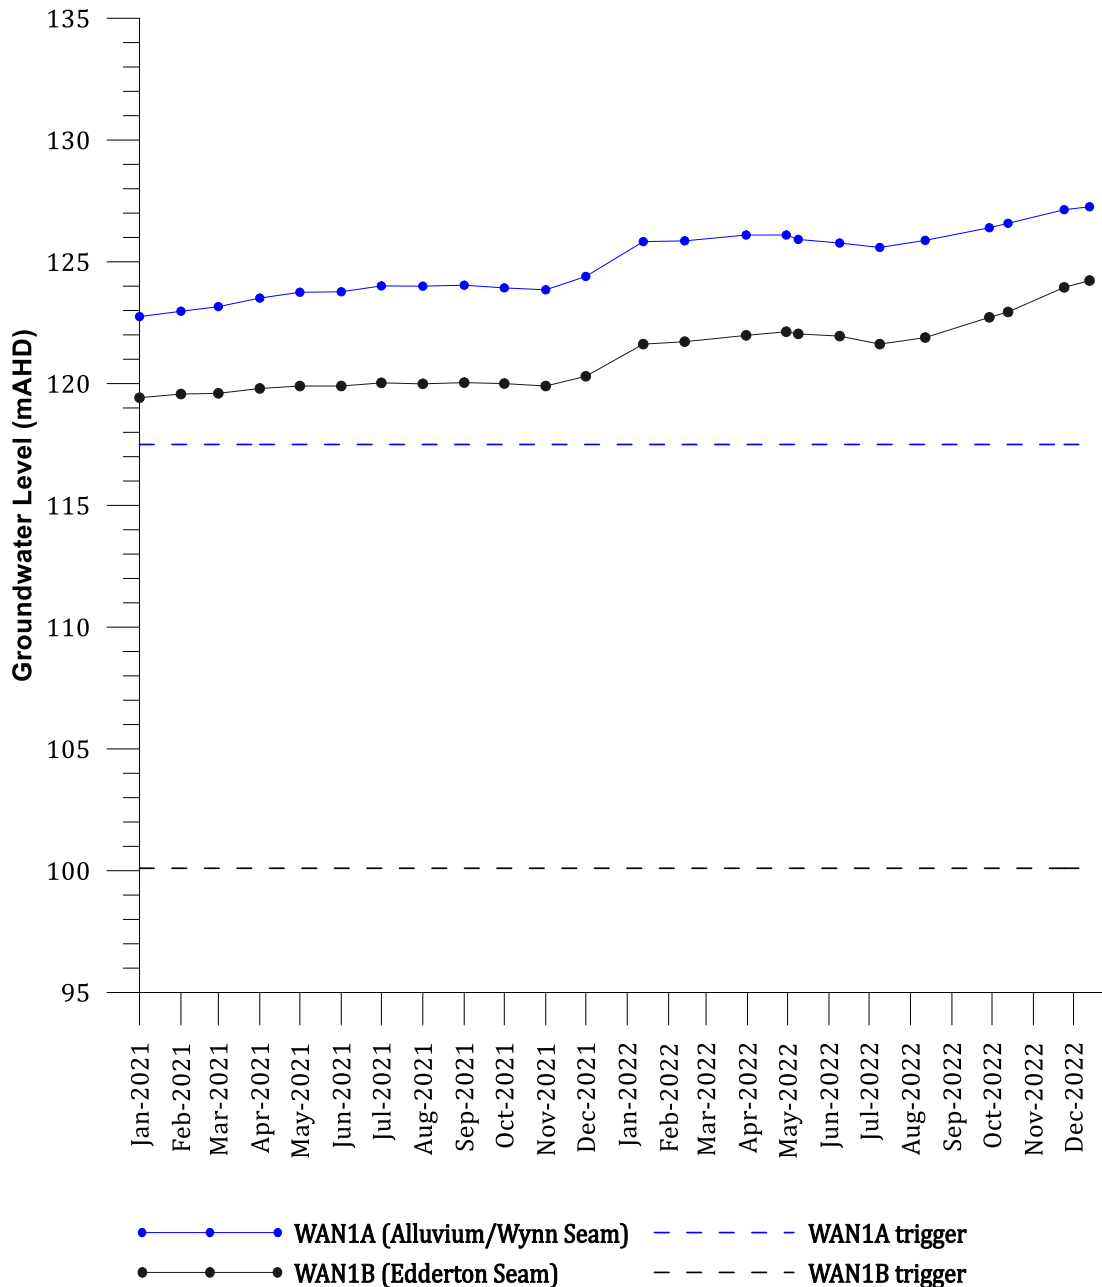
Figure 6.7 Alluvium and coal seam hydrographs – WAN1

Figure 6.7 shows the WAN1 nested site water levels. WAN1 bores retained levels above the trigger levels throughout 2022. WAN1A is screened in the Wynn seam and possibly also over part of the alluvium. At this location, the Wynn seam subcrops close to the base of the alluvium. WAN1A recorded a significant yet gradual increase in water level throughout the year, increasing from 125.83 mAHD to 127.26 mAHD (1.43 m increase). WAN1B (Edderton seam) also recorded ongoing water level recovery in 2022 (2.6 m increase in pressure head), following mining induced depressurisation from mid-2010 to late-2011. The water level of 124.23 mAHD (December 2022) has recovered to above the pre-mining level of 115.87 mAHD, demonstrating that water levels in depressurised coal seams can recover in a post-mining phase.

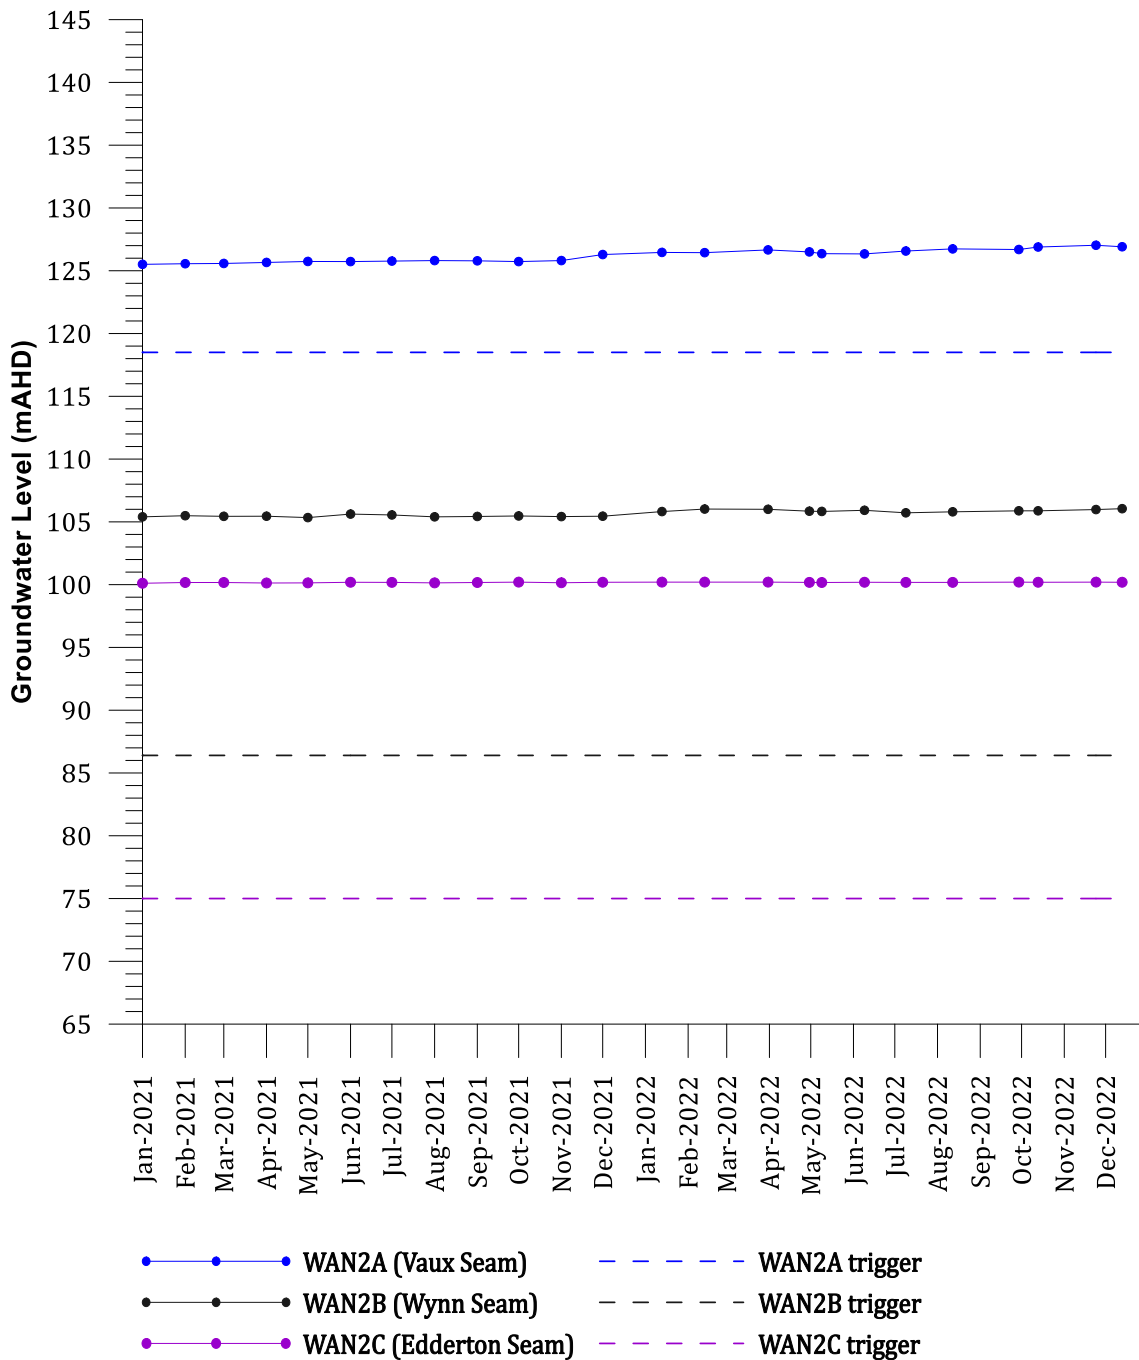
Figure 6.8 Alluvium and coal seam hydrographs – WAN2

Figure 6.8 shows the WAN2 nested site water levels. All WAN2 bores retained levels above the trigger levels throughout 2022. Water levels in WAN2A (Vaux Seam) increased slightly during the 2022 monitoring period. Levels in WAN2B (Wynn Seam) steadily declined from 2005 to December 2013 as a result of mining, remaining relatively stable thereafter (i.e. to December 2022). Monitoring bore WAN2C recorded a steady water level throughout 2022.

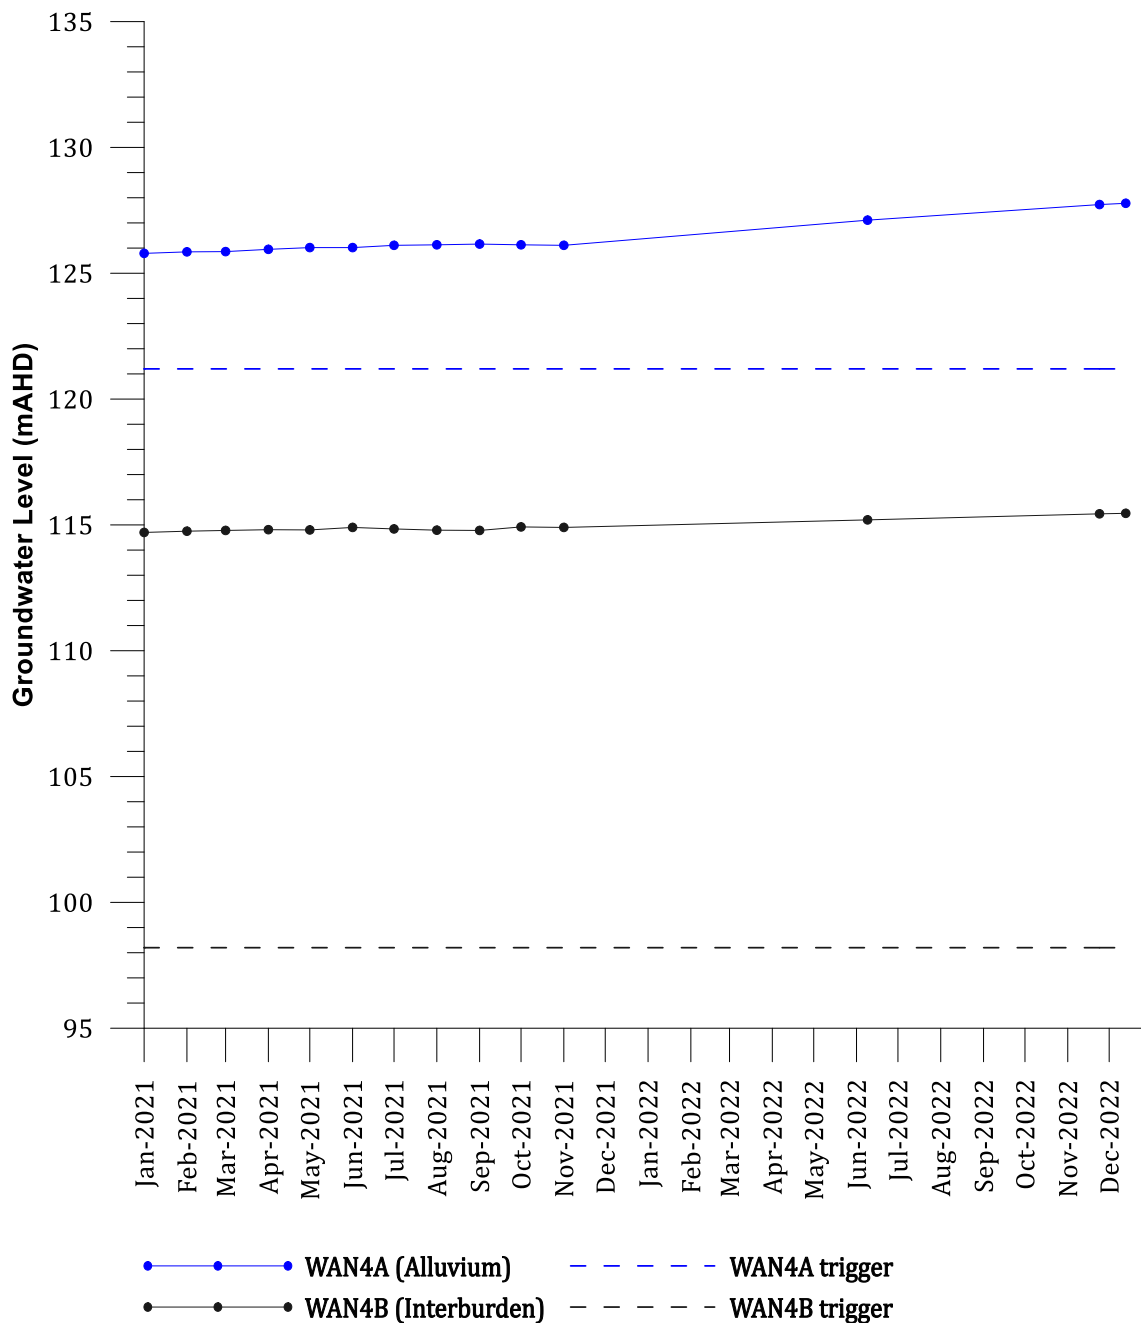
Figure 6.9 Alluvium and interburden hydrographs – WAN4

WAN4 bores retained groundwater levels above the trigger values throughout 2022 (Figure 6.9). At WAN4B, the groundwater level in the interburden prior to 2011 was 2 m lower than the water level observed in the alluvium (WAN4A). Since December 2011, the water level in the interburden bore – WAN4B – declined by 9.32 m. This rate of decline appears to have stabilised to an elevation approximately 115.5 mAHD (115.46 mAHD - December 2022). WAN4A water level in the alluvium gradually increased throughout 2022, with the groundwater level increasing by 1.67 m. This coincides with above average rainfall; however, this relatively minor response indicates little local connection between the alluvium and the interburden, or suggests the alluvium is constantly recharged by the Hunter River. Access to WAN4 bores was impeded by rainfall on multiple occasions in 2022, leading to gaps in the data.

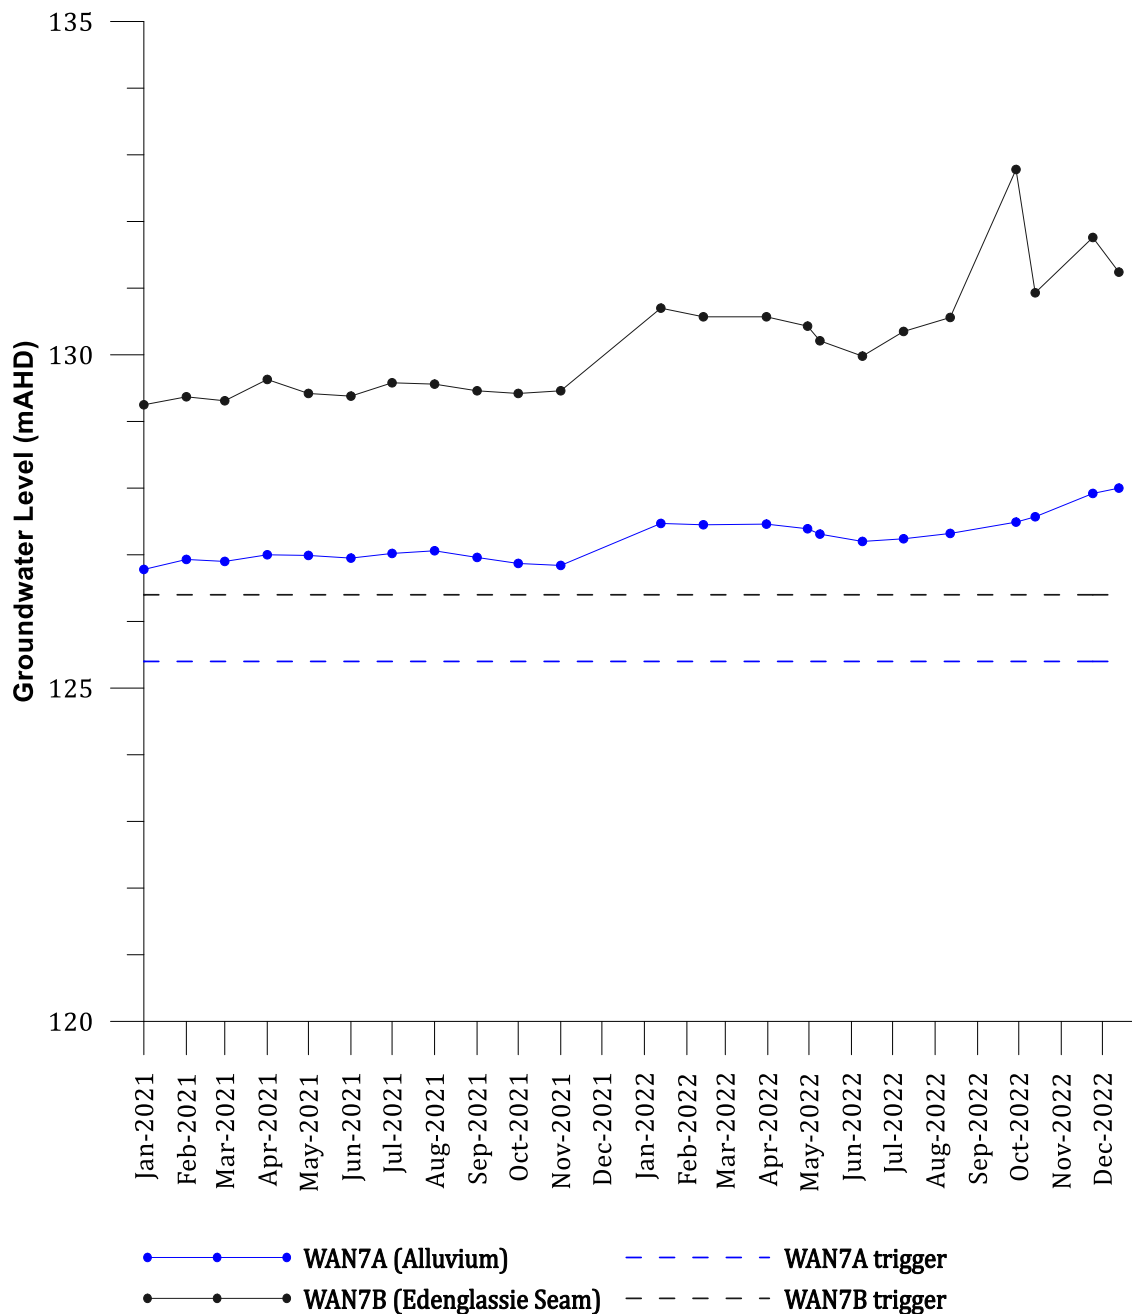
Figure 6.12 Alluvium and coal seam hydrographs – WAN7

Data from 2022 (Figure 6.12) show the groundwater level in the Edinglassie Seam is approximately 2 m above the groundwater level in the alluvium, indicating that the Edinglassie Seam is pressurised. The Edinglassie Seam is not mined at Bengalla and hence has not been impacted by mining related drawdown. The water level in WAN7A increased during 2022. WAN7A and WAN7B were above established trigger levels throughout the entirety of 2022 (Figure 6.12).
