BENGALLA MINE ANNUAL REVIEW 2022

BENGALLA MINING COMPANY PTY LIMITED
LOCKED BAG 5
MUSWELLBROOK NSW 2333

April 2023

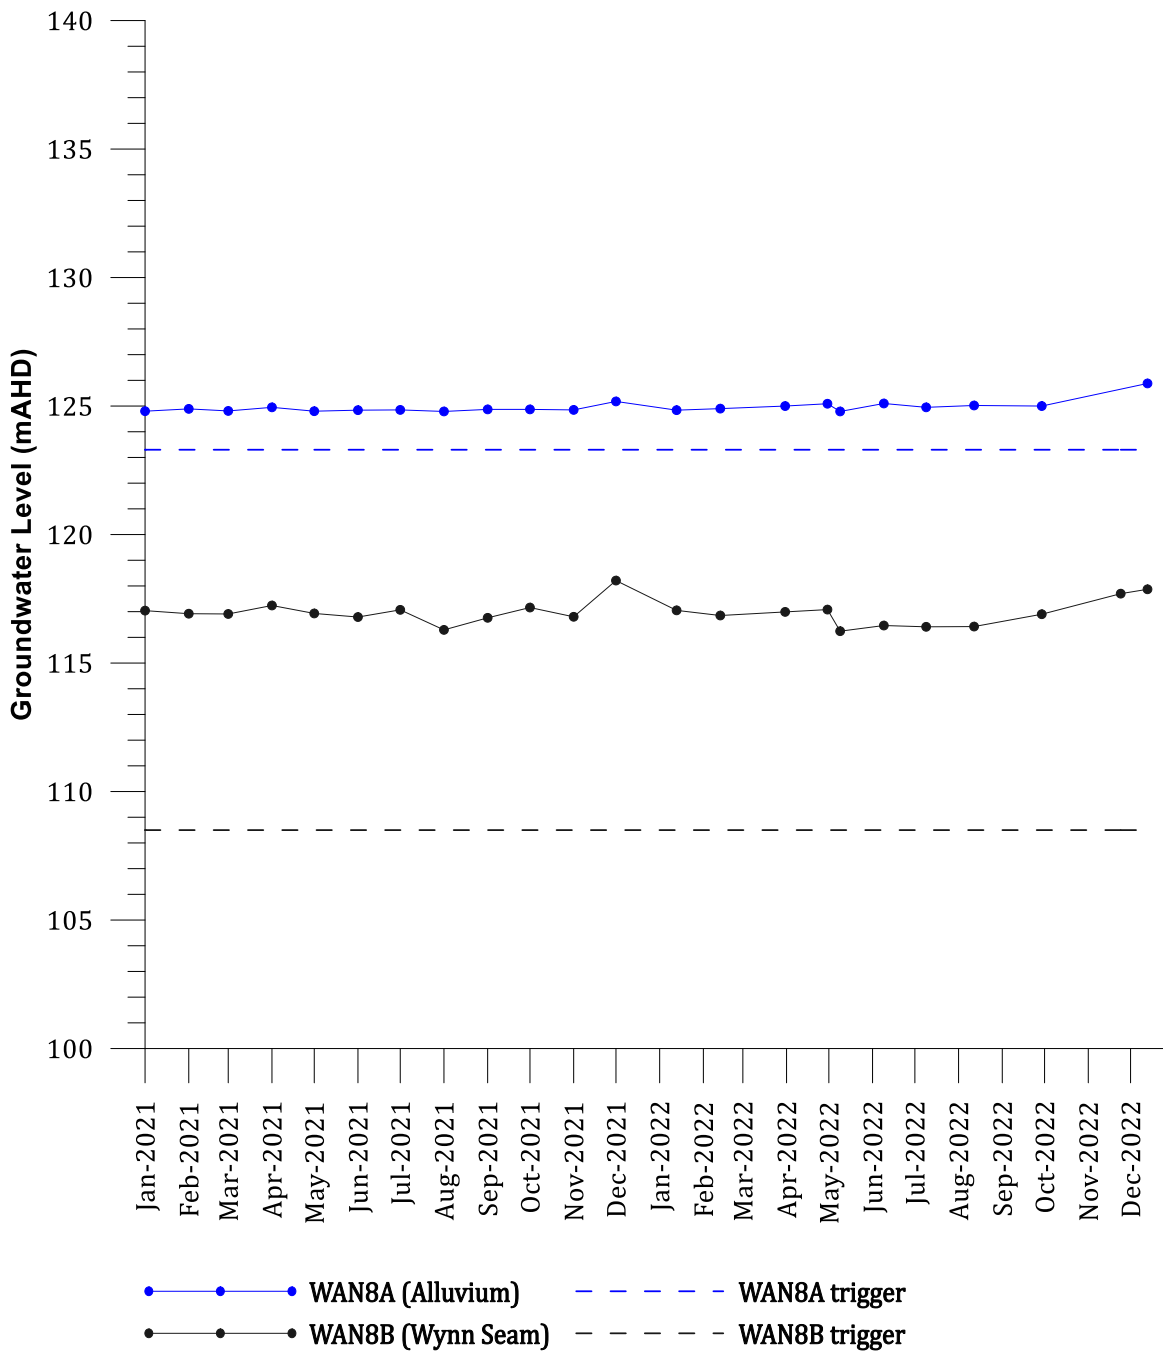
Figure 6.13 Alluvium and coal seam hydrographs – WAN8

Figure 6.13 shows the water levels at the nested site WAN8. The water levels are approximately 125 mAHD and 117 mAHD for the alluvium and the Wynn seam, respectively. The alluvium is approximately 8 m higher than the Wynn seam head, potentially demonstrating a separation of the aquifers. The head trends are relatively constant for the monitoring period, indicating that there has been no mining induced change to groundwater water levels through 2022. WAN8 groundwater levels were above established triggers in 2022.

Figure 6.13, Figure 6.14 and Figure 6.15 show groundwater levels at nested sites WAN8, WAN9 and WAN10. Monitoring bore WAN9A2 has replaced the previously dry WAN9A bore.

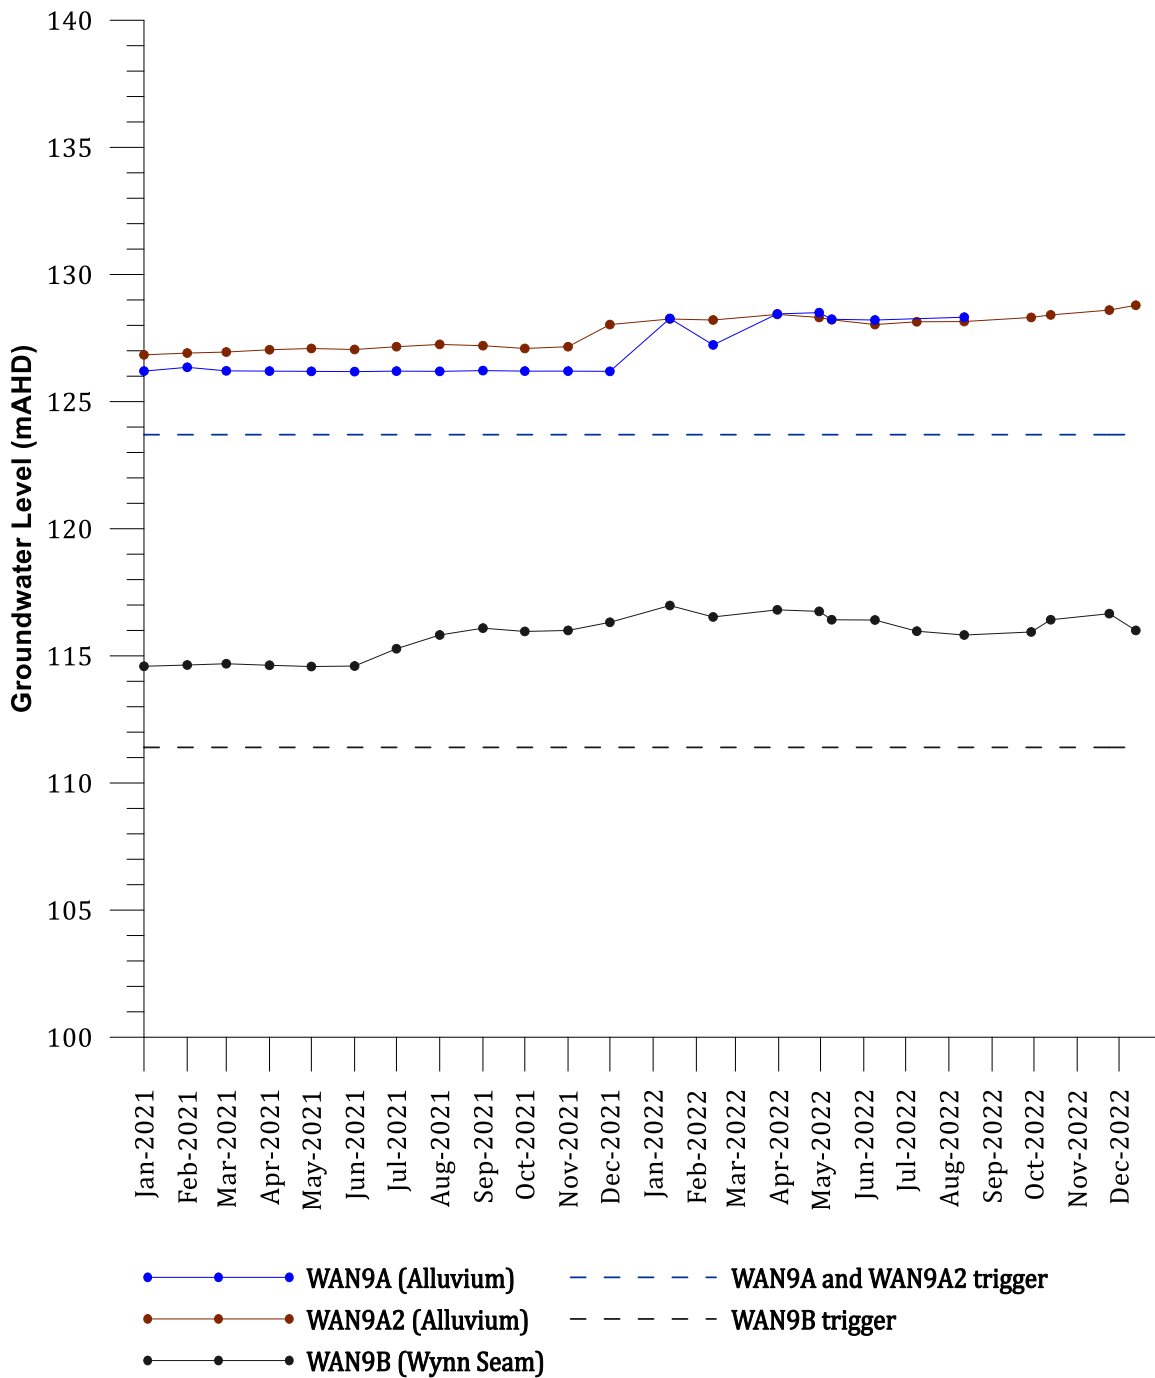
Figure 6.14 Alluvium and coal seam hydrographs – WAN9

Groundwater levels in WAN9A2 (refer Figure 6.14) increased during the monitoring period. The groundwater level in WAN9B was stable throughout 2022. The final recorded groundwater level at WAN9B in 2022 was 116.0 mAHD (December 2022), 1 m lower than the groundwater level recorded at this bore in January 2022. All WAN9 monitoring bores continued to remain above established trigger values.

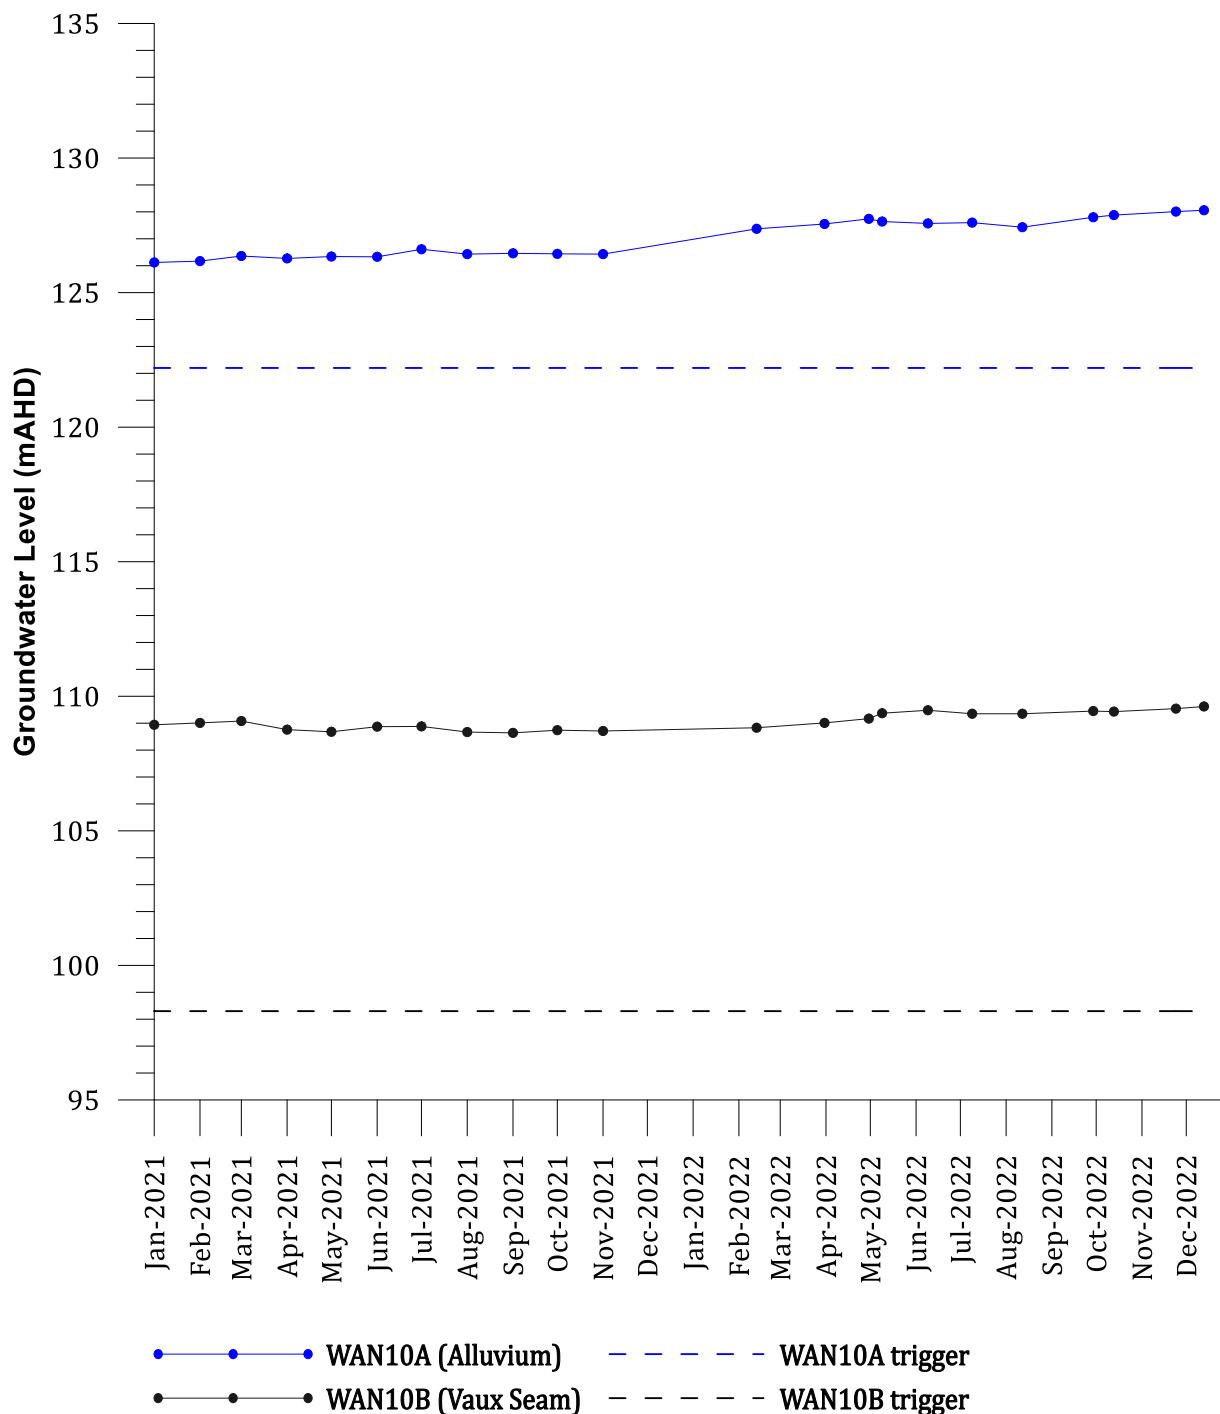
Figure 6.15 Alluvium and coal seam hydrographs – WAN10

WAN10 monitoring bores (Figure 6.15) remained above trigger values for 2022. WAN10B shows the groundwater level in the Vaux Seam increasing by 0.8 m during 2022, whilst WAN10A alluvial water levels remained stable. Since September 2012, the water level in the Vaux Seam (WAN10B) has been steadily declining. The head differential between the bores at WAN10 has now increased to approximately 18.4 m, indicating potential for alluvial groundwater to leak to the coal seams, where they subcrop below the alluvium.

The initial groundwater level at WAN10B (119.2 mAHD, May 2009) has declined to 109.62 mAHD by December 2022 (a change of 9.58 m). This represents a decline in groundwater level of approximately 50% of the range above the adopted trigger level (Figure 6.15). Despite this, the decline is still within the limits of predicted impacts. Access to WAN10 bores was impeded by rainfall in January 2022.

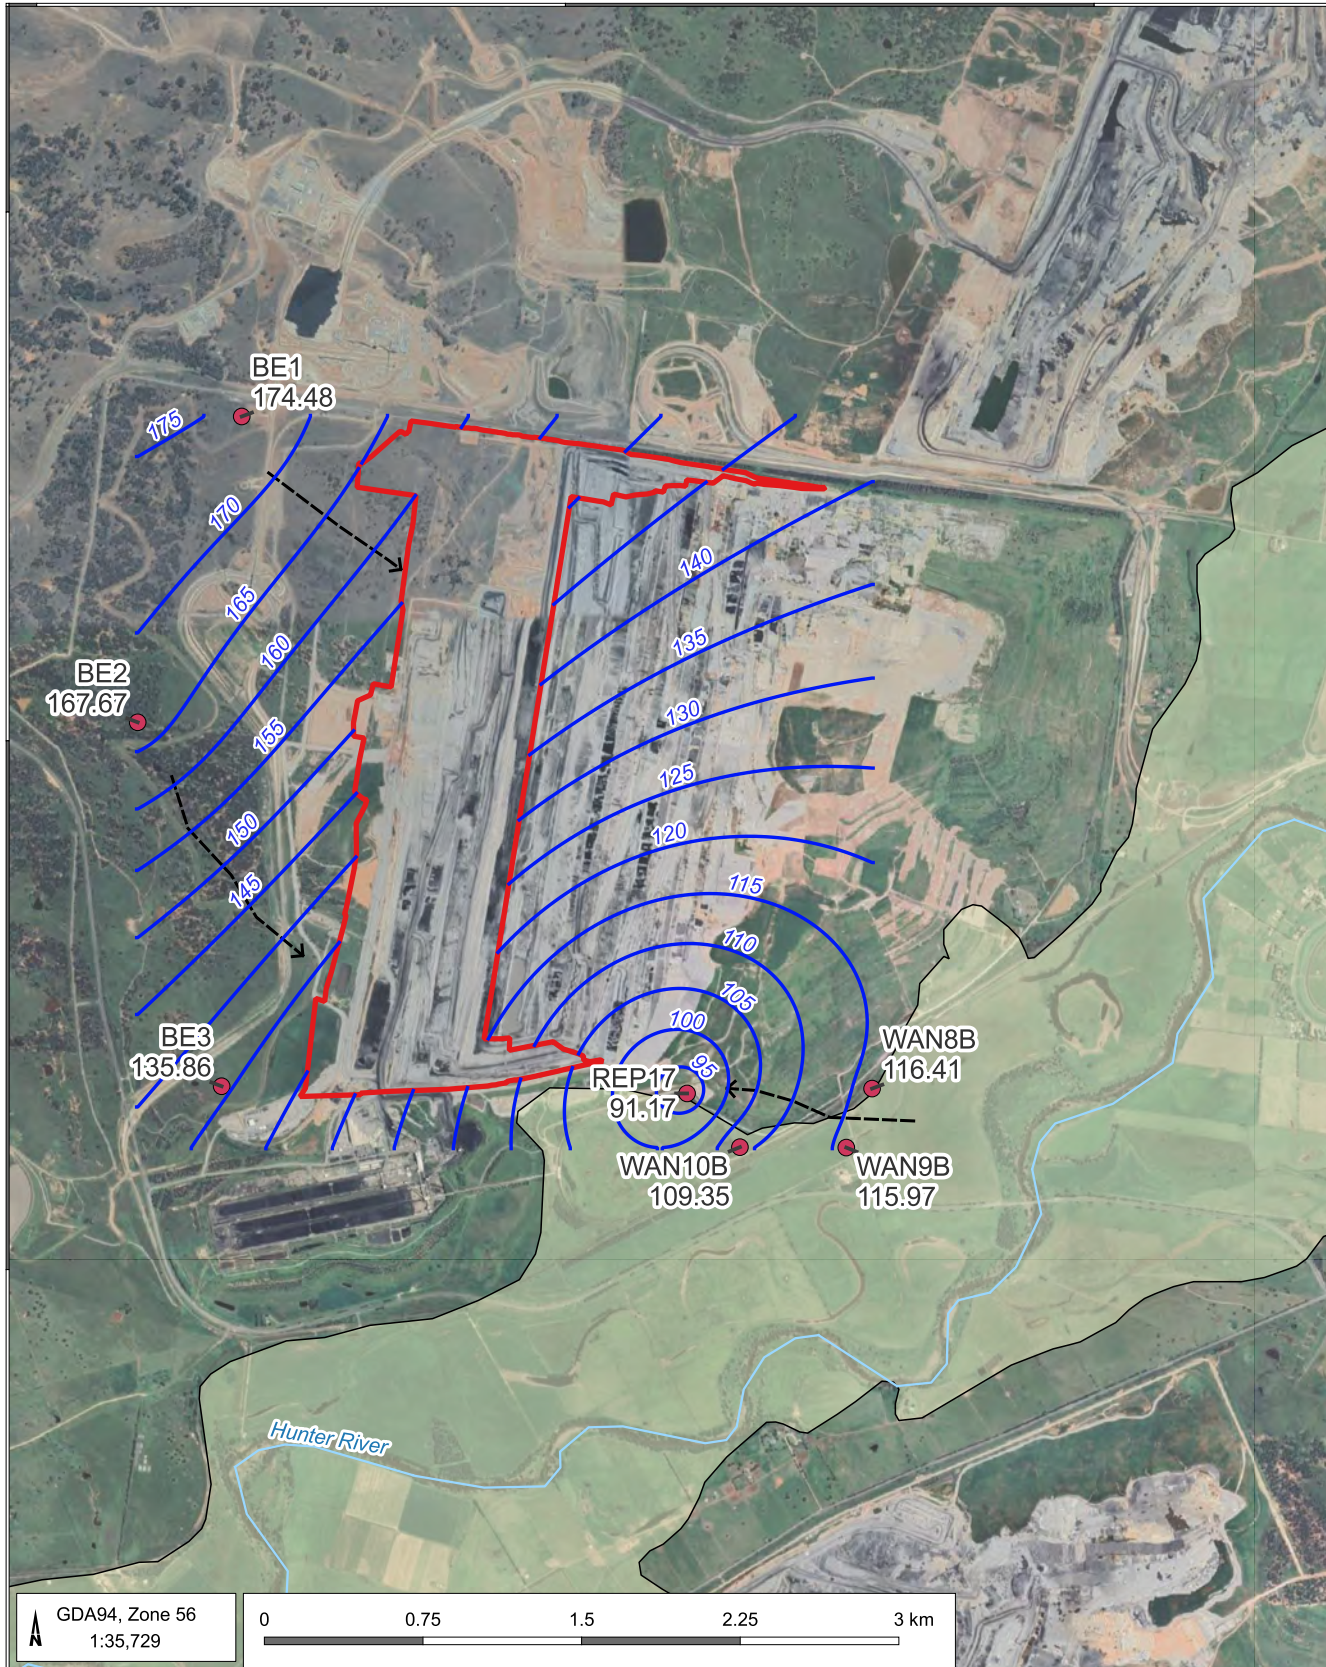
FIGURE No:
6.16

Figure 6.16 and Figure 6.17 show the interpreted groundwater flow contours for the shallow Permian units (Wynn and Vaux Seams and interburden) and deeper Permian units (Edderton and Edinglassie Seams and interburden), respectively. The depressurisation of the coal seams by open cut mining and the hydraulic gradient towards the mine is evident in the water level contours of both layers. Whilst the impact of the coal seam depressurisation is evident in the Permian units, the impact to the alluvial aquifer is minimal (refer Figure 6.3 and Section 6.1.3).

When compared to 2021, shallow Permian groundwater levels as monitored to the west (BE1, BE2, BE3) can be seen to be relatively stable (BE1, BE2) to slightly depressurised (BE3) depending on their proximity to the encroaching pit, whilst equivalent monitoring sites to the east have slightly increased groundwater levels reflective of increased rainfall recharge and more distal mining operations (Figure 6.16). Alternatively, the deeper Permian strata displays a greater comparative reduction in pressure head due to the higher hydraulic conductivity enabling enhanced lateral propagation of drawdown in these seams.

The water level contours, and flow directions are consistent with historic data and the drawdown is within predicted and approved ranges.

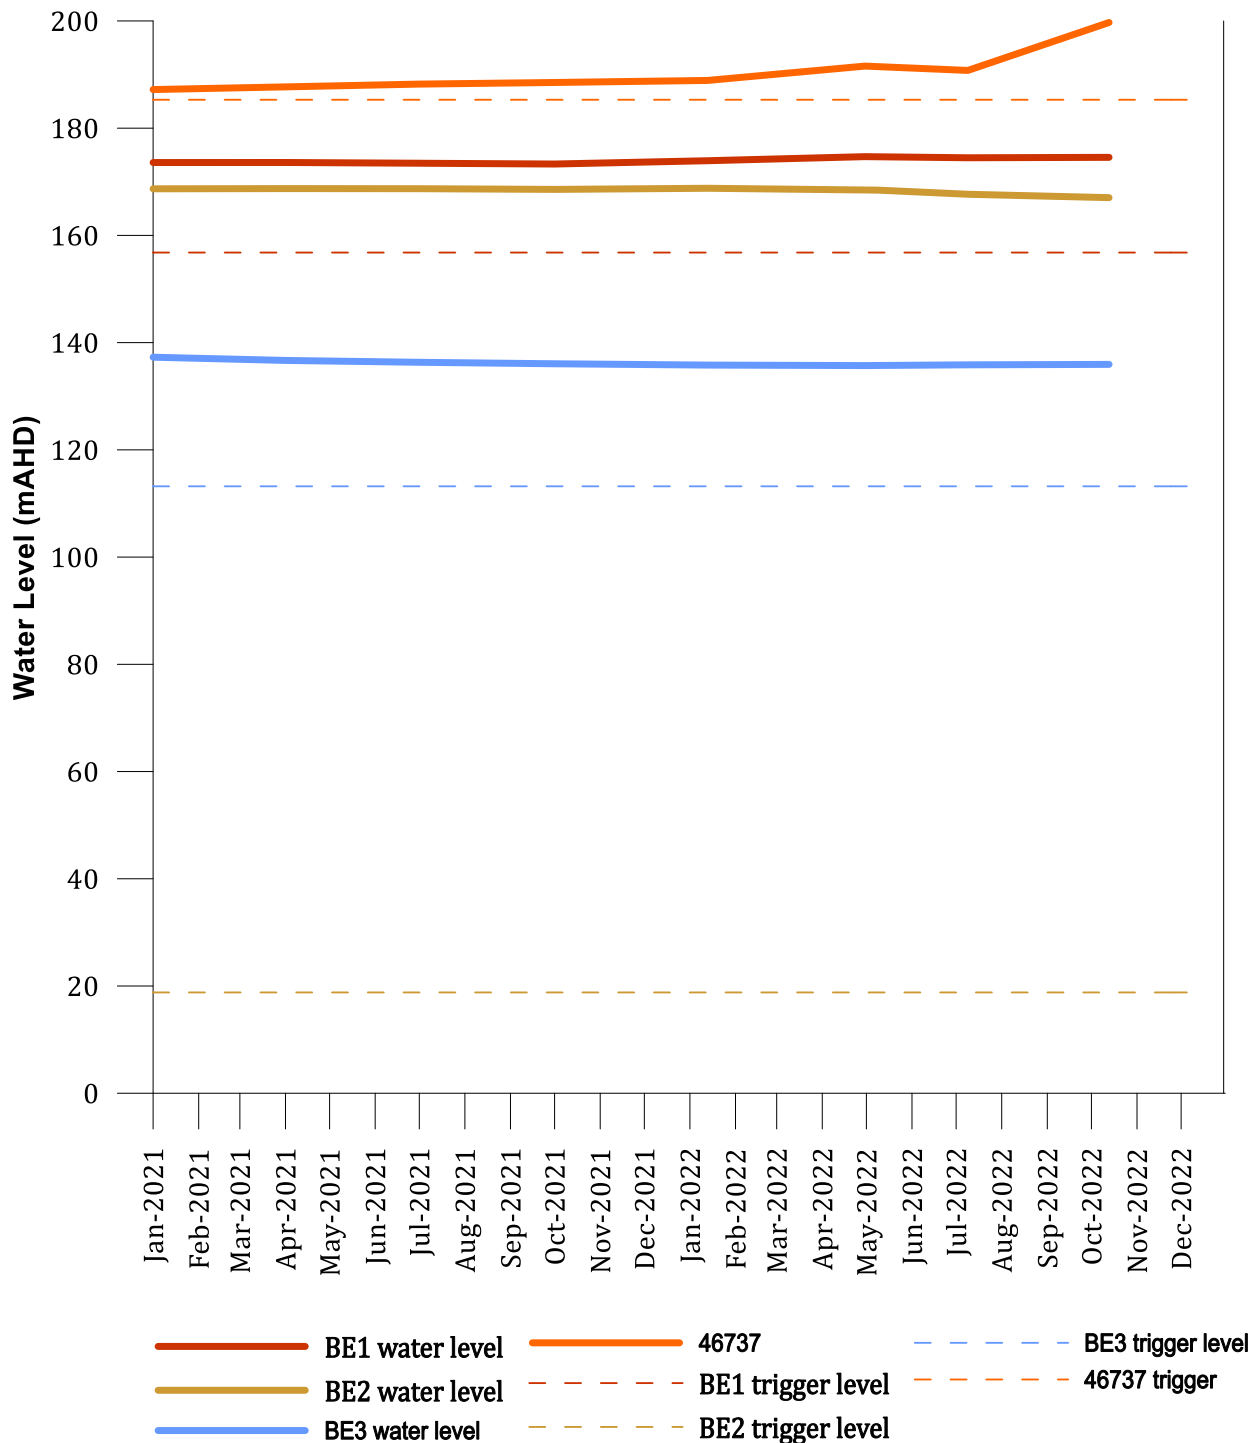
Figure 6.18 Northwest Permian monitoring bore groundwater levels

Figure 6.18 to Figure 6.23 below show the groundwater level hydrographs for those bores and VWPs located to the northwest of the active mining area, including:

The reason for the discrepancy in groundwater level trends between the VWP sensors and the monitoring bores is that pressure dissipation is greatest in the deeper coal seams, as they are more permeable than the shallow coal overburden. Additionally, the 'BE' series monitoring bores are screened in Permian sandstone/overburden, which may not yet be intersected by the pit, and is continuing to receive recharge via seepage from overlying strata and lateral groundwater flow from the north and west.

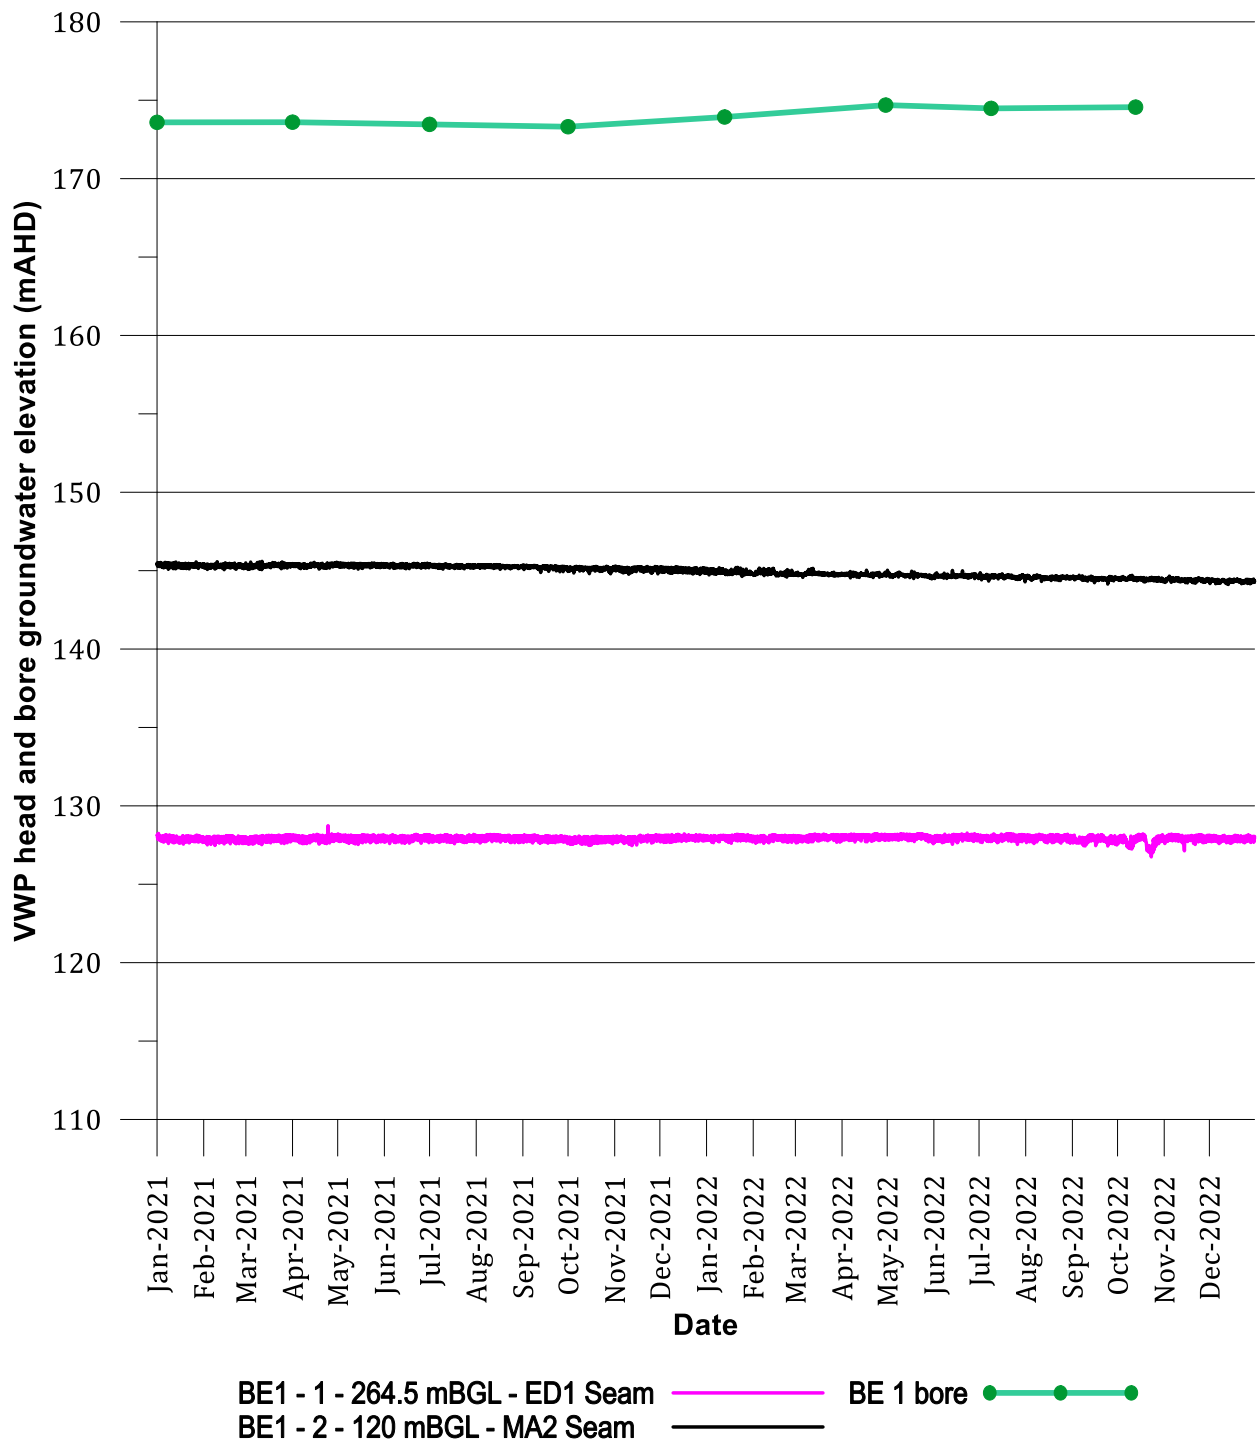
Figure 6.19 Northwest Permian VWP potentiometric heads – BE1

Figure 6.19 to Figure 6.23 show the potentiometric heads measured in VWP installations at BE1, BE2, BE3, BE4 and BE5. Each of these installations has one VWP sensor in the Mt Arthur Seam, and another sensor in the Edderton Seam. BE4 was removed 27 October 2021 due to blasting operations. The water levels from monitoring bores BE1 through BE3 have also been plotted for comparison. Observations include:

- VWPs and bore at BE1 (Figure 6.19):
 - head pressure in both the Mt Arthur Seam and the Edderton Seam have continued trends from 2021, gradually declining throughout 2022.

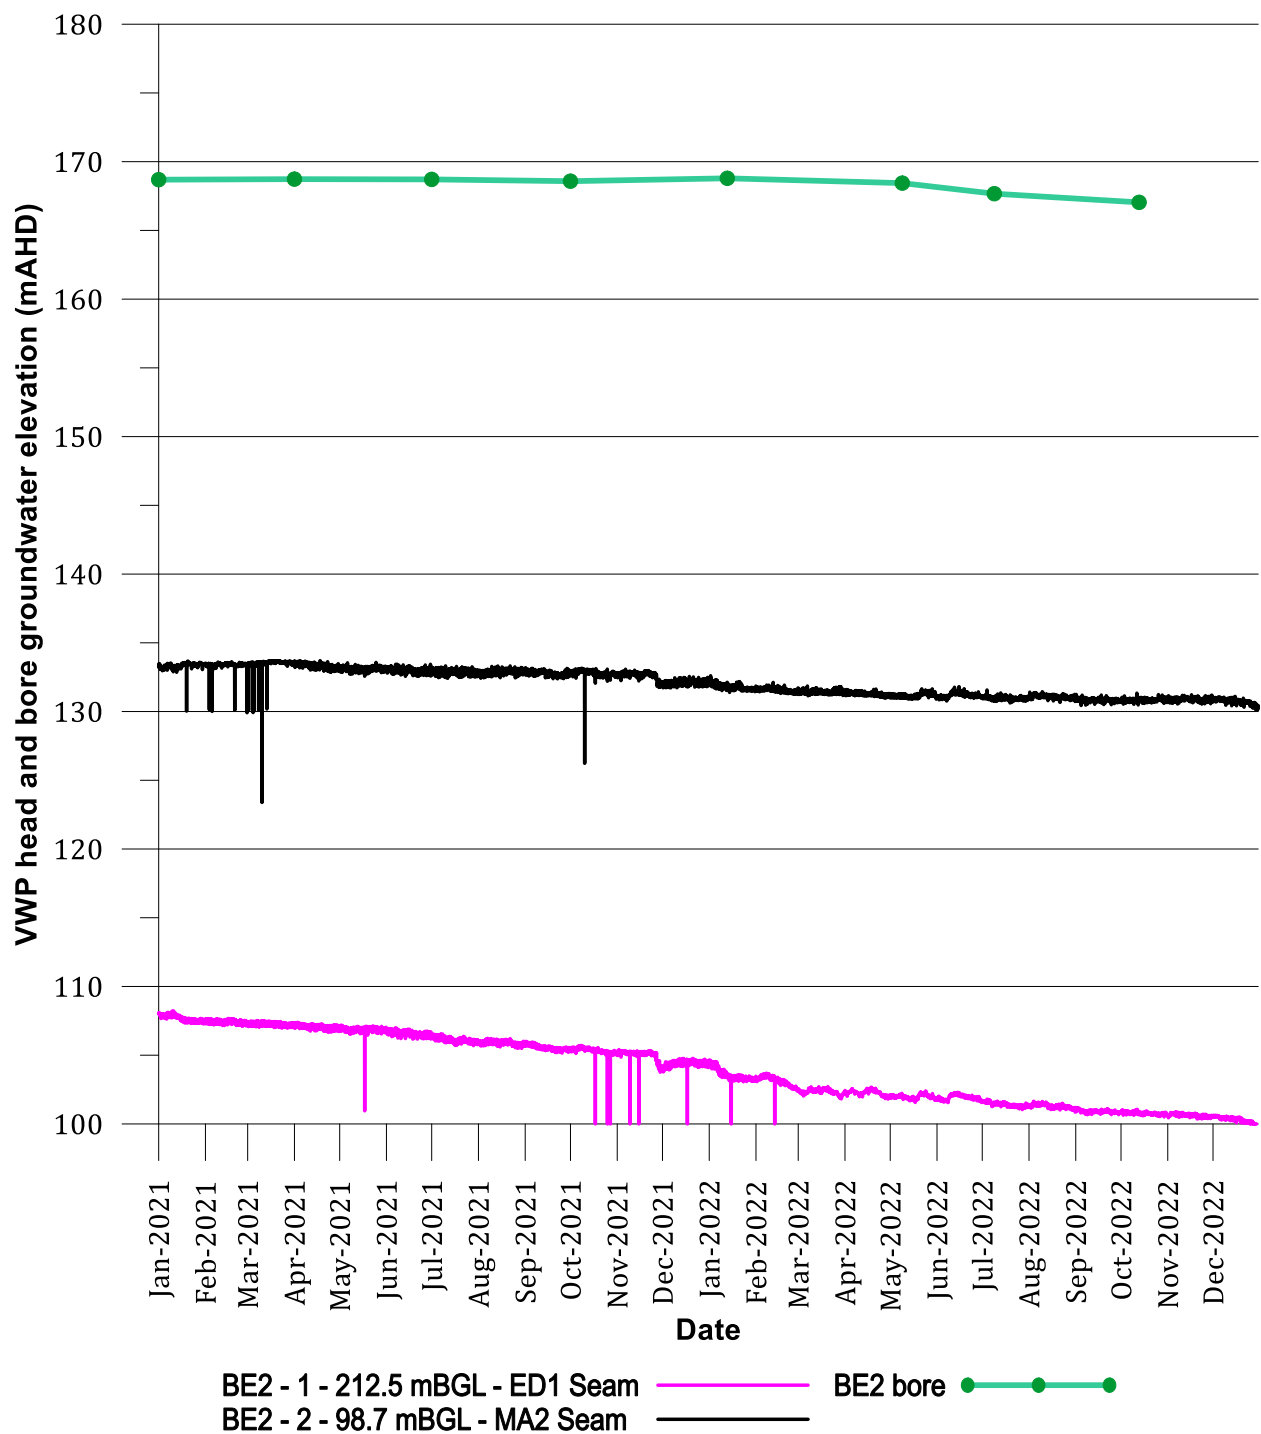
Figure 6.20 Northwest Permian VWP potentiometric heads – BE2

- VWPs and bore at BE2 (Figure 6.20):
 - the Mt Arthur Seam VWP sensor registered a gradual rate of decline throughout 2022
 - the head in the Edderton Seam VWP is declining at a greater rate than that of the Mt Arthur Seam VWP.

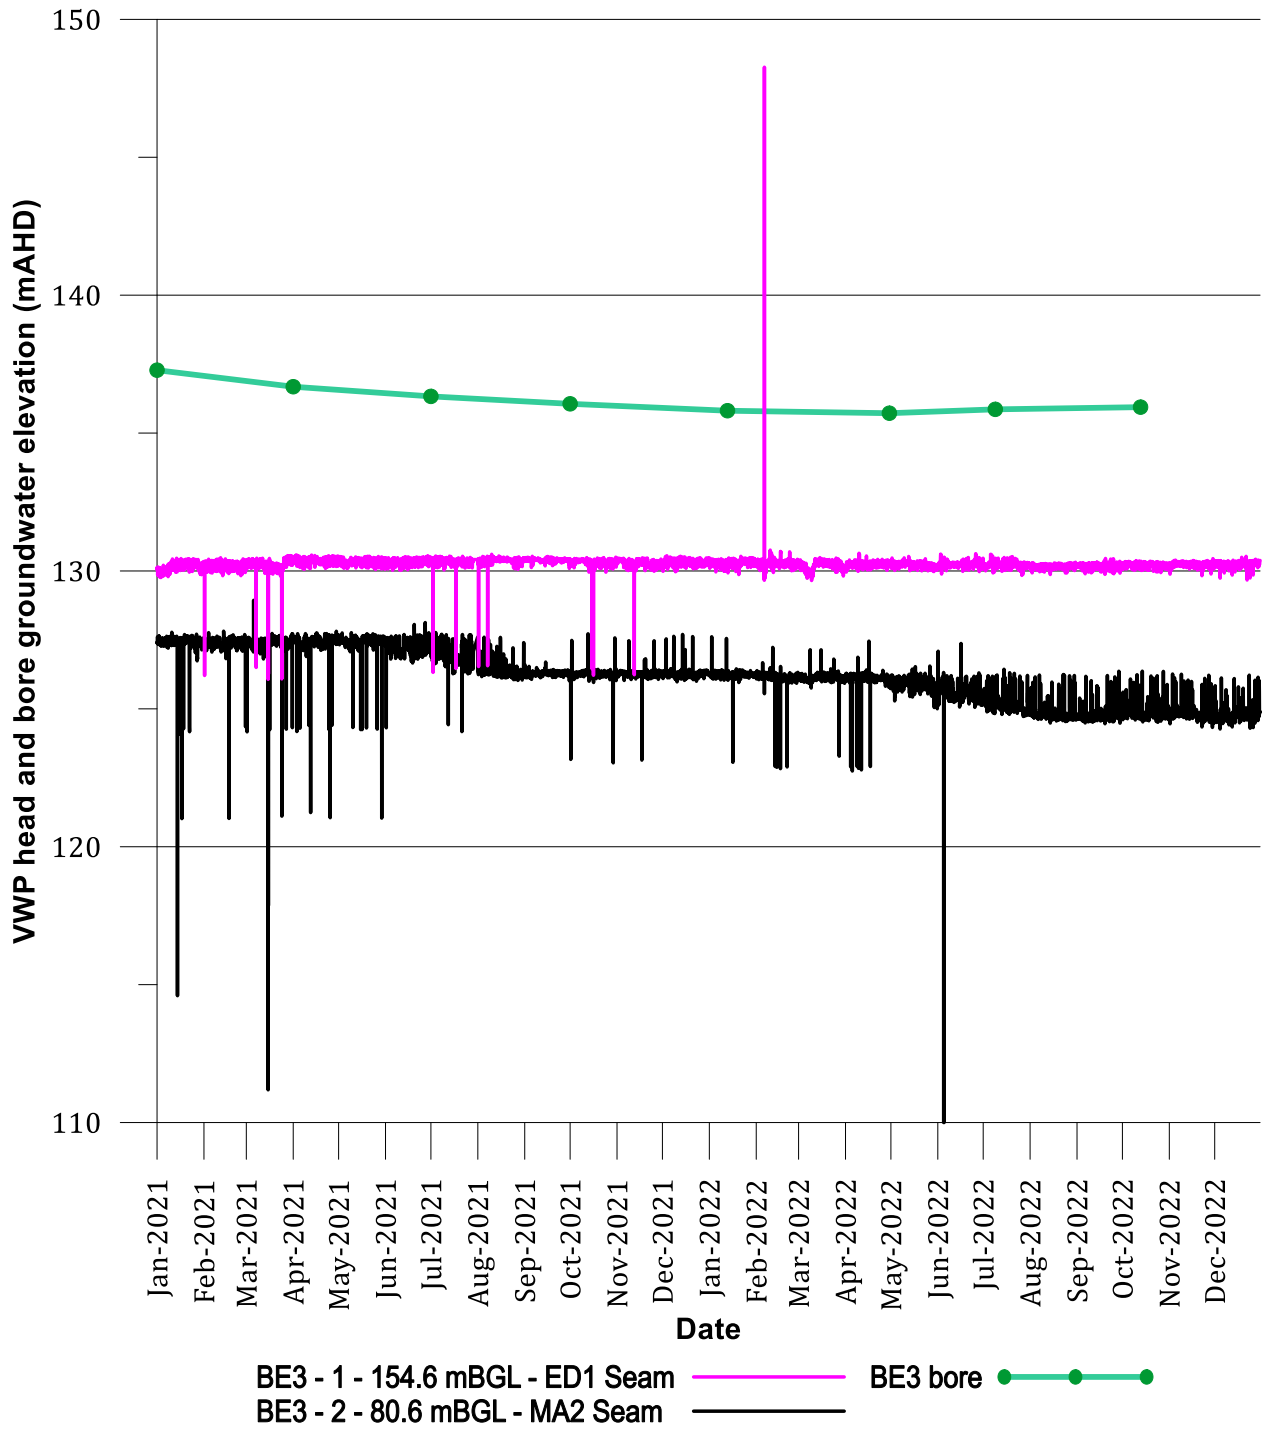
Figure 6.21 Northwest Permian VWP potentiometric heads – BE3

- VWPs and bore at BE3 (Figure 6.21):
 - the Mt Arthur Seam VWP sensor recorded an overall decrease in 2022;
 - the Edderton Seam VWP recorded a stable pressure head in 2022. Overall pressure head is expected to decline in this seam as the pit approaches.

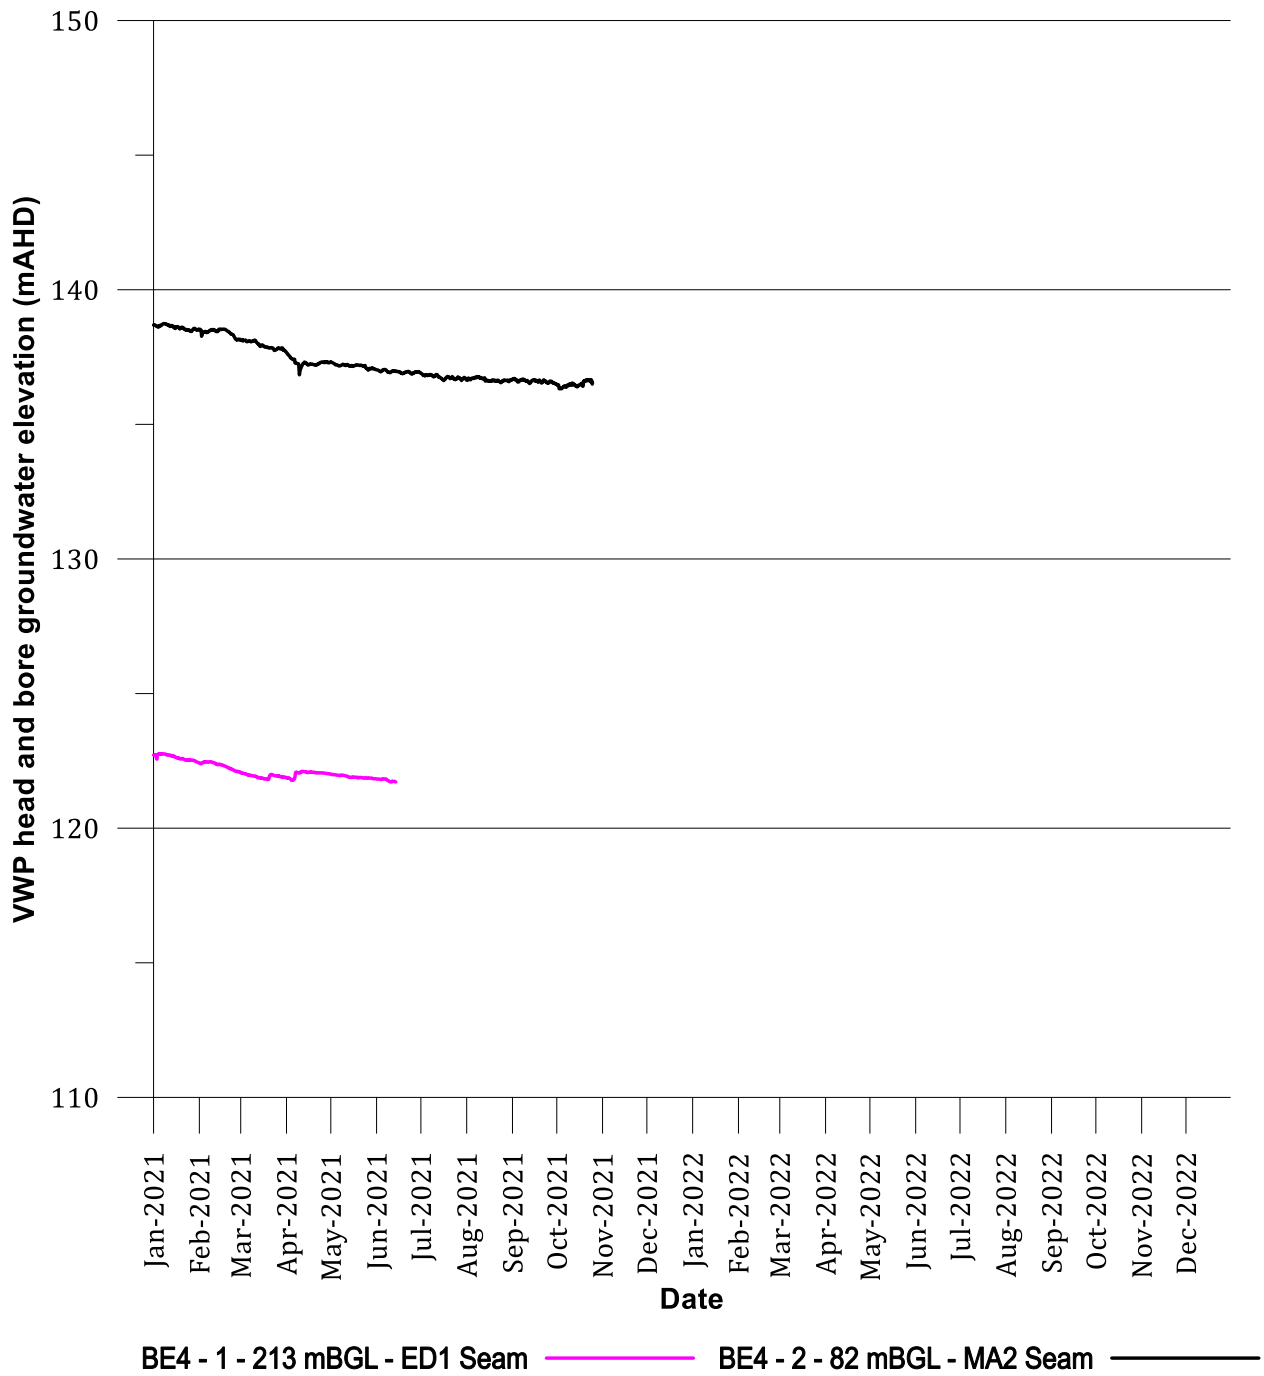
Figure 6.22 Northwest Permian VWP potentiometric heads – BE4

- VWPs at BE4 (Figure 6.22):
 - BE4 was removed in October 2021 due to blasting operations. It is recommended that a replacement VWP be installed to continue monitoring in the area.

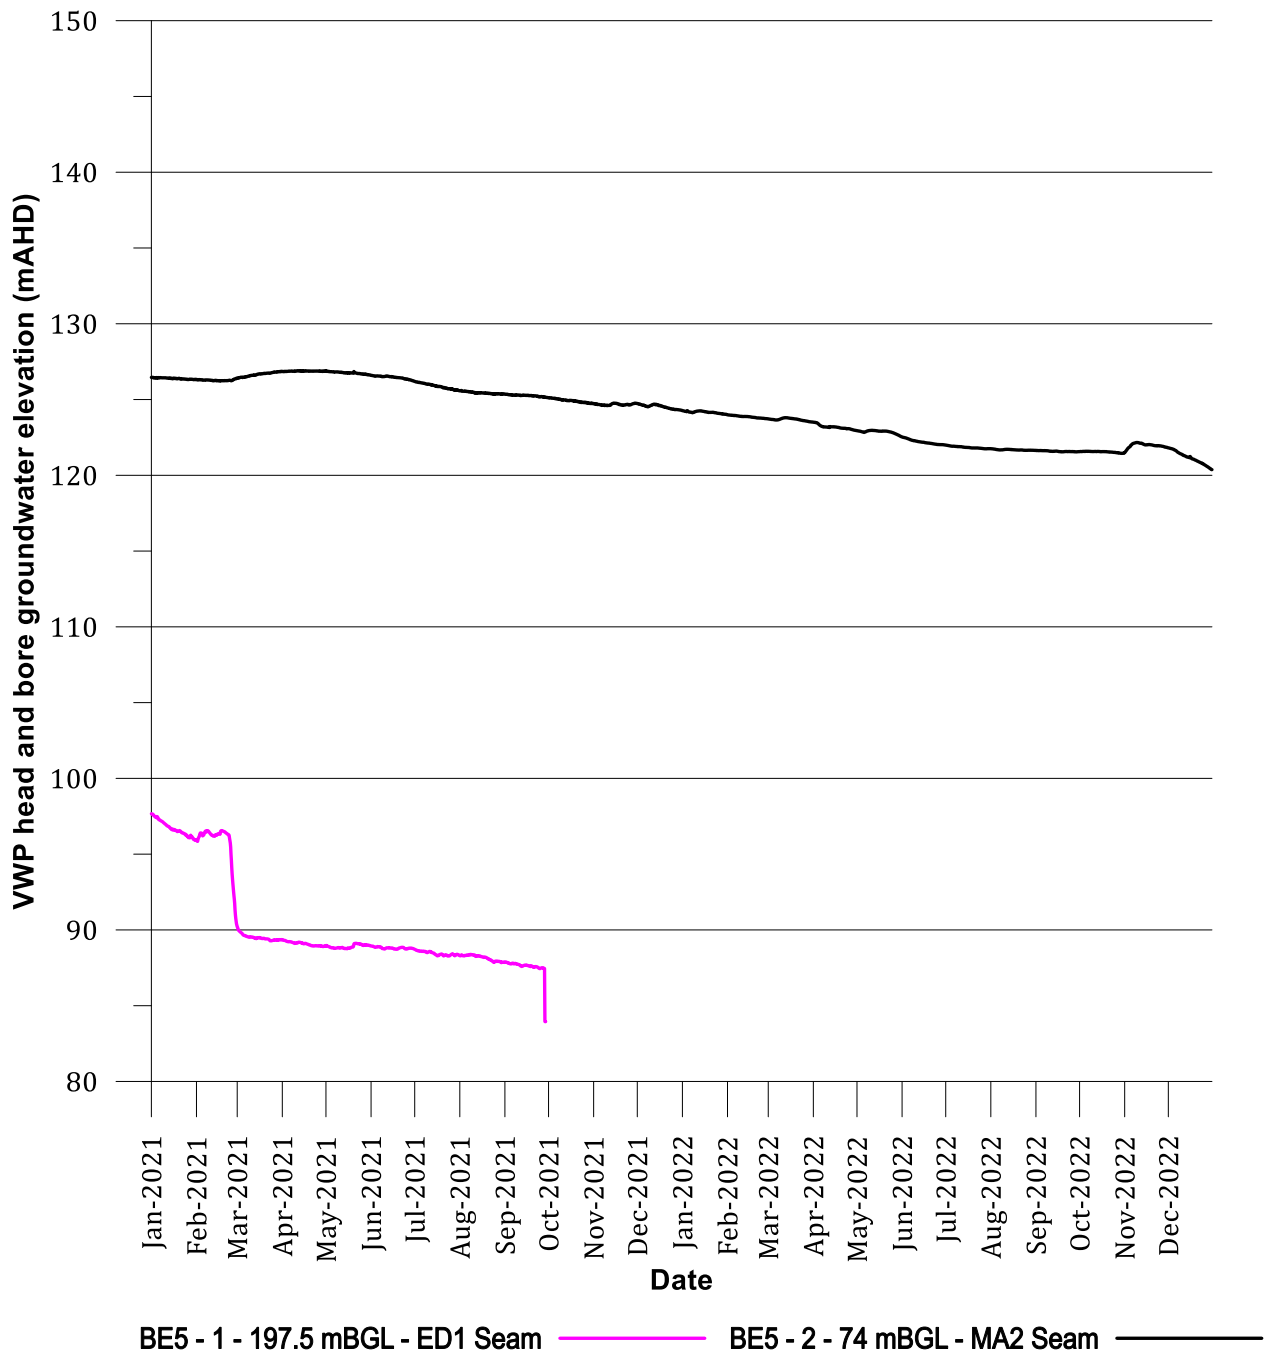
Figure 6.23 Northwest Permian VWP potentiometric heads – BE5

- VWPs at BE5 (Figure 6.23):
 - Mt Arthur VWP sensor recorded a decline in pressure head in 2022. A sudden decline in pressure head was recorded in March 2021 in the Edderton Seam.

- Erroneous data has been recorded in sensor one since September 2021. To continue monitoring pressure head in the Edderton seam a replacement VWP installation should be installed.

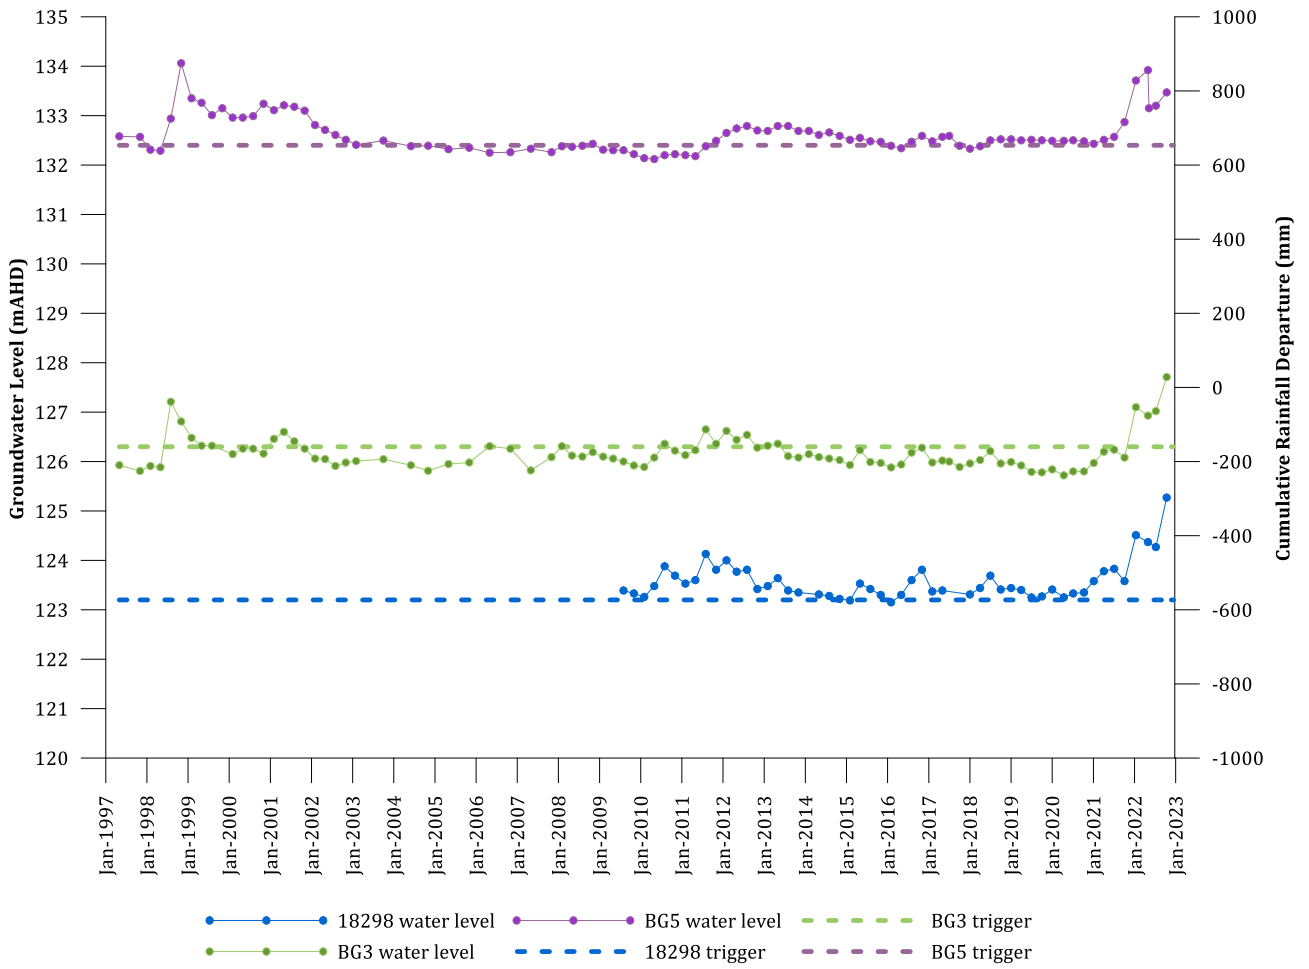
Figure 6.24 Hydrograph of bores with groundwater levels near maximum predicted drawdown

Groundwater elevation in bore BG3 no longer exceeded its trigger level in 2022, following four consecutive quarterly exceedances in 2021. The groundwater level for bore BG5 has also fluctuated around its trigger level and had water level trigger exceedances in 2018 (Figure 6.24). However, there were no exceedances for this bore in 2022. Similarly, bore 18298 is encroaching on the established trigger value but did not exceed this value in 2022.

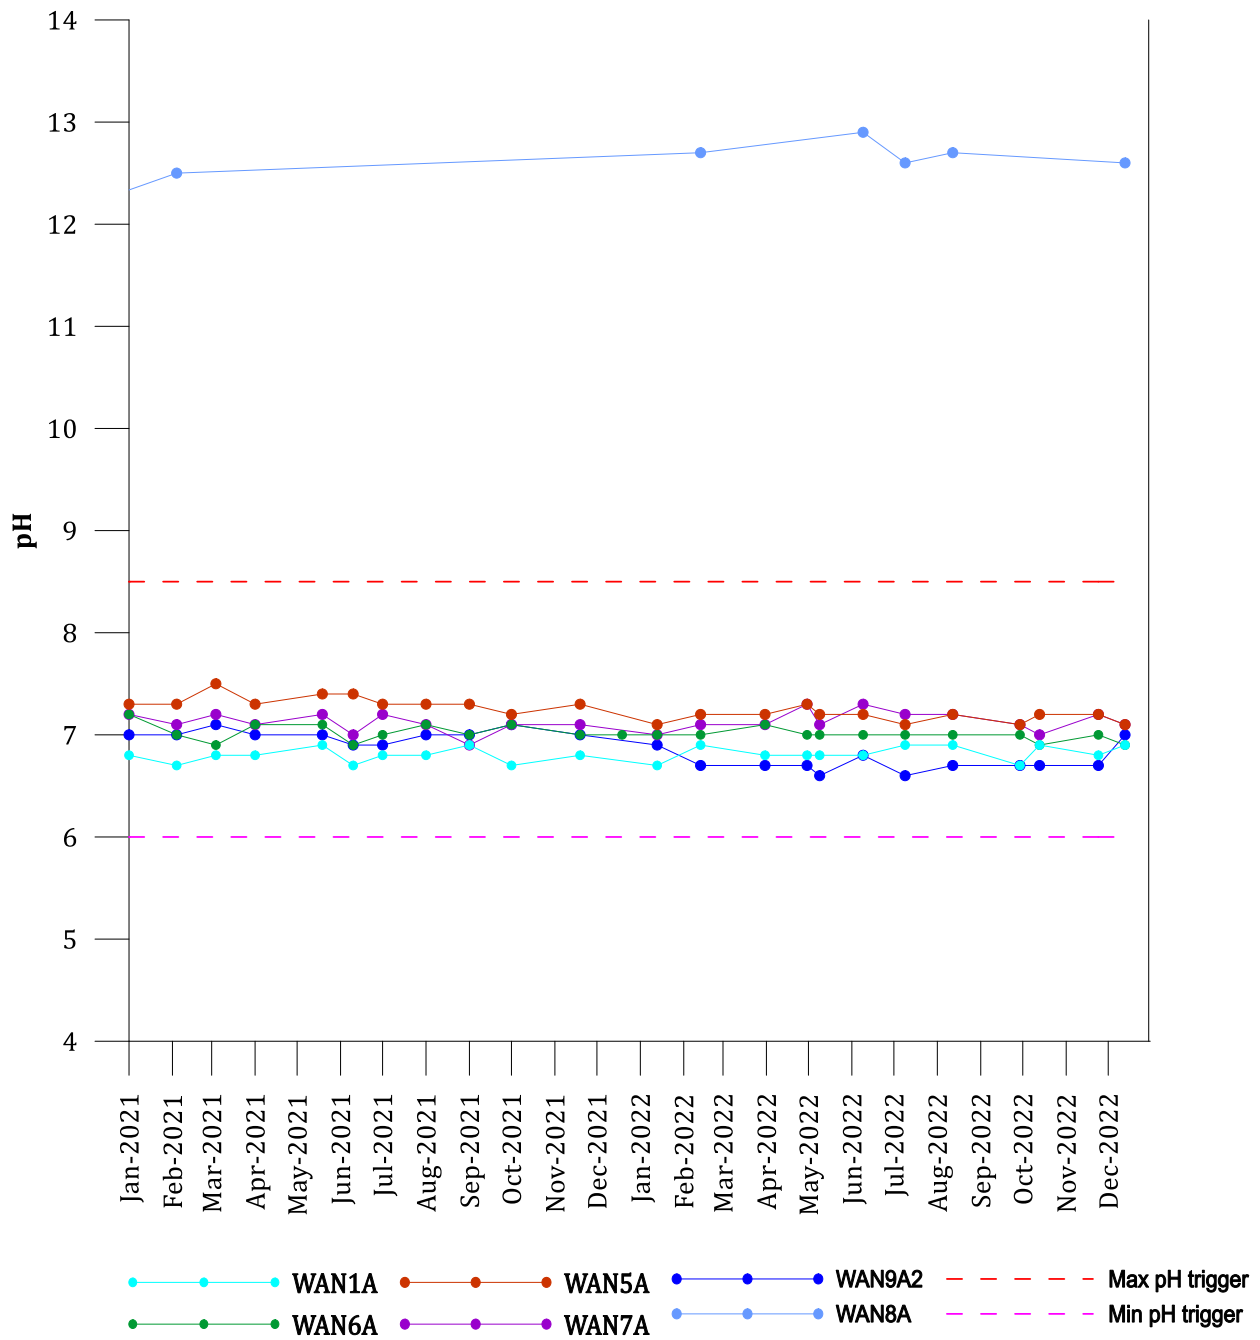
Figure 7.1 pH trends – Hunter River alluvial bores

Figure 7.1, Figure 7.2 and Figure 7.3 show pH trends in alluvial bores. Groundwater pH trends for Hunter River alluvial bores have remained consistent across 2022 with some minor fluctuations evident.

Groundwater pH in WAN8A remained anomalously high. The bore has historically contained insufficient water to sample. Excepting December 2022, there was less than 0.6 m of water in the bore for both pH readings from WAN8A, below the bore screen. These observations of water level and water quality together indicate that the water being sampled from WAN8A is stagnant water from the bore sump, rather than a representative sample of the screened formation. The monitoring procedure for this bore should be redressed to exclude sampling if there is insufficient water to provide a representative sample. The high pH values at this site do not pose an environmental risk.
