BENGALLA MINE ANNUAL REVIEW 2022

BENGALLA MINING COMPANY PTY LIMITED
LOCKED BAG 5
MUSWELLBROOK NSW 2333

April 2023

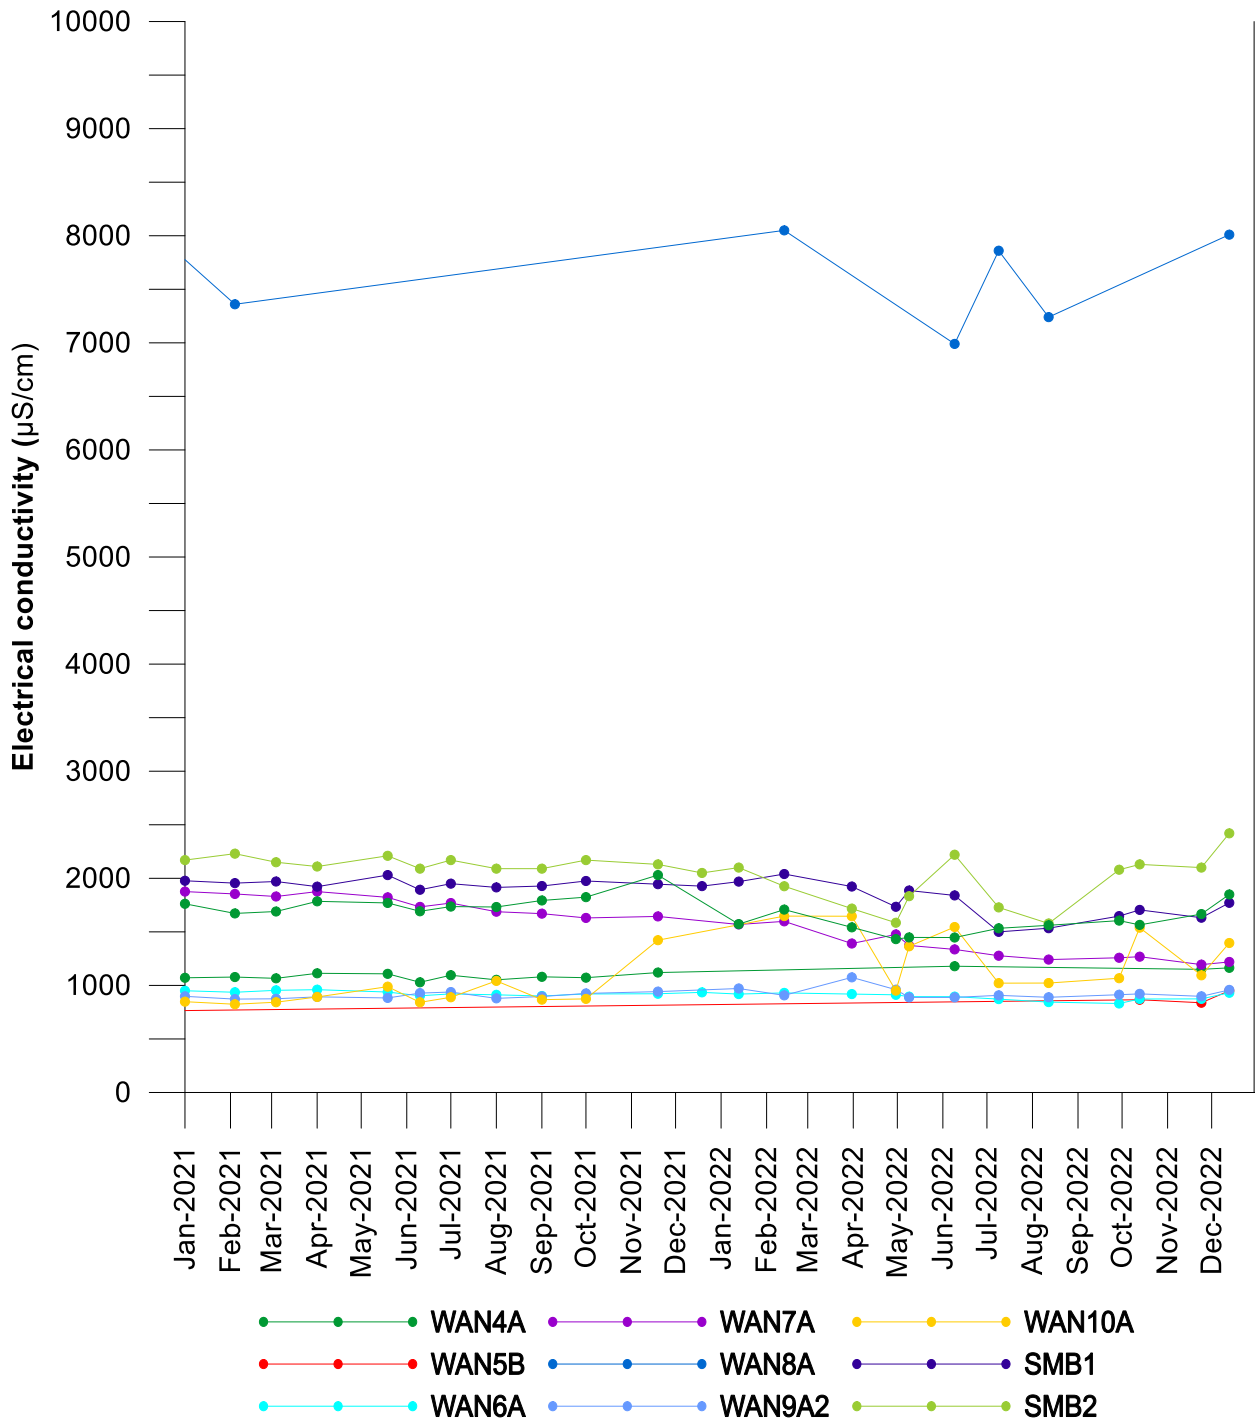
Figure 7.4 EC trends – Hunter River Alluvium (Wantana Extension)

Figure 7.4 and Figure 7.5 show EC trends in alluvial bores in the Wantana Extension Area and Regional alluvial monitoring bores, respectively.

WAN4A has been recording a gentle decline in EC since early 2015 with the last recorded value 1,164 $\mu\text{S}/\text{cm}$ (December 2022). WAN4A is on a “spur” of alluvium to the south of Bengalla’s southern endwall. The coal seams in this area have depressurised due to mining and the decrease in pressure has allowed local infiltration of less saline river water in the alluvium, causing a decrease in EC. The water level in this bore does not appear to be impacted. The EC values in this bore should continue to be monitored.

Throughout 2022, monitoring bores WAN7A, SMB1 and SMB2 presented EC values between 1,500 $\mu\text{S}/\text{cm}$ and 2,500 $\mu\text{S}/\text{cm}$. Although these results are above 1,500 $\mu\text{S}/\text{cm}$, these bores have generally remained consistent throughout 2022 and are comparable to historical values (Figure 7.4). Monitoring bore WAN10A recorded anomalously high EC values above 1,422 $\mu\text{S}/\text{cm}$ from November 2021 to June 2022, however all other values ranged between 820 $\mu\text{S}/\text{cm}$ and 1,045 $\mu\text{S}/\text{cm}$, consistent with historic values. No values were recorded for December 2021 and January 2022 as the access to site was flooded.

- WAN4A EC values continued to decline throughout 2022, recording a measurement of 1,164 $\mu\text{S}/\text{cm}$ in December 2022. The bore is likely impacted by underlying coal seam depressurisation due to mining. The decrease in pressure has allowed local infiltration of less saline river water into the alluvium, causing a decrease in EC. The water level in this bore does not appear to be impacted. The water quality appears to be returning to a level in line with the pre-2008 water quality in this bore. The EC values in this bore should continue to be monitored.

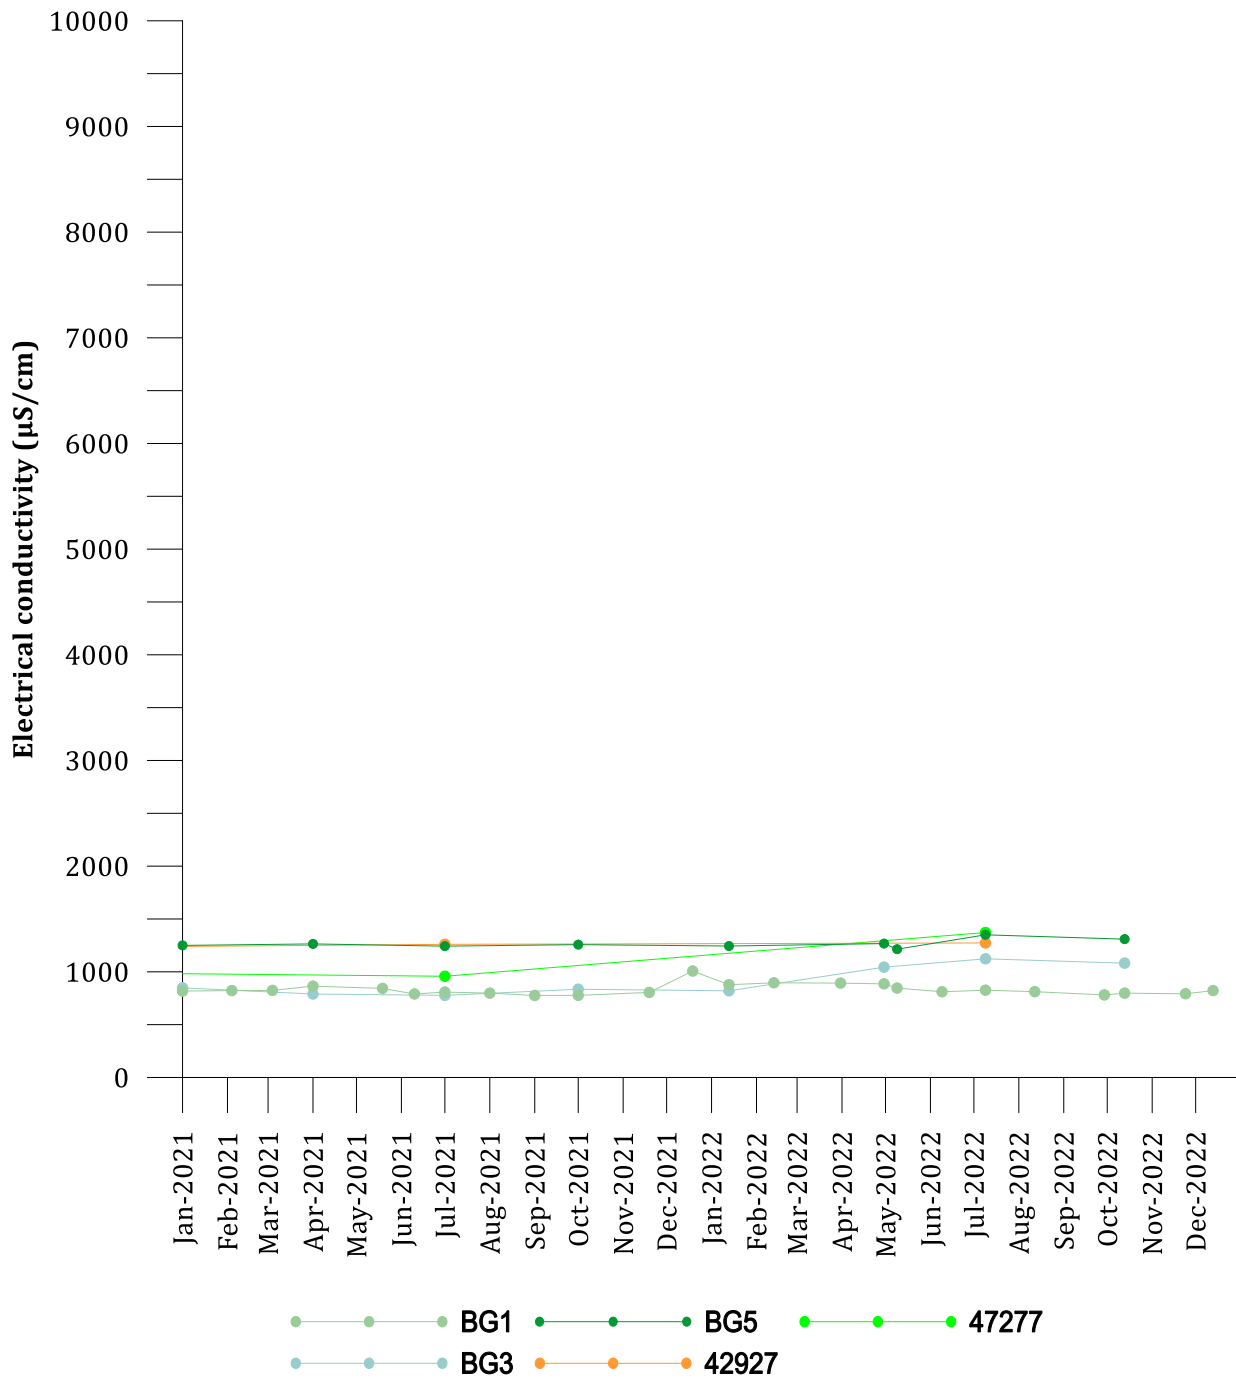
Figure 7.5 EC trends – Hunter River Alluvium (Regional)

Regional monitoring bore BG3 is situated along strike to seams currently being mined at Bengalla (and north of Mt Arthur where the same geological profile is mined), and has historically shown significant variation in EC, following a generally decreasing trend since 2015. EC values have slightly increased in 2022, recording an average EC of 813 $\mu\text{S}/\text{cm}$ in 2021 and an average of 1017 $\mu\text{S}/\text{cm}$ in 2022 (Figure 7.5).

EC values in alluvial bores generally remained stable between 2021 and 2022, with fluctuations coincident with increased rainfall over 2022. It does not appear that there are mine related impacts on groundwater EC within these bores.

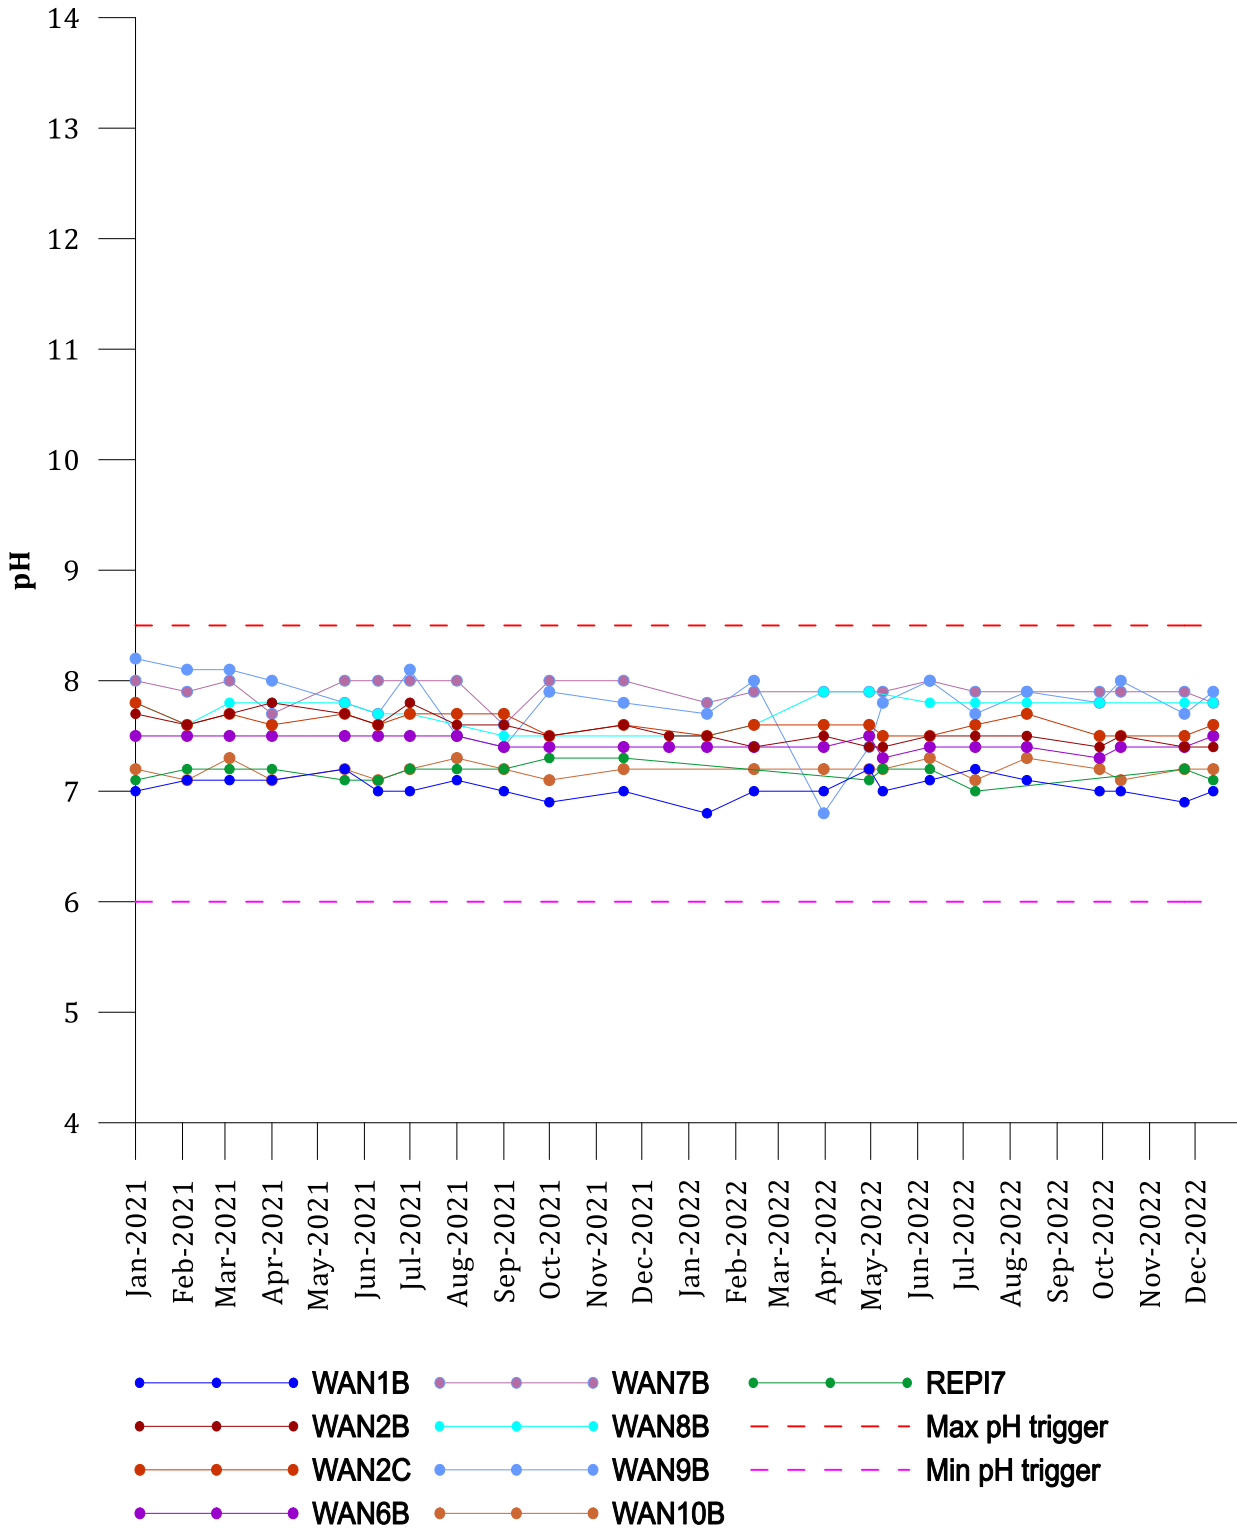
Figure 7.6 pH trends – coal seam aquifers

Figure 7.6 and Figure 7.7 show pH trends for coal seam units and interburden bores in the Wantana area, respectively. Groundwater pH trends in coal seams and interburden have remained circumneutral and stable, and generally share the same trends over 2022. No coal seam/interburden bores have exceeded pH trigger values throughout 2022.

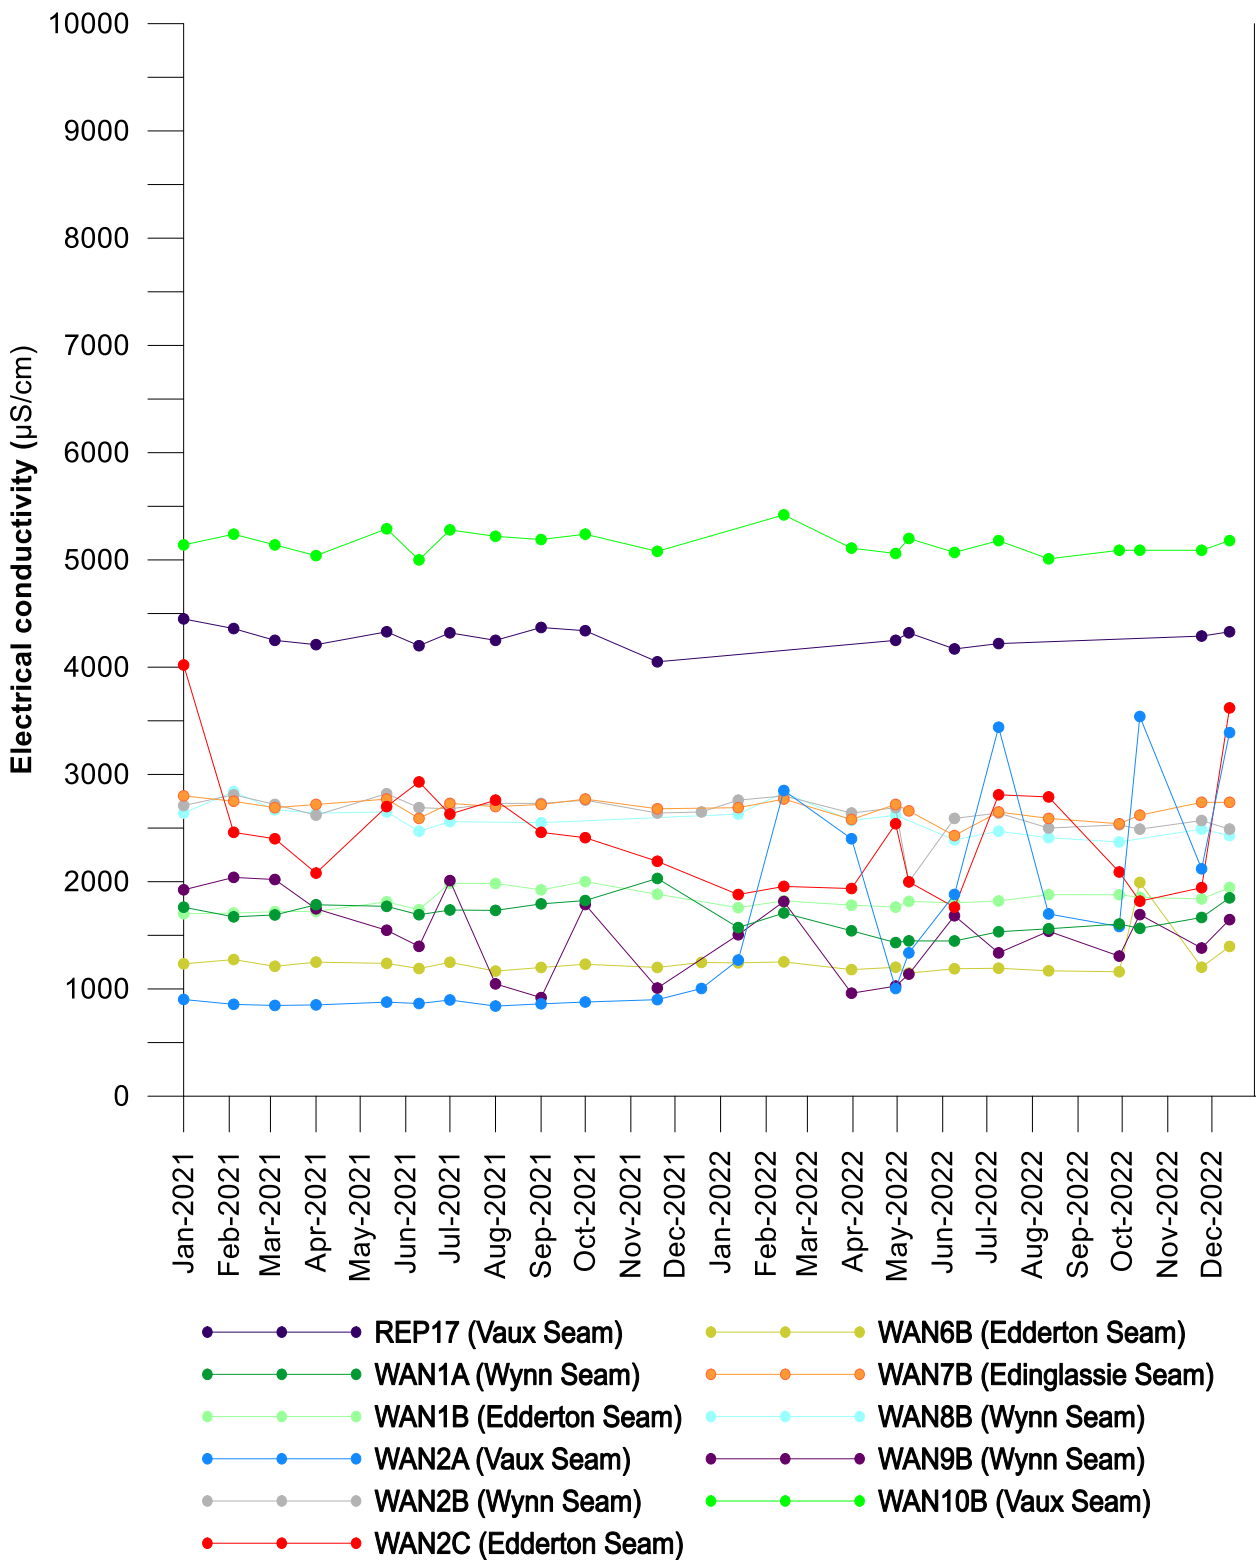
Figure 7.8 Electrical conductivity trends – Coal seam aquifers (Wantana Area)

Figure 7.8 and Figure 7.9 show EC trends for coal seam units and interburden bores in the Wantana area and regional monitoring bores, respectively. Water quality trigger events in 2022 are described in Section 7.5.

- bores that have EC measurements generally less than 2,000 $\mu\text{S}/\text{cm}$, including WAN1A, WAN1B, WAN6B, and REP17 (lower EC group; Figure 7.8);
- bores that have EC measurements between 2,000 $\mu\text{S}/\text{cm}$ and 3,000 $\mu\text{S}/\text{cm}$, including WAN2A, WAN2B, WAN2C, WAN4B, WAN7B and WAN8B; and
- bores that have EC measurements between 3,000 $\mu\text{S}/\text{cm}$ and 9,000 $\mu\text{S}/\text{cm}$, including WAN5B, WAN9B and WAN10B that are within the expected range for coal seam bores (Figure 7.8 and Figure 7.9).

Groundwater EC in seven coal seam monitoring bores exceeded their derived triggers in 2022 (Table 7.1):

- REP17;
- WAN1B;
- WAN2A;
- WAN2C;
- WAN6B;
- WAN8B; and
- WAN10.

- Four bores in the coal seams (WAN1A, WAN1B, WAN6B, and REP17) show EC less than 2,000 $\mu\text{S}/\text{cm}$, suggesting leakage from the alluvium due to depressurisation of the coal seams. WAN9B has historically recorded EC at or above 2,000 $\mu\text{S}/\text{cm}$. EC values in WAN9B increased in 2022, with the latest recorded measurement in December being 1,646 $\mu\text{S}/\text{cm}$. It should be noted that WAN1A and WAN2A are screened nearby the contact of a coal seam and alluvial material and are not considered to be screened wholly within coal. This freshening of the alluvium, coal measures and interburden was predicted in the EIS groundwater model, which states "*Water quality in the alluvial sediments will improve as a result of decreased discharge of water from hardrock aquifers to the alluvial aquifer due to aquifer depressurisation.*"

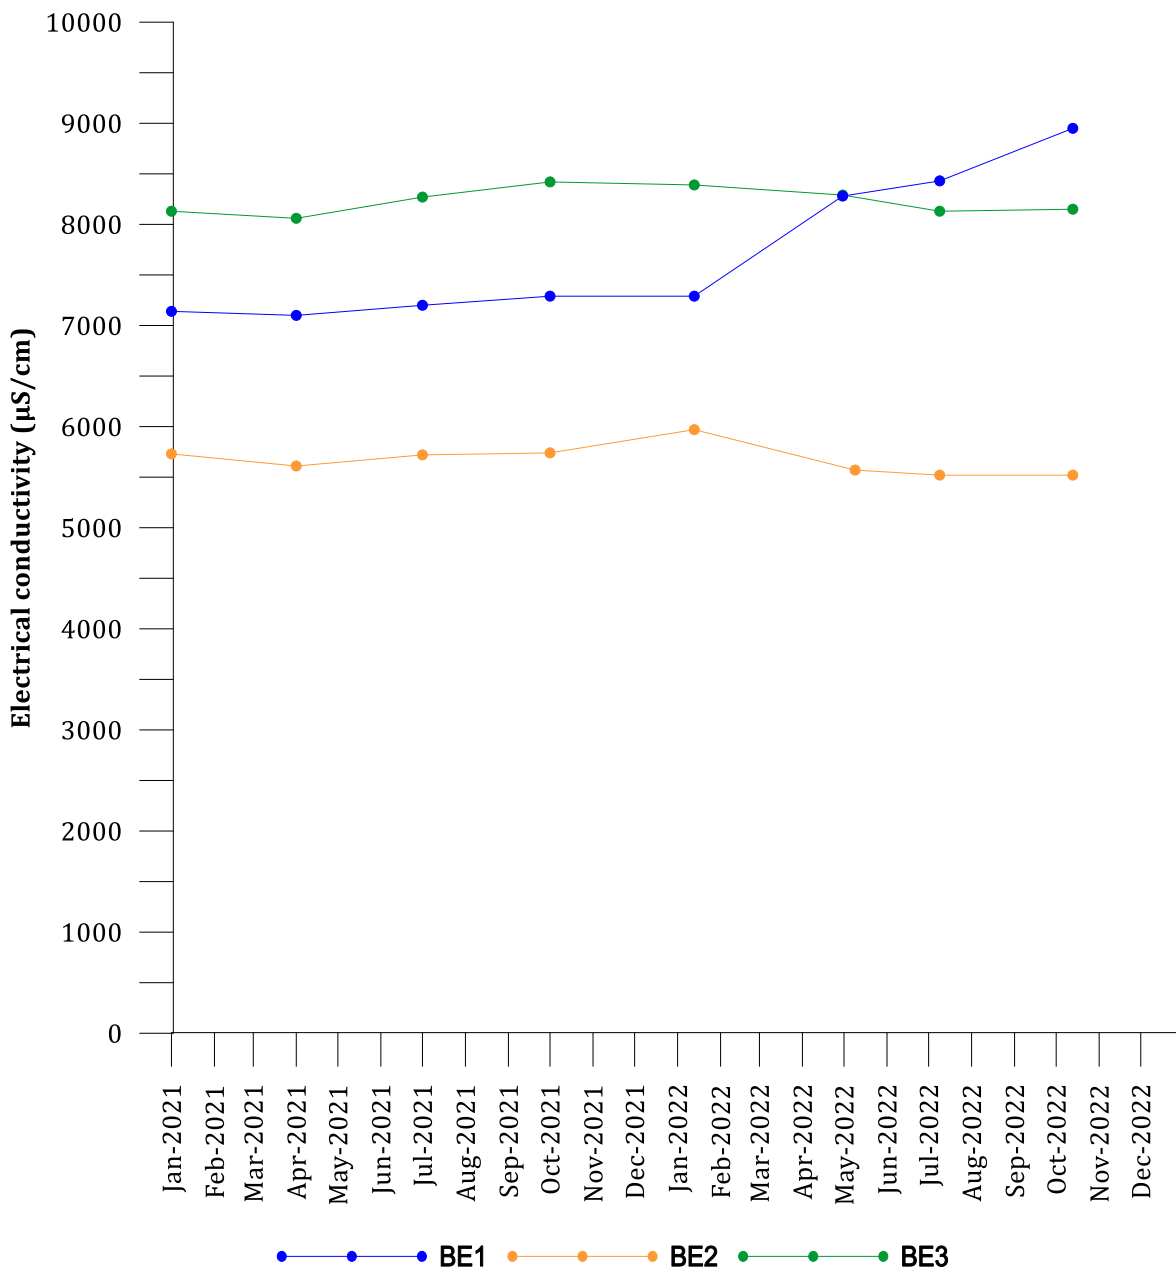
Figure 7.10 Electrical conductivity of Permian bores to the northwest of active mining

Figure 7.10 and Figure 7.11 show the EC and pH, respectively, for bores to the northwest of active mining. These bores include:

Figure 7.10 showed similar trends for bores BE2 and BE3, wherein EC remained stable between January 2021 and January 2022, then decreased throughout 2022. BE1 remained stable throughout 2021, then increased from January 2022 onward. These bores are ahead of the mine highwall and there is no apparent depressurisation. The changes in EC, which is naturally elevated, are likely due to natural variation.

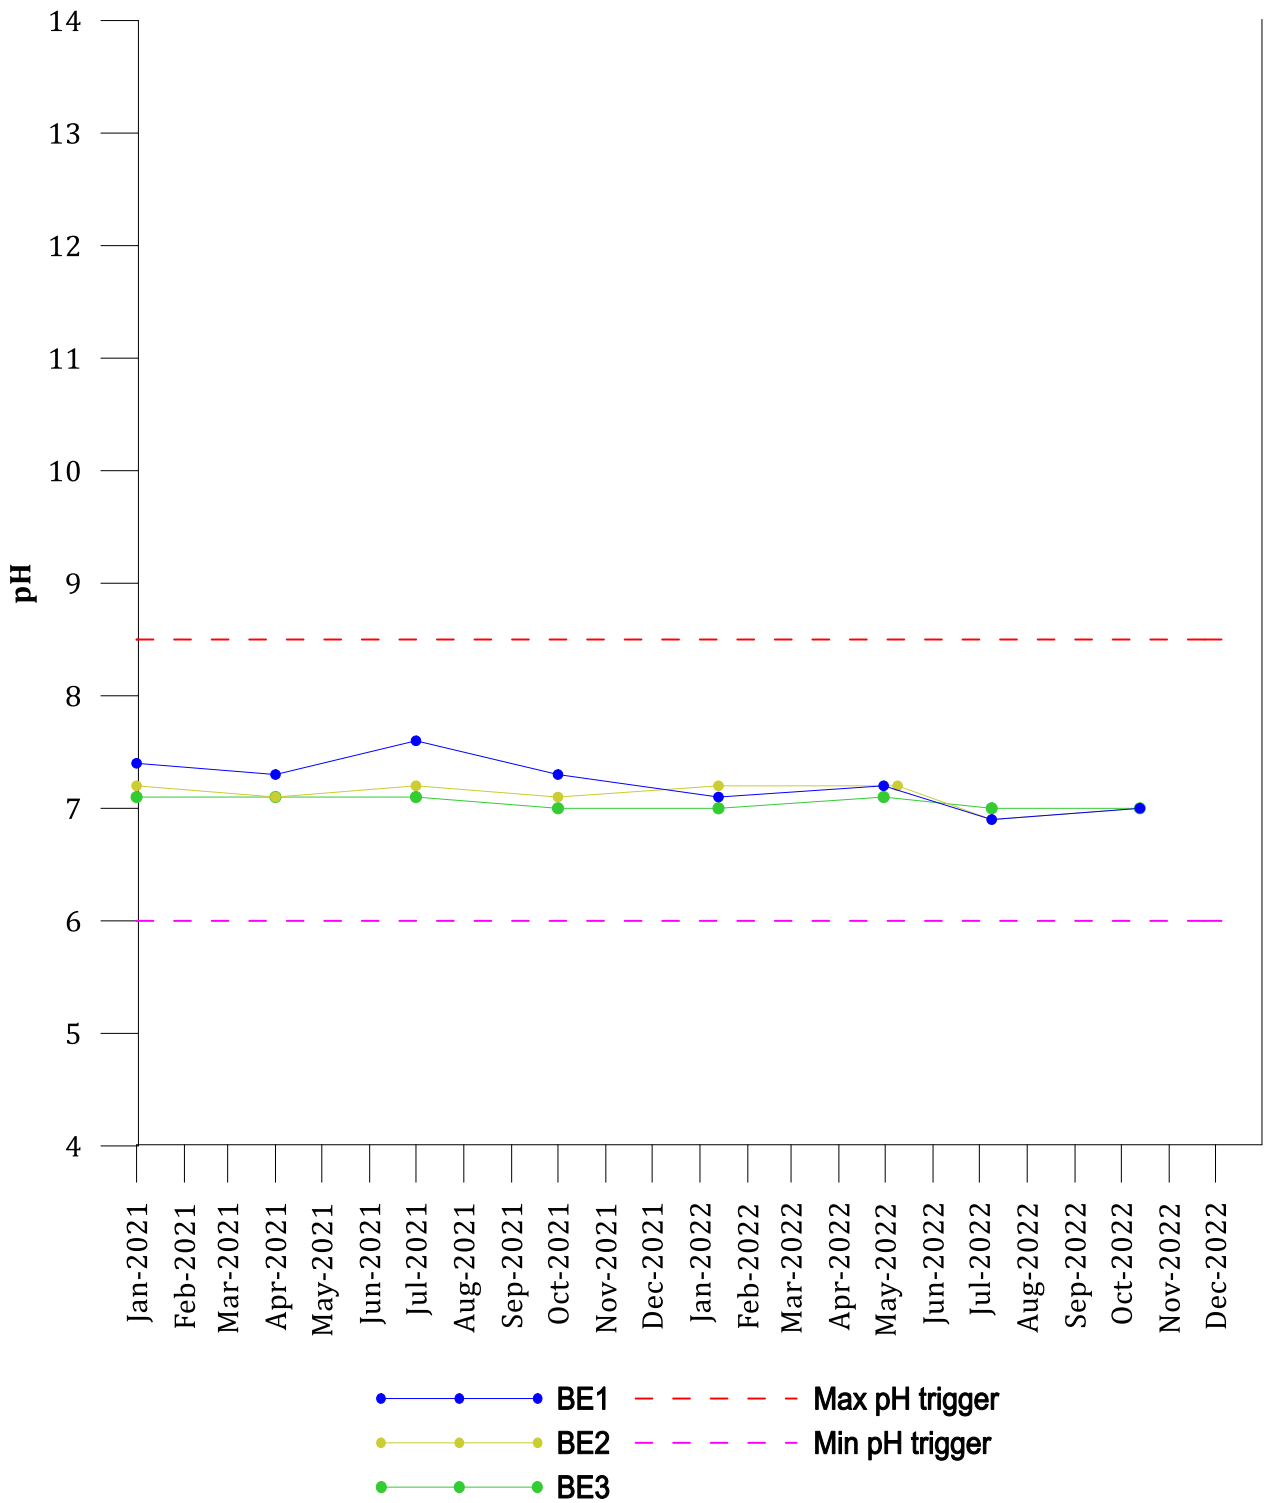
Figure 7.11 pH of Permian bores to the northwest of active mining

Figure 7.11 shows pH values have remained circum-neutral and stable in 2022. Groundwater pH values for all monitoring bores are within historic ranges.
