# BENGALLA MINE ANNUAL REVIEW 2020

**BENGALLA MINING COMPANY PTY LIMITED**  
LOCKED BAG 5  
MUSWELLBROOK NSW 2333

APRIL 2020

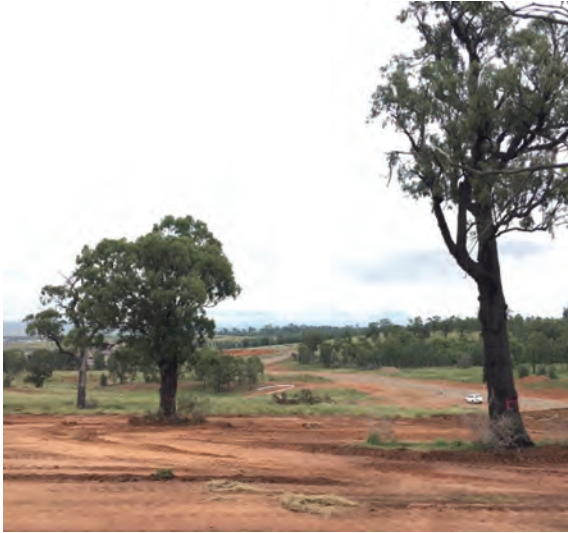
Photo 3.1 Stage 2 – clearing – GDP 2001

Prior to the habitat trees being felled, the trees were visually inspected to identify signs of fauna utilisation. Habitat trees were gently shaken prior to felling to encourage any resident fauna to vacate any fissure and/ or hollow. Habitat trees were then felled sequentially when directed by the supervising ecologist.

Immediately following the felling of each habitat tree, the supervising ecologist inspected the trees for remaining fauna. Tree hollows were inspected using a hand-held torch. Felled habitat trees were left undisturbed over night to allow any undetected fauna further opportunity to relocate. The habitat trees were then stockpiled for utilisation in rehabilitation areas.

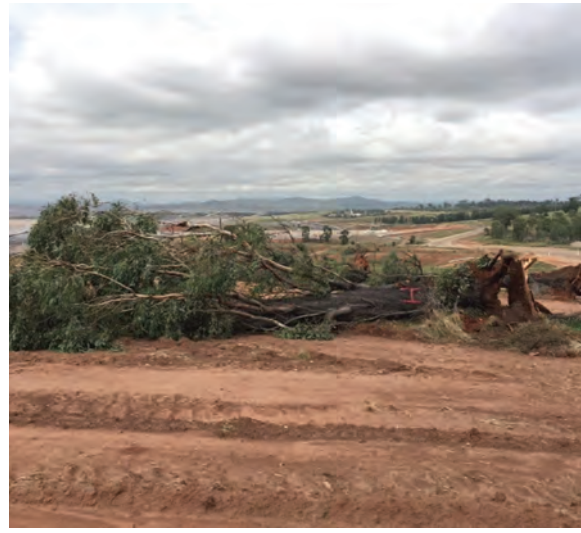
Photo 3.2 Stage 2 – clearing – post felling

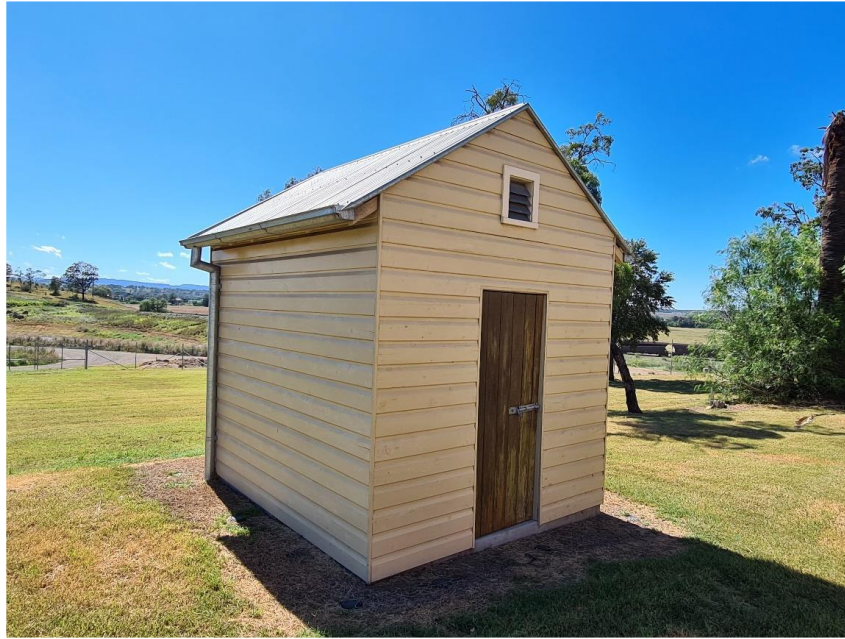
Reconstructed garden shed - cladding and framing

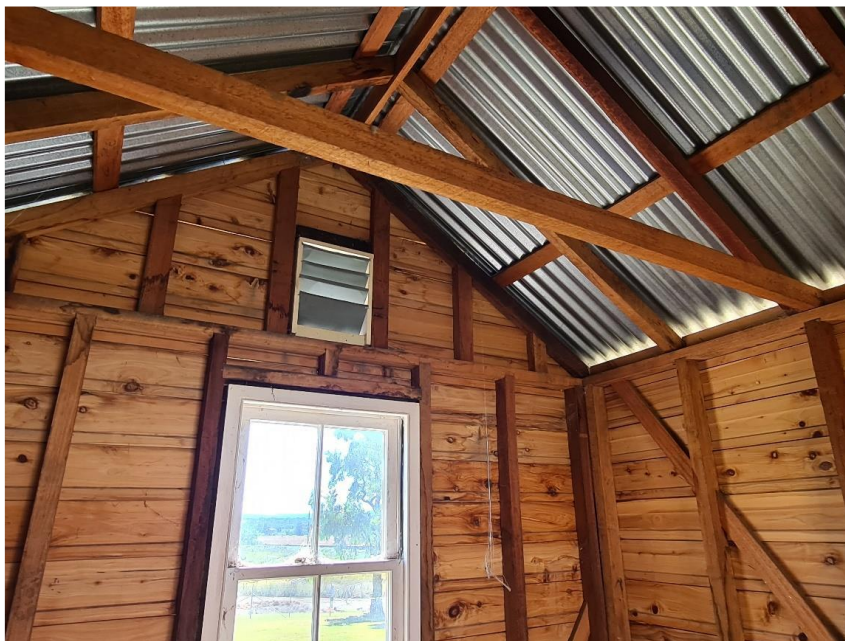
Reconstructed garden shed internal view of cladding and framing
