**J.1 In-Pit Tailing Storage Facility
Management Plan**

IN-PIT TAILINGS STORAGE FACILITY MANAGEMENT PLAN

*New Acland Coal Mine
Stage 3 Project*

JANUARY 2014

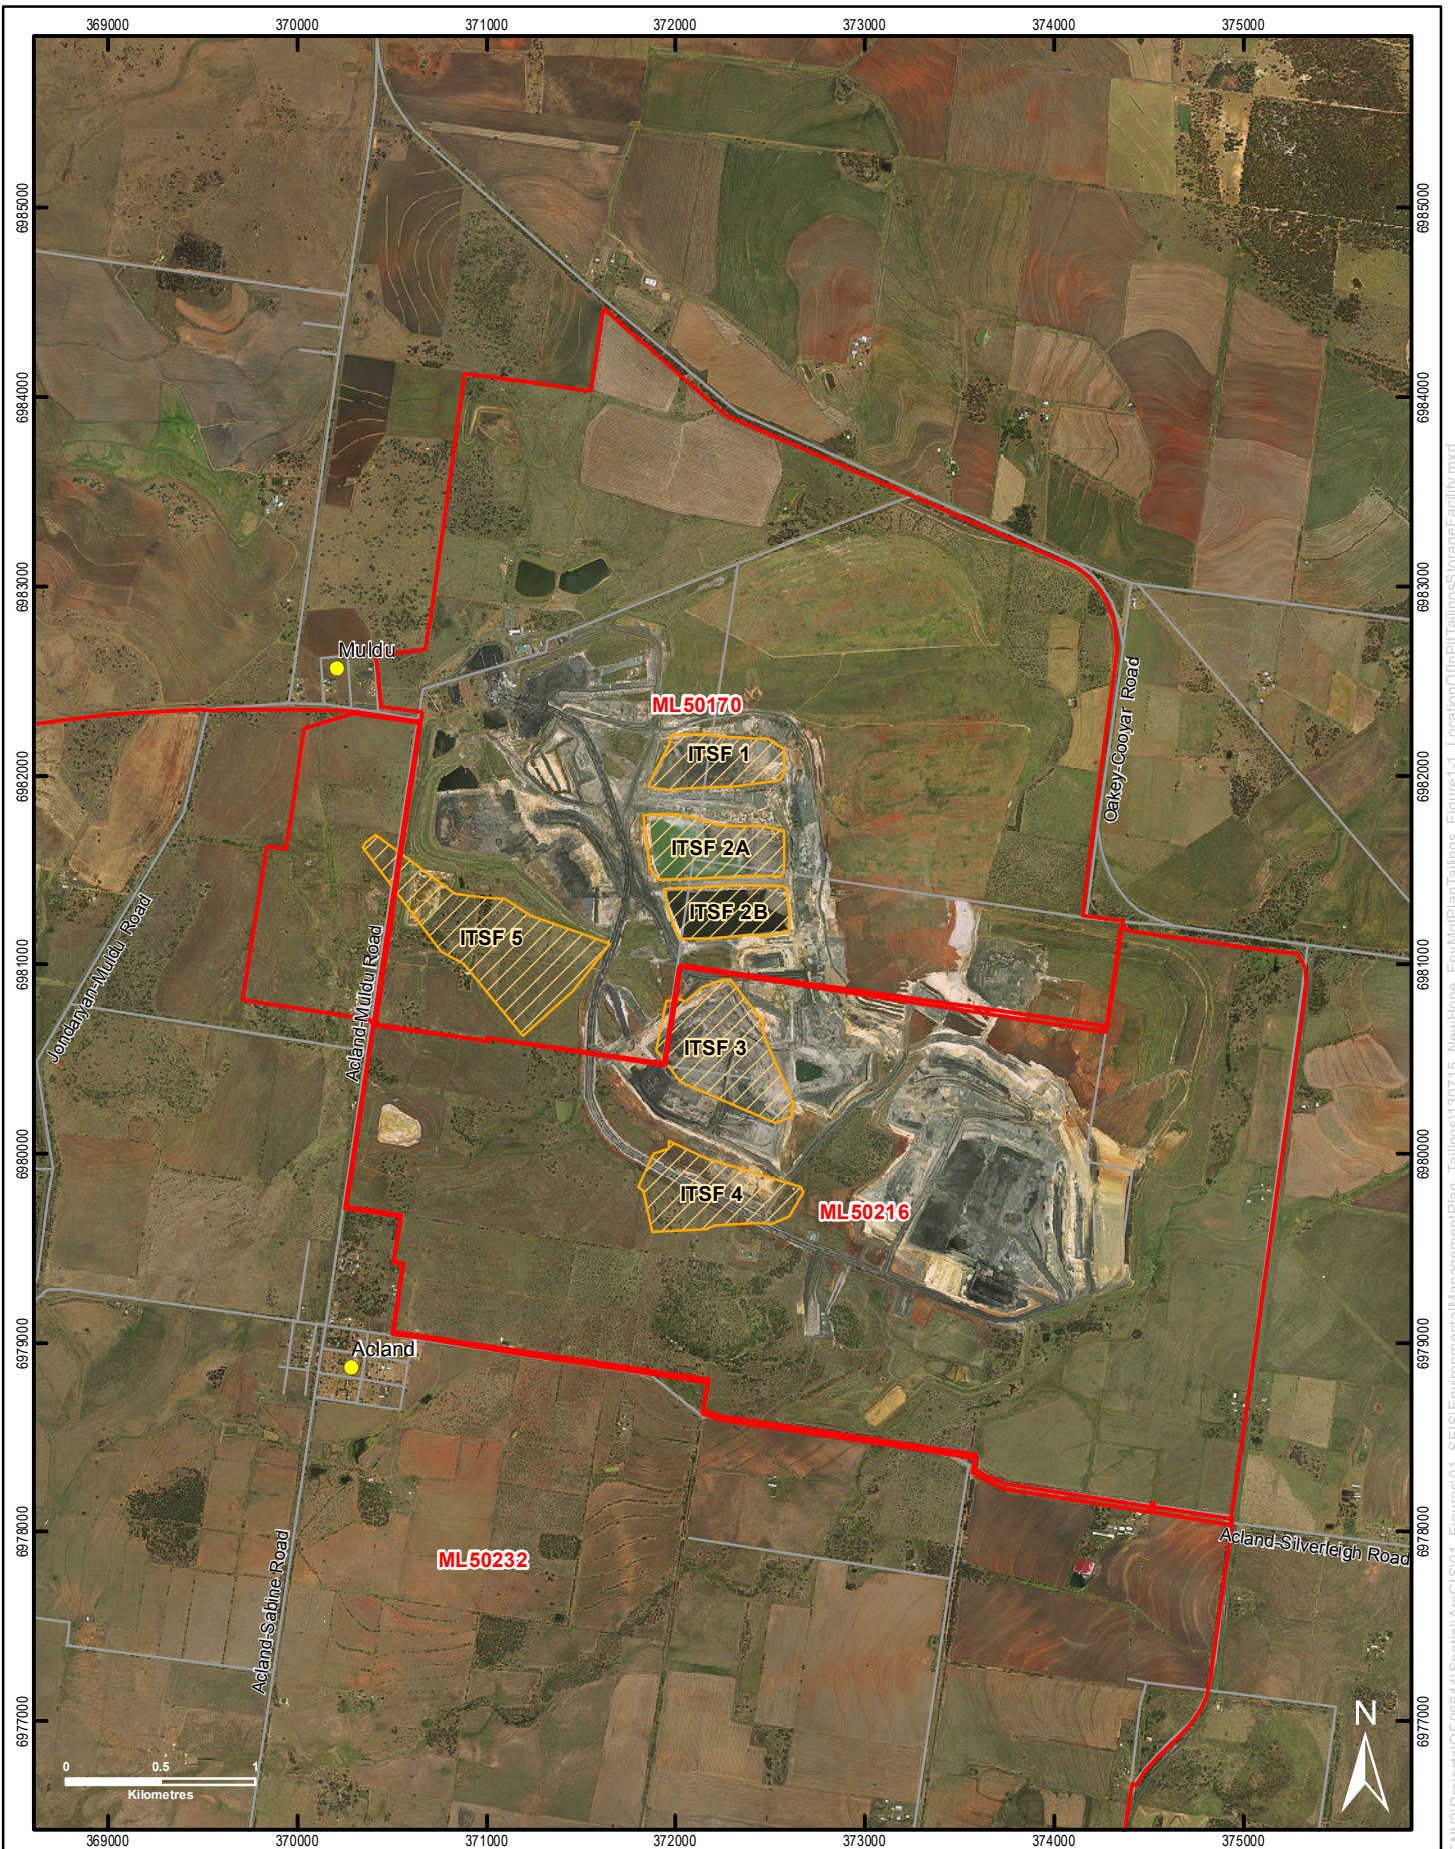
Figure 2-1 - Location of In-Pit Tailings Storage Facilities (ITSF)

the tailings produced by the revised Project. The locations of the ITSFs for the revised Project are shown in Figure 2-1.

The tailings produced as a result of the revised Project will be deposited into ITSF 4 & ITSF 5 (as depicted in Figure 2-1) within the Centre Pit void area. Therefore, it is considered unlikely that the area designated for the disposal of tailings from the revised Project will result in impacts on groundwater resources. Monitoring to date has shown that there is no evidence that ITSF seepage has occurred into any localised shallow basalt and deeper coal measure aquifers. However, the potential seepage from the ITSF infiltrating the localised shallow basalt and deeper coal measure aquifers will be monitored by NAC's groundwater monitoring regime under the revised Projects EA.
